Property Status	Ownership H / Ast. Status HB / Rep. Status	
Key	<input checked="" type="checkbox"/> MITM-2615525 WF	s11C(1) 15/01/2018 10:14
Raised From	<input type="checkbox"/> INSP-533205 WF PT Product Team 25/10/2017 09:00	
Invoice	<input type="checkbox"/> MINV-1574966 WF	Maintenance Use... 21/01/2018 08:53
Tax Invoice	<input type="checkbox"/> View Tax Invoice	
Status	<input checked="" type="checkbox"/> Maintenance Done	
Summary	s11C(1)(b) - business : GMATM : Ease and adjust gate Repair broken fence pailings appro...	
Location	Rear Yard	
Fixture Maint. Type		
Charge Type	P (Ready House)	
Maintenance Code	GMATM: Grounds maintenance T&M	View Spec.
Estimated Price	\$250.00	
Contractor Instructions	Ease and adjust gate Repair broken fence pailings approximately 4. Install sleeper along rear RHS fence.	
Access Details

Visual Termite Inspection Report in accord with AS 3660.2-2000

Account To:	DEFENCE HOUSING AUSTRALIA	Phone:	
	SUITE 3-6, 240 WATERWORKS RD	Fax:	07 3294 2660
	ASHGROVE QLD 4060	Invoice No:	0000
Re: Structure at:	[REDACTED]		
Date Inspection:	08 May 2018	Report No:	s11C(1)(b) - business [REDACTED]

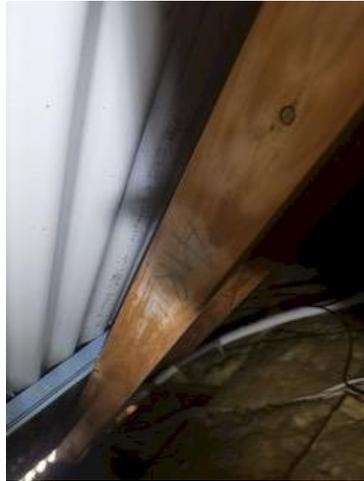
Internal ceiling above moulded area

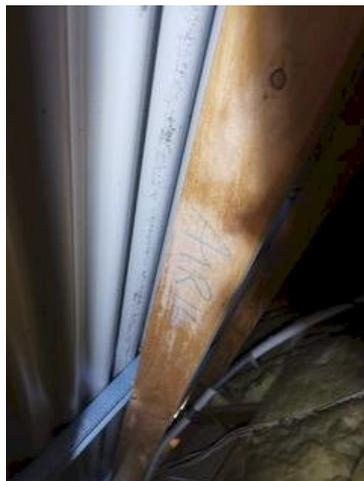
Mould evident on the underside of the sheets

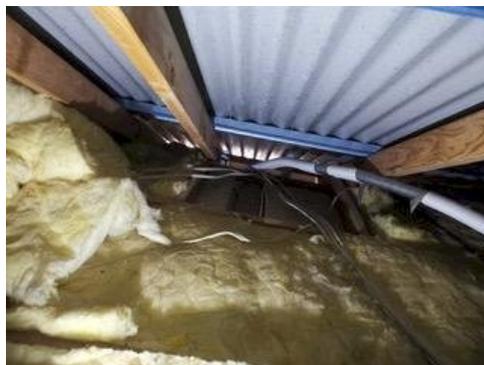
Internal ceiling with electrical cables insulation is in good condition

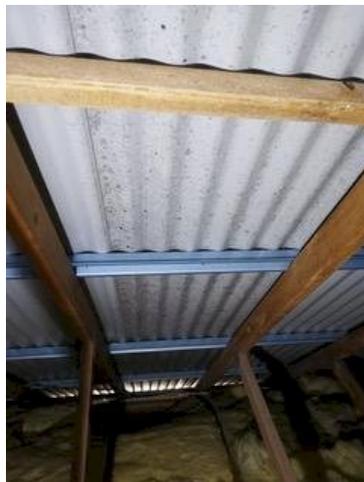
Sheet 1m from gutter has evidence of mould

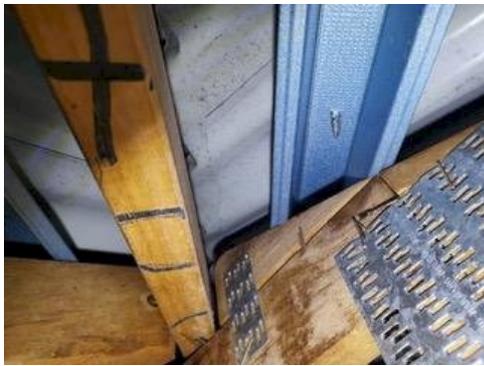
Water staining to timber evident

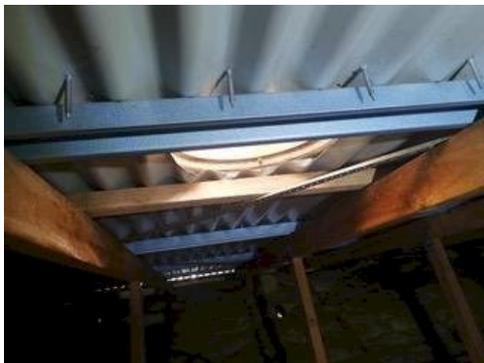
Underside sheets near whirlybird

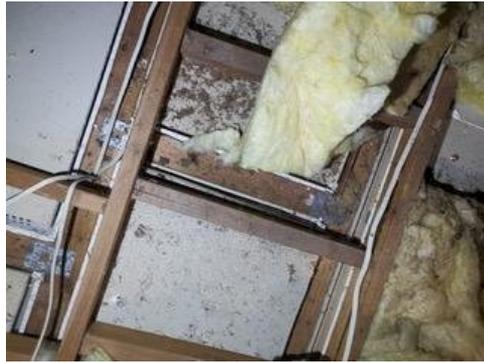
Ceiling above affected area no mould evident

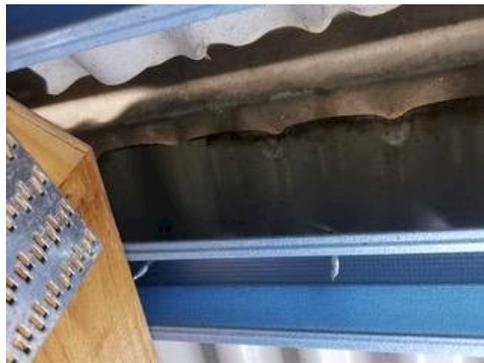
Underside of ridge capping

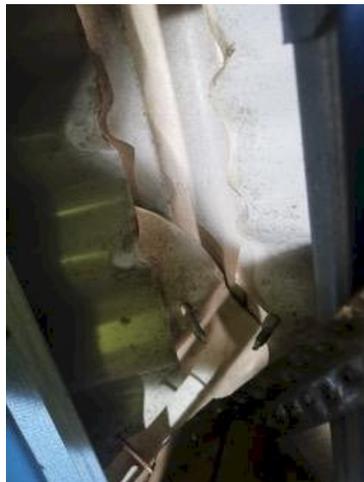
Underneath ridge capping and three way

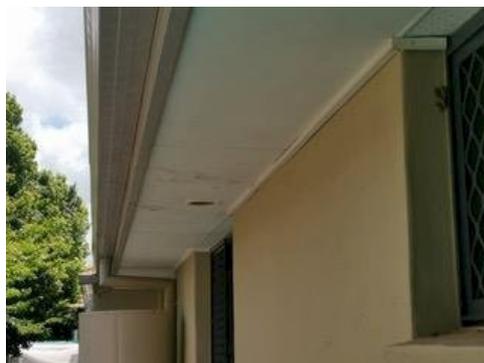
Soffitt on left hand side mould evident

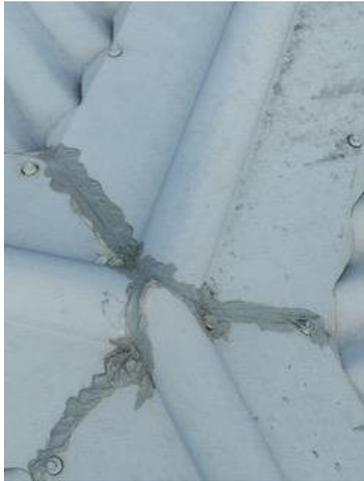
Silicone evident on three way junction

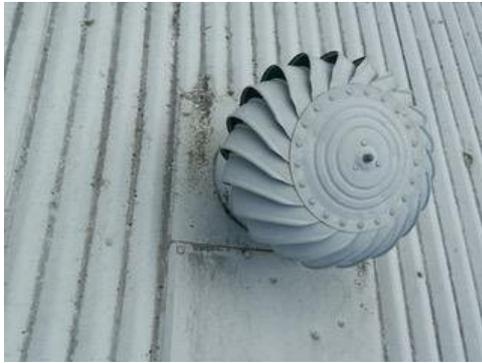
Whirly bird has no evident storm related damage

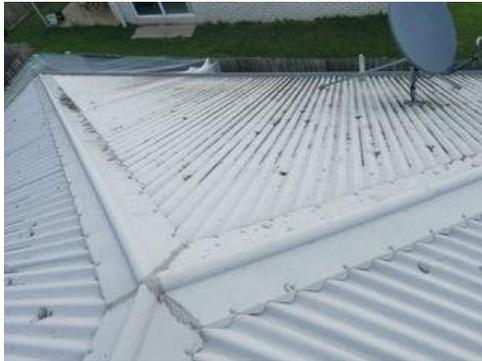
Evidence of mould on roof sheeting

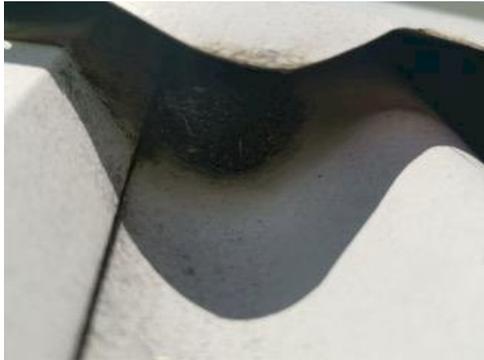
Scribed ridge capping on rear elevation
Leaf debris underneath

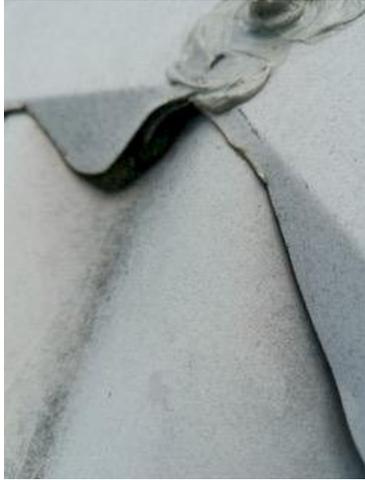
Gap evident on scribed ridge capping

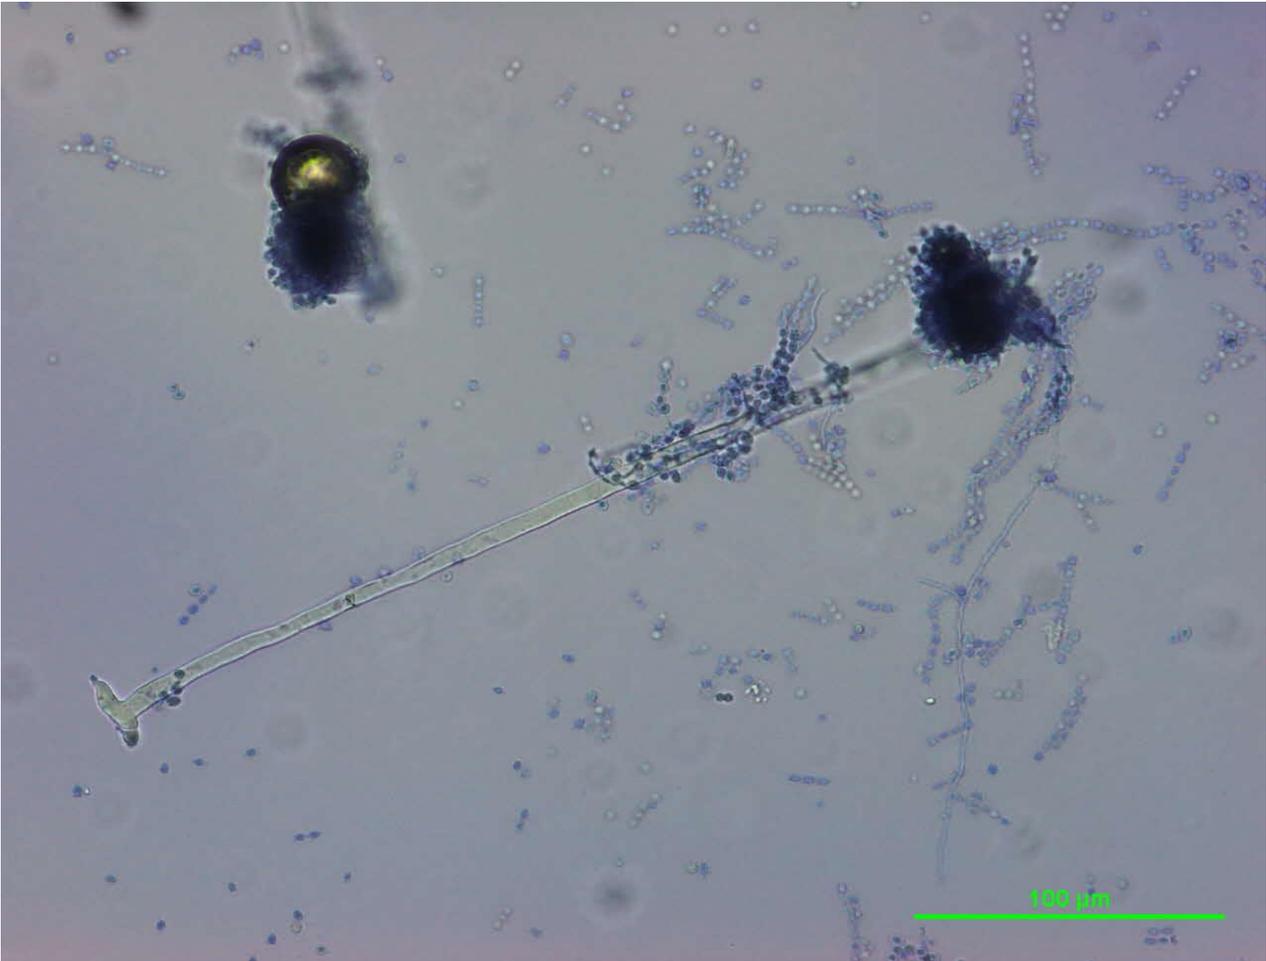
Figure 7.4: Microscopy image from Bed #1 Off Inside of Skirting (sample 9). Sample was stained with Lactophenol Cotton Blue and visualised using a Nikon Eclipse Ci microscope. The large structure is typical of an *Aspergillus* conidiophore, small round spores are aspergillus/penicillium. 200x magnification.

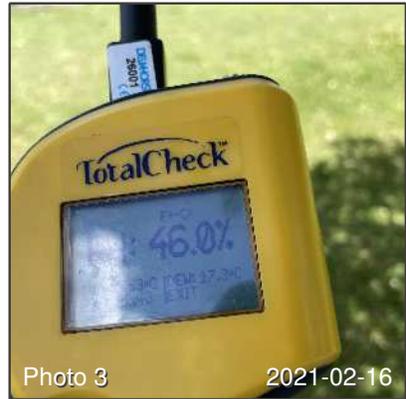
Inside 62 and 65%, Outside 45%, Ceiling 45%
