MOULD ANALYTICAL REPORT

Report Number: 1999

Purpose of Report: To assess the levels and genera of mould present pre-remediation.

Inspection Report & Findings

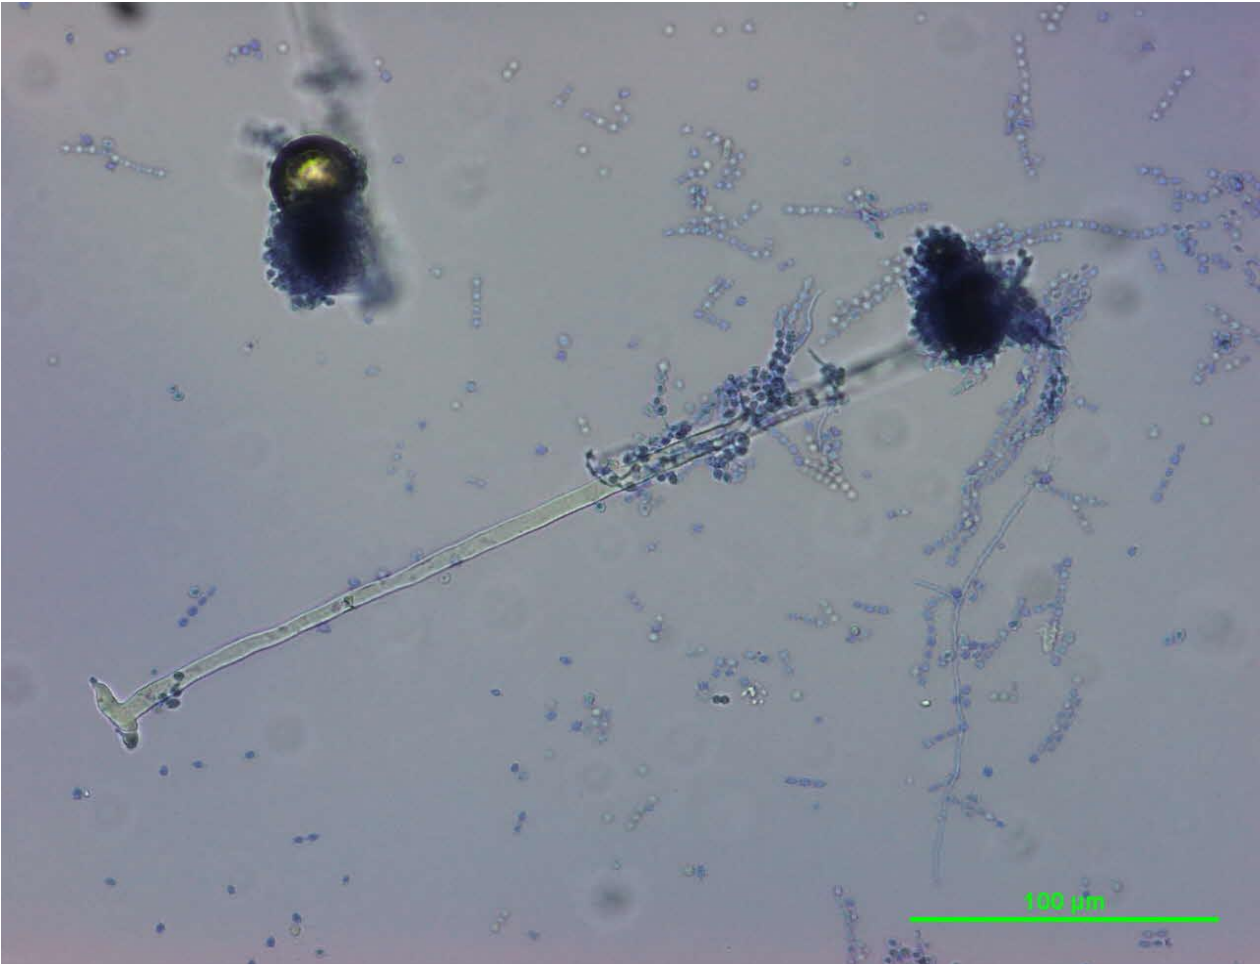
Air sampling of the living areas (2,3,4,6) revealed elevated levels of *Aspergillus*/*Penicillium* as compared to the Outside Reference (1). Air sampling of the Ceiling Void (5) revealed extremely high levels of *Aspergillus*/*Penicillium* and fungal hyphae. Surface sampling of the premises revealed high levels of mould in the HVAC splits (7,8) consisting of *Cladosporium* and fungal hyphae. Surface sampling of the skirting in Bed #1 (9) revealed very high levels of *Aspergillus*/*Penicillium* and fungal hyphae. It should also be noted that fungal structures consistent with *Aspergillus* species were observed in sample 9 (see Figure 7.4). *Aspergillus*/*Penicillium* contain species which are known to be allergenic and produce mycotoxins. The presence of fungal hyphae is indicative of recent active mould growth. From the sampling provided the premises would be classed as 'Condition 3' (active mould growth) according to the IICRC S520 guidelines. At the levels detected mould in the premises pose a significant hazard to health and wellbeing of occupants.

Table 7.1c Extended results (Cont'd) % Analysed	HVAC Split Lounge Room / Dining (7) B2374968 BT 4.0%			HVAC Split Living Room (8) B2431292 BT 4.0%			Bed #1 Off Inside of Skirting (set below HVAC other side of hall) (9) B2491252 BTA40 0.8%		
	Raw count	FS / cm ²	% of total	Raw count	FS / cm ²	% of total	Raw count	FS / cm ²	% of total
Pollen									
Fungal Hyphae	1056	6600	53%	2080	13000	43%	4	12454	3%
Unidentified spores						0%			
<i>Alternaria</i>				4	25	0%			
Ascospores	10	63	1%	1	6	0%			
<i>Aureobasidium</i>									
<i>Aspergillus/Penicillium</i>	39	244	2%	21	131	0%	142	411550	97%
Basidiospores	51	319	3%	58	363	1%			
<i>Bipolaris/Drechslera</i>	2	13	0%						
<i>Chaetomium</i>				1	6	0%			
<i>Cladosporium</i>	777	4856	39%	2690	16813	55%			
<i>Curvularia</i>	15	94	1%	7	44	0%			
<i>Diplodia</i>									
<i>Epicoccum</i>									
<i>Fusarium</i>									
<i>Mucor</i>									
<i>Nigrospora</i>	4	25	0%	7	44	0%

Figure 7.4: Microscopy image from Bed #1 Off Inside of Skirting (sample 9). Sample was stained with Lactophenol Cotton Blue and visualised using a Nikon Eclipse Ci microscope. The large structure is typical of an *Aspergillus* conidiophore, small round spores are aspergillus/penicillium. 200x magnification.

2) Replace 2 skirting sections in bedroom 1 robe. Mould remediation required to property before reinstatement.

Note: Visual mould growth on back side of skirting board found (see results test sample #9)
