HERITAGE MANAGEMENT PLAN

Fort Wallace, Stockton,
Volume 2

DEFENCE HOUSING AUSTRALIA

12 October 2021

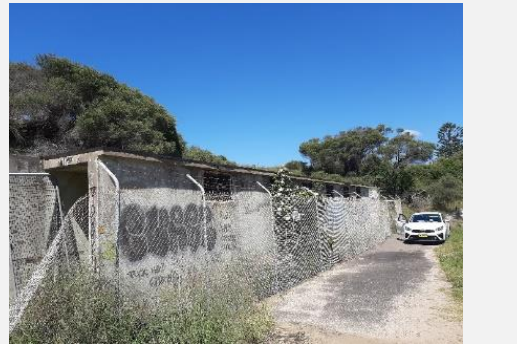
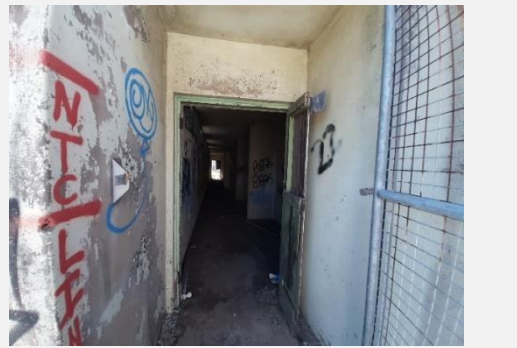
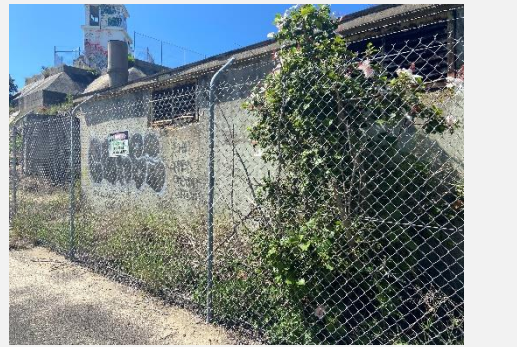
No.	Information		Photo
13	Name: Casualty Station	Date of Construction: 1937

<p>Description: A low, long, reinforced concrete structure with a flat slab roof and entrances at either end, with southern wall acting as retaining wall. This building was an emergency first aid post for the gun emplacements as well as a surgery for vaccinations etc. The building has a principal room with five recesses (2700x750 for stretchers) and steel louvres in the northern wall for ventilation. Later uses included as a gardener's store.</p>			
<p>Condition: Overall: Poor (2)</p>			
<p>Significance: High</p>		<p>Significant Elements: Overall form (high), Concrete (medium)</p>	
<p>Tolerance for Change: Medium</p>			
<p>Maintenance:</p> <ul style="list-style-type: none"> – Removal all vegetation to built structure and remove debris. – Mow / trim immediate vegetation within fence line to be clear of building – Ensure fence doors and windows are secure to prevent entry, vandalism and water ingress <p>Management Policy:</p> <ol style="list-style-type: none"> 1. Retain and conserve in accordance with this HMP. Undertake immediate conservation works outlined in Volume 1. 2. Item may be adaptively reused for an appropriate use. 3. Minor alterations including new windows openings, internal partitions and internal fitouts are appropriate subject to heritage consultant advice. 4. Proximate development should have sufficient setback such that the north western façade is not obscured,

<p>Photos:</p> <p>Top: <i>exterior, view south west, Urbis, 2021.</i></p> <p>Middle: <i>Interior, view east. Urbis, 2021.</i></p> <p>Bottom: <i>exterior view, south east, Urbis 2021</i></p>

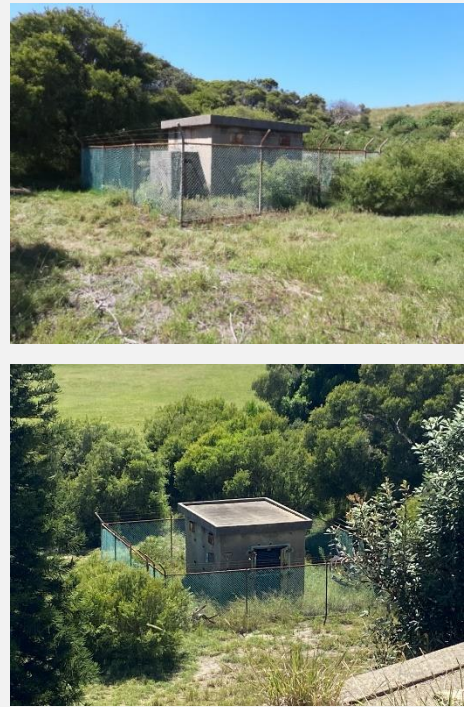
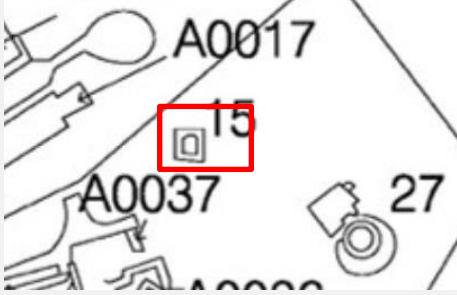
No.	Information		Photo
15	Name: Engine Room, Northern Searchlight – 9.2 inch guns Date of Construction: 1937

Description: Rectangular reinforced concrete building with flat slab roof and steel double doors. Bricked up openings on both side walls with pin hinges still in place from original steel shutters, and vents to either side with steel weather plates. Concrete stand projects from the northern wall. Standard military design of the time.			
Condition: Overall: Fair (3)			
Significance: High	Significant Elements: Overall form (high), Concrete (medium)		
Tolerance for Change: Medium			
Maintenance: <ul style="list-style-type: none"> – Ensure rainwater good are draining correctly and no water ingress into building – Ensure fence doors and windows are secure to prevent entry, vandalism and water ingress Management Policy: <ol style="list-style-type: none"> 1. Retain and conserve in accordance with this HMP. Undertake immediate conservation works outlined in Volume 1. 2. Item has little adaptive reuse value and should be retained as a landscape element. 3. Proximate development should ensure some view lines are available to the element from the north/west.

Location:	Photos: Top: <i>General view, Urbis, 2021.</i> Bottom: <i>General view: Urbis, 2021.</i>

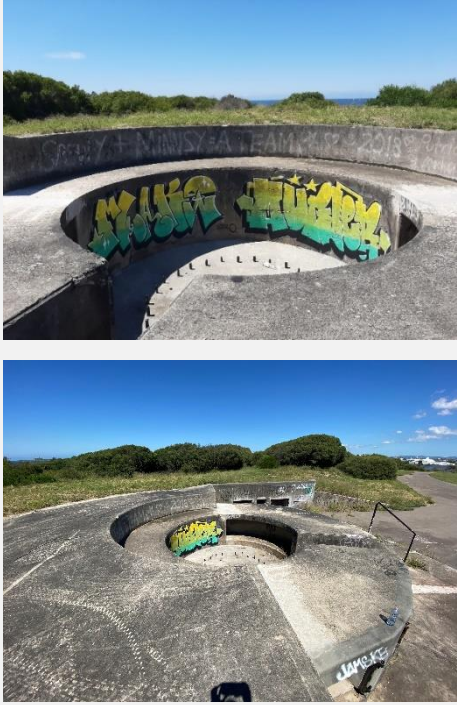
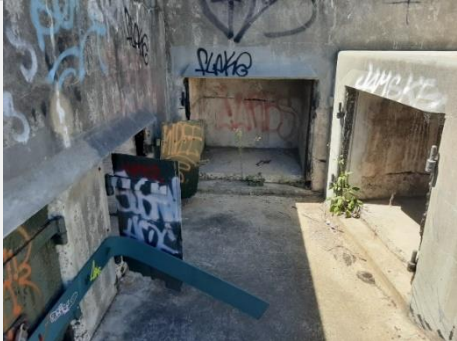
No.	Information		Photo
16	Name: No.2 Gun emplacement – 6 inch guns	Date of Construction: Unknown (WWI)

Description: Reinforced concrete gun emplacement set level with the surrounding dunes. At the lower gun floor level shells and cartridges were delivered from the magazine via the ammunition hoist. Both shells and cartridges were stored in single depth chambers set into the circular wall of the pit. The steel place doors on the chamber have been removed or rusted out, but gave regulated access to the lower gun floor. This was later physically restricted by the erection of the concrete blast wall across the door open. Fabricated steel platform covered with bitumen constitutes the upper gun floor.			
Condition: Overall: Fair (3) to Poor (2). Exterior: heavily graffitied, some damage to concrete and rusting of metal elements, recently repainted and bitumen removed. Damage to wooden doors accessing gun cartridge storage areas. Interior: unable to be accessed

Significance: Exceptional		Significant Elements: Overall form (Exceptional), concrete (High), remnant original doors (moderate), remnant fixings to lower gun floor (moderate)	
Tolerance for Change: Low			
Maintenance: <ul style="list-style-type: none"> – Removal all vegetation to built structure and remove debris. – Include weed killing to interior of gun emplacement to concrete floor. – Ensure all roofing is secure and watertight, check rainwater good are draining correctly and no water ingress into buildings or structures. – Ensure doors and windows are secure to prevent entry, vandalism repair to match existing as required Management Policy:

<p>Photos:</p> <p>Top: <i>interior of gun circle, Urbis 2021.</i></p> <p>Middle: <i>general view gun emplacement, Urbis, 2021.</i></p> <p>Bottom: <i>Interior, storage, Urbis, 2021.</i></p>

No.	Information	Photo
	<ol style="list-style-type: none"> 1. Retain and conserve in accordance with this HMP. Undertake immediate conservation works outlined in Volume 1. 2. Item has little adaptive reuse value and should be retained as a landscape element. 3. Substantial development in the vicinity of this item (i.e., within the Heritage Precinct) is not appropriate. Minor structures only within the Heritage Precinct, refer policies in Volume 1. All minor structures are to be designed to ensure no views to the item are significantly obstructed. 4. Investigate retaining the remnant doors if possible. Conserve elements and fix in closed position. 5. Make safe works to allow public access to Heritage Precinct are appropriate where designed in conjunction with heritage consultant. Avoid fixing directly to concrete where possible.

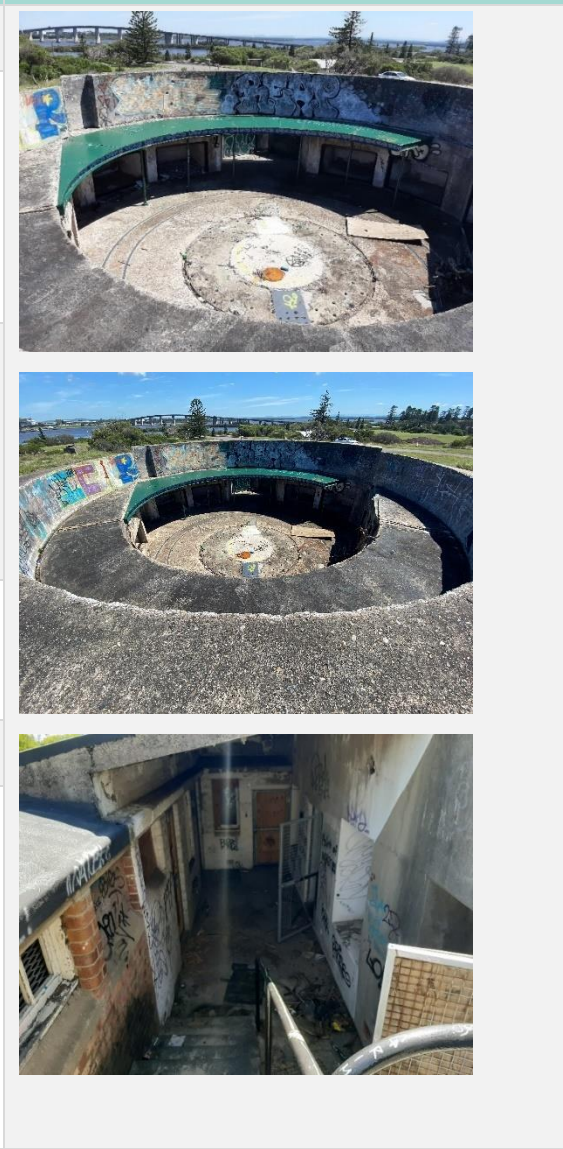
No.	Information		Photo
18	<p>Name: No. 1 Gun emplacement – 9.2 inch guns</p>	<p>Date of Construction: 1939</p>

<p>Description: Reinforced concrete gun emplacement set level with the surrounding dunes. At the lower gun floor level shells and cartridges were delivered from the magazine via the ammunition hoist. Both shells and cartridges were stored in single depth chambers set into the circular wall of the pit. The steel place doors on the chamber have been removed or rusted out, but gave regulated access to the lower gun floor. This was later physically restricted by the erection of the concrete blast wall across the door open. Fabricated steel platform covered with bitumen constitutes the upper gun floor.</p>			
<p>Condition: Overall: Fair (3) to Poor (2)</p> <p>Exterior: heavily graffitied, some damage to concrete and rusting of metal elements, recently repainted and bitumen removed. Damage to wooden doors accessing gun cartridge storage areas.</p> <p>Interior: heavily graffitied, damage to fixture sand fittings including doors and windows, damage to walls through vandalism.</p>

<p>Significance: Exceptional</p>		<p>Significant Elements: Overall form (Exceptional), concrete (High), remnant original doors (moderate), remnant fixings to lower gun floor (moderate)</p>	
<p>Tolerance for Change: Low</p>			
<p>Maintenance:</p> <ul style="list-style-type: none"> – Removal all vegetation to built structure and remove debris. – Include weed killing to interior of gun emplacement to concrete floor. – Ensure all roofing is secure and watertight, check rainwater good are draining correctly and no water ingress into buildings or structures. – Ensure doors and windows are secure to prevent entry, vandalism repair to match existing as required <p>Management Policy:</p>

<p>Photos:</p> <p>Top: <i>interior of gun circle, Urbis 2021.</i></p> <p>Middle: <i>gun emplacement, Urbis, 2021.</i></p> <p>Bottom: <i>Interior, tunnel systems, Urbis, 2021.</i></p>

No.	Information	Photo
	<ol style="list-style-type: none"> 1. Retain and conserve in accordance with this HMP. Undertake immediate conservation works outlined in Volume 1. 2. Item has little adaptive reuse value and should be retained as a landscape element. 3. Substantial development in the vicinity of this item (i.e., within the Heritage Precinct) is not appropriate. Minor structures only within the Heritage Precinct, refer policies in Volume 1. All minor structures are to be designed to ensure no views to the item are significantly obstructed. 4. Investigate retaining the remnant doors if possible. Conserve elements and fix in closed position. 5. Make safe works to allow public access to Heritage Precinct are appropriate where designed in conjunction with heritage consultant. Avoid fixing directly to concrete where possible. 	
	<p>Location:</p>

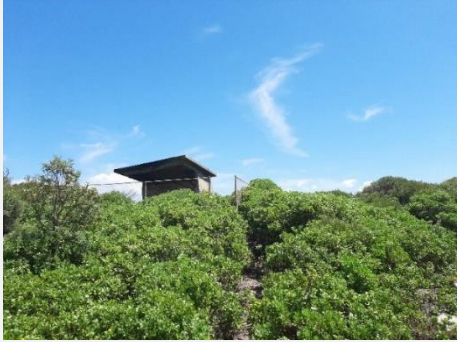
Name: Northern and Southern Searchlight 6- inch guns	Date of Construction: 1917			
<p>Description: Reinforced concrete building with flat roof. Entered from double doors from the south. Walls to the forward half of the building are completely open allowing an uninterrupted sweep for the searchlight, with cantilevered concrete roof. Original opening enclosed by timber shutters.</p>				
<p>Condition: Overall: Poor (2). Only one visible. Poor condition although roof remains. Some damage evident to concrete.</p>				
Significance: High	Significant Elements: Overall form (High)			
Tolerance for Change: Make safe/stabilisation works only				
<p>Maintenance:</p> <ul style="list-style-type: none"> – Removal all vegetation to built structure and remove debris. – Include weed killing to interior of gun emplacement to concrete floor. – Construct and maintain fencing to prevent entry, vandalism. <p>Management Policy:</p> <ol style="list-style-type: none"> 1. Retain and conserve in accordance with this HMP. 2. Item has little adaptive reuse value and should be retained as a landscape element for as long as practicable with consideration for environmental factors and deterioration of condition. 3. Substantial development in the vicinity of this item is not appropriate. Minor structures only within the Heritage Precinct to the west of this item, refer policies in Volume 1. All minor structures are to be designed to ensure no views to the item are significantly obstructed.

<p>Photos:</p> <p>Top: <i>Northern search light, Urbis 2021.</i></p>

No.	Information	Photo
	<p>4. Make safe works, stabilisation and boundary fencing around this item are appropriate. Avoid fixing directly to concrete where possible.</p> <p>5. Any proposal to remove this element should be subject to a Heritage Impact Statement prepared by a suitably qualified heritage consultant and the items should be recorded prior to removal.</p>	
	<p>Location:</p>

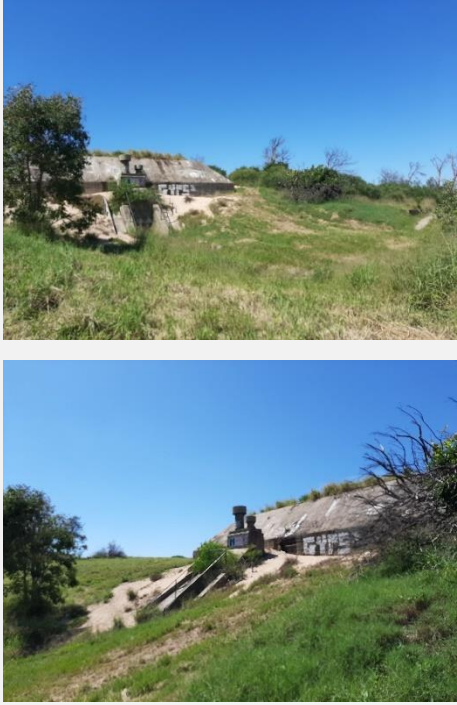
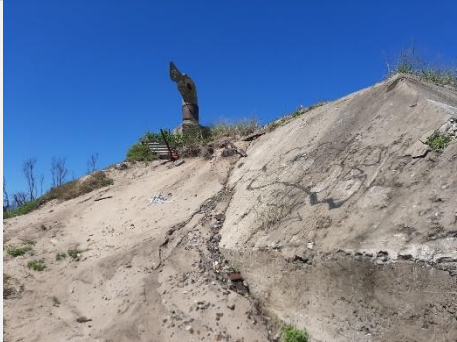
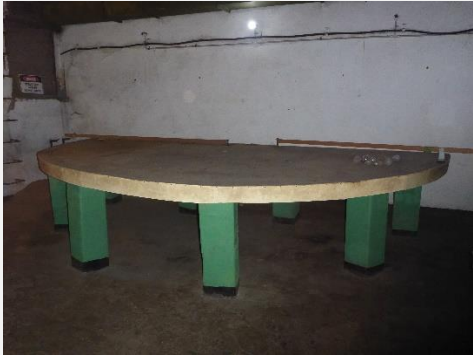
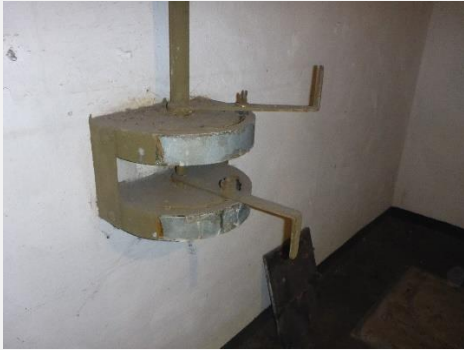
No.	Information		Photo
23	Name: Plotting Room	Date of Construction: 1937

Description: Underground structure with two principal rooms where target information was potted and relayed to the guns. Entrance doors and air vents are the only part visible above ground level. Constructed of reinforced concrete with profiles steel roof acting as formwork. Covered by a sand burster and then a concrete burster and then a concrete burster to provide explosion proof construction. Complex air filtering system for the event of a gas attack.			
Condition: Overall: fair (3). Exterior: partially covered by vegetation and sands, some graffiti and damage to concrete. Interior: not inspected.			
Significance: Exceptional	Significant Elements: Overall form (high), concrete (moderate), internal steel structure (moderate), plotting table (high), internal layout and remnant operations elements e.g. air circulation equipment (moderate)

Tolerance for Change: Low			
Maintenance: <ol style="list-style-type: none"> Removal all vegetation to built structure and remove debris Mow / trim immediate vegetation within fence line to be clear of building Check over all doors and windows for security, Several doors are open and access not prevented, close existing doors and lock. Secure all doors and windows to prevent access, install plywood over openings if required where door or window missing or glass broken Management Policy:

<p>Photos:</p> <p>Top: <i>Plotting Room, exterior, view north east, Urbis, 2021.</i></p> <p>Second: <i>Plotting Room, exterior, view south east, Urbis 2021.</i></p> <p>Third : <i>Plotting Room, exterior, view north east, Urbis 2021.</i></p> <p>Fourth: <i>Plotting Room, interior, plotting desk, Urbis 2016.</i></p> <p>Fifth: <i>Plotting Room, interior, Urbis 2016.</i></p>

No.	Information	Photo
	<ol style="list-style-type: none"> 1. Retain and conserve in accordance with this HMP. Undertake immediate conservation works outlined in Volume 1. 2. Item may be adaptively reused for an appropriate use. 3. The significance of the item is partly vested in its inconspicuous presentation. Any future adaptive reuse should retain this character. 4. The item is substantially sub surface however it partly visible in the landscape. Any future development in the vicinity should maintain view lines. 5. If the item is used for interpretation or education all internal elements of significance including the plotting desk should be retained on site. Any other uses should consider the retention of these elements on site. Where this is not possible, the elements are to be relocated to an appropriate location decided in conjunction with the heritage consultant and any public stakeholders. 6. Make safe works to allow public access to Heritage Precinct are appropriate where designed in conjunction with heritage consultant. Avoid fixing directly to concrete where possible.

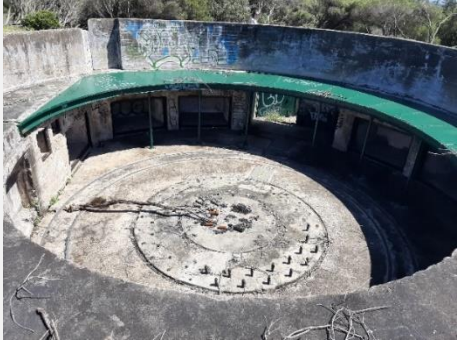
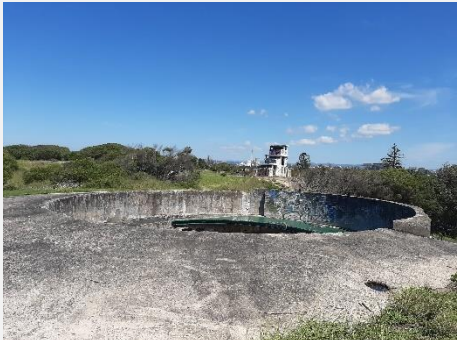
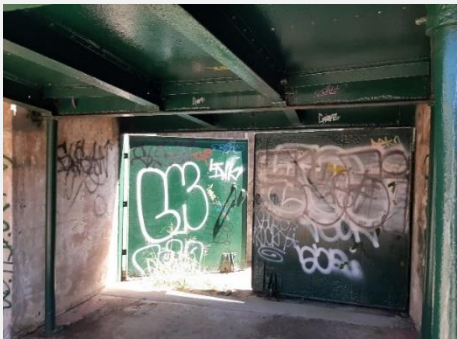
No.	Information	Photo
27	<p>Name: No. 2 Gun Emplacement – 9.2 inch guns Date of Construction: c.1939</p> <p>Description: Reinforced concrete gun emplacement set level with the surrounding dunes. At the lower gun floor level shells and cartridges were delivered from the magazine via the ammunition hoist. Both shells and cartridges were stored in single depth chambers set into the circular wall of the pit. The steel place doors on the chamber have been removed or rusted out, but gave regulated access to the lower gun floor. This was later physically restricted by the erection of the concrete blast wall across the door open. Fabricated steel platform covered with bitumen constitutes the upper gun floor</p> <p>Condition: Overall: fair (3) to poor (2)</p> <p>Exterior: heavily graffitied, some damage to concrete and rusting of metal elements, recently repainted and bitumen removed. Damage to/removal of gun cartridge store doors.</p> <p>Interior: heavily graffitied, damage to fixture sand fittings including doors and windows, damage to walls through vandalism.</p> <p>Significance: Exceptional Significant Elements: Overall form (Exceptional), concrete (High), remnant original doors (moderate), remnant fixings to lower gun floor (moderate)</p> <p>Tolerance for Change: Low</p> <p>Maintenance:</p> <ul style="list-style-type: none"> – Removal all vegetation to built structure and remove debris. – Include weed killing to interior of gun emplacement to concrete floor. – Ensure all roofing is secure and watertight, check rainwater good are draining correctly and no water ingress into buildings or structures. – Ensure doors and windows are secure to prevent entry, vandalism repair to match existing as required <p>Management Policy:</p>

<p>Photos:</p> <p>Top: <i>interior of gun circle, Urbis 2021.</i></p> <p>Middle: <i>exterior view of gun emplacement, Urbis 2021.</i></p> <p>Bottom: <i>Interior of gun circle, facing out, Urbis, 2021.</i></p>

No.	Information	Photo
	<ol style="list-style-type: none"> 1. Retain and conserve in accordance with this HMP. Undertake immediate conservation works outlined in Volume 1. 2. Item has little adaptive reuse value and should be retained as a landscape element. 3. Substantial development in the vicinity of this item (i.e., within the Heritage Precinct) is not appropriate. Minor structures only within the Heritage Precinct, refer policies in Volume 1. All minor structures are to be designed to ensure no views to the item are significantly obstructed. 4. Investigate retaining the remnant doors if possible. Conserve elements and fix in closed position. 5. Make safe works to allow public access to Heritage Precinct are appropriate where designed in conjunction with heritage consultant. Avoid fixing directly to concrete where possible. 	
	<p>Location:</p>

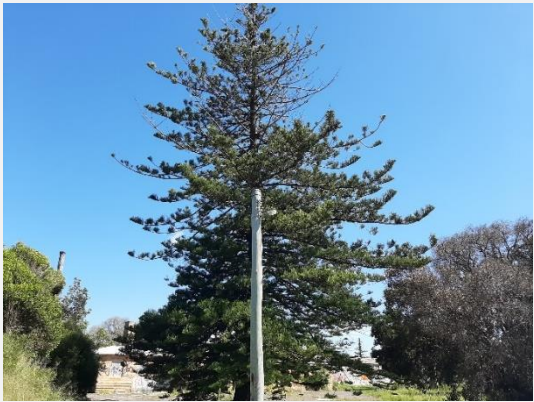
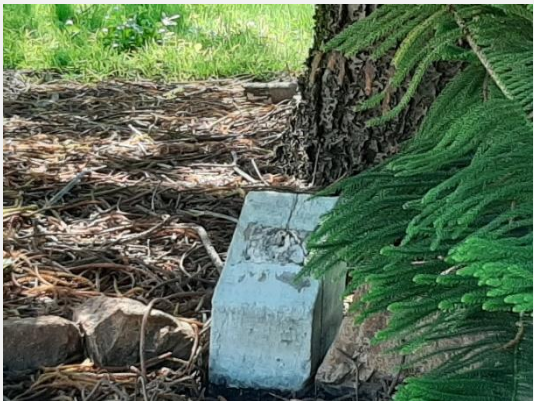
No.	Information		Photo
56	Name: Hoban Commemorative Tree	Date of Construction: 1949

Description: Individual tree planted to commemorate the tragic fatal accident involving Gunner Meryn Hoban during the operation of one of the 9.2" Guns. Norfolk Island Pine. Brass plaque affixed to short white painted concrete plinth at base.			
Condition: Overall: Poor (2) Tree still present with assessment of health to be undertaken by arborist. Commemorative Plaque removed and missing, plinth remains.			
Significance: High	Significant Elements: N/A (plaque missing)		
Tolerance for Change: Make safe/stabilisation only			
Maintenance: N/A Management Policy: 1. Retain and conserve in accordance with this HMP and arboricultural advice as required. 2. Replicate and replace original plaque on existing plinth. 3. All development in the vicinity should be subject to an assessment by an arborist to ensure that ground disturbance has no detrimental impacts on the root system of the tree.

Location:	Photos: Top: <i>view of Hoban Commemorative Tree, Urbis 2021.</i> Bottom: <i>Plinth for plaque, since removed, Urbis, 2021.</i>

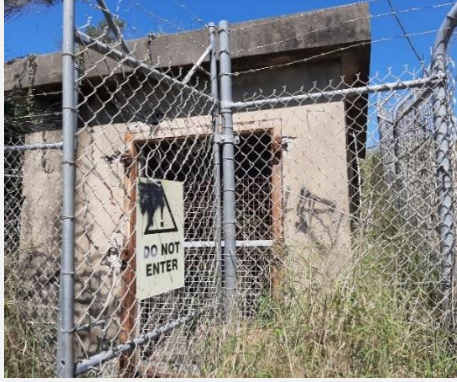
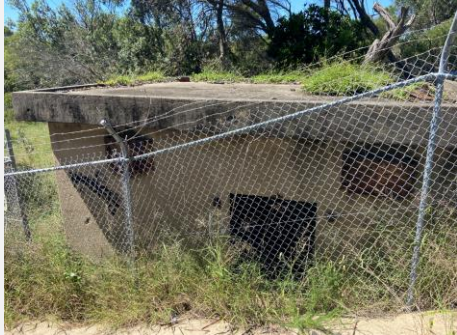
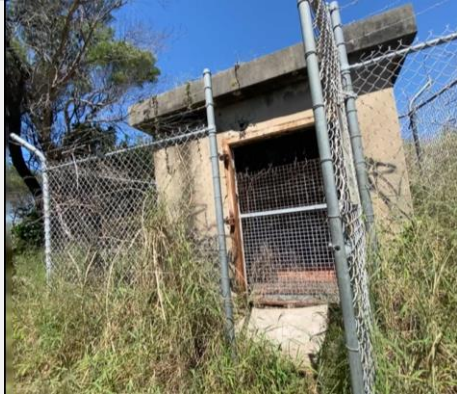
No.	Information		Photo
101	Name: Engine Room, Southern Searchlight – 9.2 inch guns	Date of Construction: 1939

Description: Rectangular reinforced concrete building with flat slab roof and steel double doors. Bricked up openings on both side walls with pin hinges still in place from original steel shutters, and vents to either side with steel weather plates. Standard military design of the time.		
	Condition: Overall: fair (3) Exterior – overgrown, with some damage to concrete and vegetation in guttering. Building is fenced from access with do not enter signs present. Some windows/grates missing.

Significance: High	Significant Elements: Overall form (high), concrete (medium)	
Tolerance for Change: Medium			
Maintenance: <ul style="list-style-type: none"> – Ensure rainwater good are draining correctly and no water ingress into building – Ensure fence doors and windows are secure to prevent entry, vandalism and water ingress Management Policy: <ol style="list-style-type: none"> 1. Retain and conserve in accordance with this HMP. Undertake immediate conservation works outlined in Volume 1. 2. Item has little adaptive reuse value and should be retained as a landscape element. Proximate development should ensure some view lines are available to the element from the north/west.

<p>Top: <i>View of search light engine room, exterior, Urbis 2021.</i></p> <p>Middle: <i>view of search light engine room, exterior, Urbis 2021.</i></p> <p>Bottom: <i>View of search light engine room, Urbis 2021.</i></p>

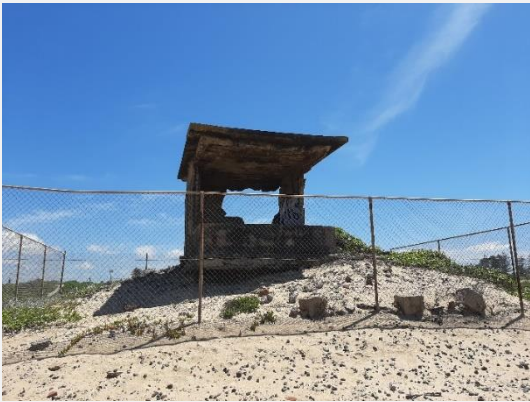
No.	Information		Photo
102	Name: Northern Searchlight 9.2- inch guns	Date of Construction: c.1939

Description: reinforced concrete building with flat roof. Entered from double doors from the south. Walls to the forward half of the building are completely open allowing an uninterrupted sweep for the searchlight, with cantilevered concrete roof. Original opening enclosed by timber shutters.			
Condition: Very poor (1). Considerable degradation to concrete, erosion to sand dune base compromising structural integrity. Complete loss of internal fixtures and fittings. This building is at risk of entire ruin.			
Significance: High		Significant Elements: Overall form (High)	
Tolerance for Change: Make safe/stabilisation work only			
Maintenance: <ul style="list-style-type: none"> – Removal all vegetation to built structure and remove debris. – Include weed killing to interior of gun emplacement to concrete floor. – Construct and maintain fencing to prevent entry, vandalism. Management Policy: <ol style="list-style-type: none"> 1. Retain and conserve in accordance with this HMP. 2. Item has little adaptive reuse value and should be retained as a landscape element for as long as practicable with consideration for environmental factors and deterioration of condition. 3. Substantial development in the vicinity of this item is not appropriate. Minor structures only within the Heritage Precinct to the west of this item, refer policies in Volume 1. All minor structures are to be designed to ensure no views to the item are significantly obstructed.

<p>Photos:</p> <p>Top: <i>northern searchlight, Urbis 2021.</i></p>

No.	Information	Photo
	<p>4. Make safe works, stabilisation and boundary fencing around this item are appropriate. Avoid fixing directly to concrete where possible.</p> <p>5. Any proposal to removal this element should be subject to a Heritage Impact Statement prepared by a suitably qualified heritage consultant and the items should be recorded prior to removal.</p> <p>Location:</p>

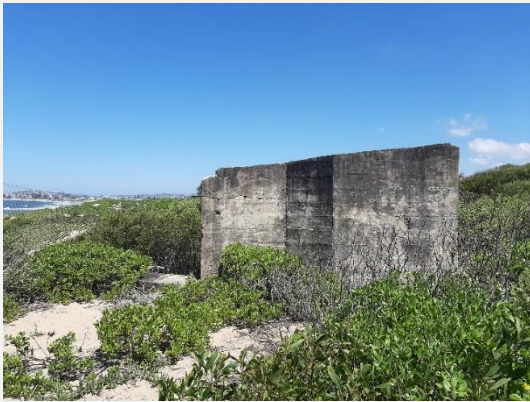
No.	Information	Photo
103	<p>Name: Southern Searchlight 9.2- inch guns Date of Construction: c.1939</p> <p>Description: Reinforced concrete building with flat roof. Entered from double doors from the south. Walls to the forward half of the building are completely open allowing an uninterrupted sweep for the searchlight, with cantilevered concrete roof. Original opening enclosed by timber shutters.</p> <p>Condition: Very Poor (1). Considerable degradation to concrete, complete loss of roof and internal fixtures and fittings. This building is at risk of entire ruin.</p> <p>Significance: High Significant Elements: Overall form (Medium)</p> <p>Tolerance for Change: Make safe/stabilisation work only</p> <p>Maintenance:</p> <ul style="list-style-type: none"> – Removal all vegetation to built structure and remove debris. – Include weed killing to interior of gun emplacement to concrete floor. – Construct and maintain fencing to prevent entry, vandalism. <p>Management Policy:</p> <ol style="list-style-type: none"> 1. Retain and conserve in accordance with this HMP. 2. Item has little adaptive reuse value and should be retained as a landscape element for as long as practicable with consideration for environmental factors and deterioration of condition. 3. Substantial development in the vicinity of this item is not appropriate. Minor structures only within the Heritage Precinct to the west of this item, refer policies in Volume 1. All minor structures are to be designed to ensure no views to the item are significantly obstructed.

<p>Photos:</p> <p>Top: <i>southern searchlight, view south, Urbis 2021.</i></p>

No.	Information	Photo
	<p>4. Make safe works, stabilisation and boundary fencing around this item are appropriate. Avoid fixing directly to concrete where possible.</p> <p>Any proposal to removal this element should be subject to a Heritage Impact Statement prepared by a suitably qualified heritage consultant and the items should be recorded prior to removal.</p>	
	<p>Location:</p>

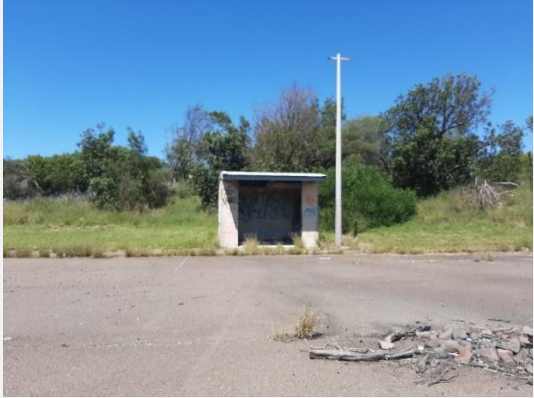
No.	Information	Photo
A0004	<p>Name: Bus Shelter Date of Construction: Unknown</p> <p>Description: concrete shelter, open to the north, with corrugated roof.</p> <p>Condition: Overall: fair (3) The bus shelter has been heavily graffitied with some damage to the concrete.</p> <p>Significance: Little Significant Elements: N/A</p> <p>Tolerance for Change: High</p> <p>Maintenance:</p> <ul style="list-style-type: none"> – Ensure rainwater good are draining correctly and no water ingress into building <p>Management Policy:</p> <ol style="list-style-type: none"> 1. Item may be retained or removed in conjunction with the adaptive reuse of the site overall.

<p>Photos:</p> <p>Top: <i>View of bus shelter, Urbis, 2021</i></p>

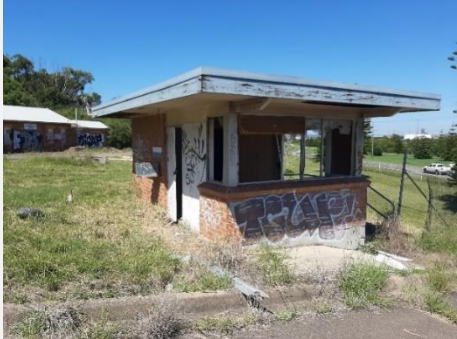
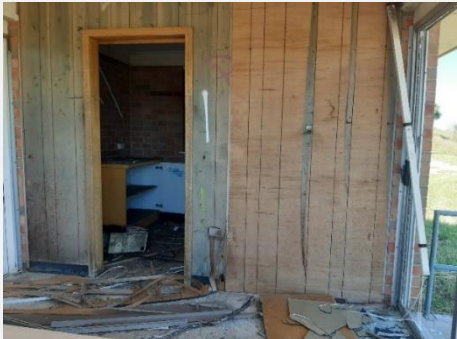
No.	Information		Photo
A0006	Name: Security Office, Guard House Date of Construction: Unknown

Description: brick square structure with flat wooden and corrugated metal roof. The Guard House was accessed by a door to the western façade and had windows lining the northern façade to allow the stationed guard to greet incoming visitors and ascertain their purpose for being on the site.		
	Condition: Overall: very poor (1). Exterior: the exterior is heavily graffitied with damage from vandalism to walls, windows and doors. The building is no longer structurally sound or weatherproof. Interior: The interior of the building is heavily damaged with wall panelling, fixtures and fittings stripped and destroyed through vandalism.		
	Significance: Little	Significant Elements: N/A	
	Tolerance for Change: High		
	Maintenance: <ul style="list-style-type: none"> - Ensure rainwater good are draining correctly and no water ingress into building Management Policy: <ol style="list-style-type: none"> 1. Item may be retained or removed in conjunction with the adaptive reuse of the site overall.

No.	Information	Photo
	<p>Location:</p>  	<p>Photos:</p> <p>Top: <i>exterior, security office, Urbis 2021</i></p> <p>Bottom: <i>interior, security office, Urbis 2021.</i></p>

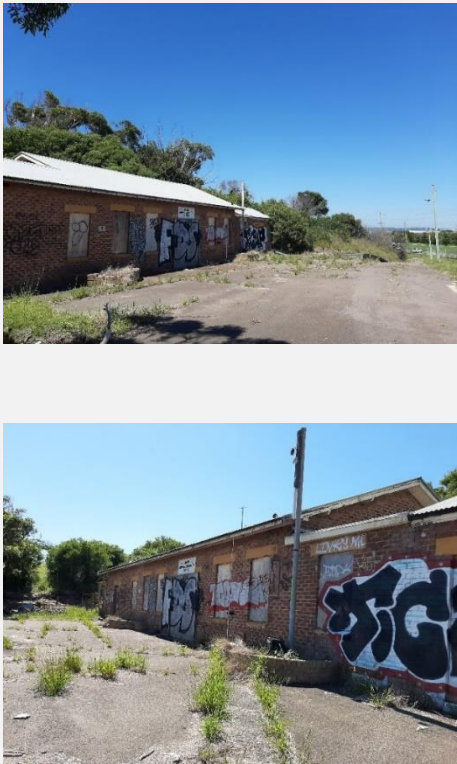
No.	Information	Photo
A0007	<p>Name: Admin Building, Engine House 6 inch guns Date of Construction: 1917</p>

<p>Description: Single storey, red-brick building originally containing electrical generators for searchlights and ancillary equipment (6" gun era). The building has concrete lintels, timber windows and doors and a gable roof clad in corrugated asbestos cement sheet with galvanised steel vents. Extensions to the north and south house a substation and toilet respectively.</p>	
	<p>Condition: Overall: Fair (3). Exterior: fair condition with graffiti and boarded up windows/doors. Some damage to concrete lintels. Interior: not inspected.</p>	
	<p>Significance: High Significant Elements: Overall form (high),</p>	
	<p>Tolerance for Change: Medium</p>	
	<p>Maintenance:</p> <ul style="list-style-type: none"> – Ensure rainwater good are draining correctly and no water ingress into building – Ensure fence doors and windows are secure to prevent entry, vandalism and water ingress <p>Management Policy:</p> <ol style="list-style-type: none"> 1. Retain and conserve in accordance with this HMP. Undertake immediate conservation works outlined in Volume 1. 2. Item may be adaptively reused for an appropriate use. 3. Minor alterations including new windows openings, internal partitions and internal fitouts are appropriate subject to heritage consultant advice. 4. Minor, single storey additions to the north or south may be appropriate to facilitate an appropriate new use.

</div> <div data-bbox="873 357 1512 676"> <p data-bbox="873 357 981 383">Photos:</p> <p data-bbox="873 414 1249 440">Top: <i>exterior view, Urbis 2021.</i></p> <p data-bbox="873 472 1281 497">Bottom: <i>Exterior view, Urbis 2021.</i></p> </div>

No.	Information	Photo
	<p data-bbox="277 252 1512 322">5. Proximate development should have sufficient setback and be of an appropriate scale such that it does not visually dominate the item.</p> <div data-bbox="277 347 734 676"> <p data-bbox="277 357 403 383">Location:</p>

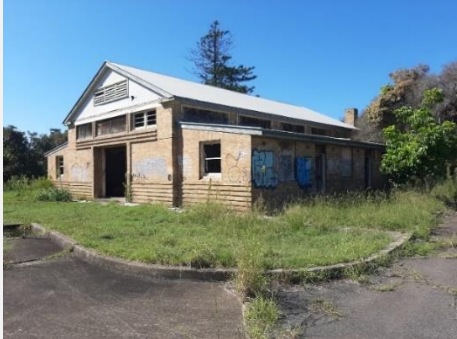
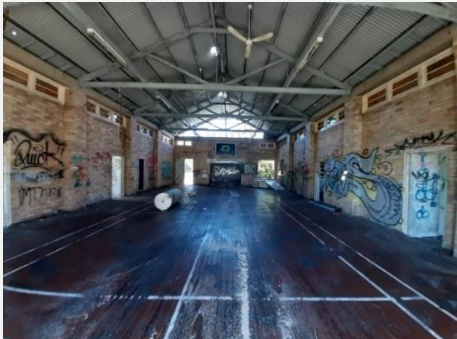
No.	Information	Photo
A0008	<p>Name: Gymnasium, Drill Hall Date of Construction: 1939</p> <p>Description: Single-storey brick structure with gable and skillion roofs, clad in corrugated asbestos-cement sheeting. Horizontal brick detailing skirts the base of the building. Timber double hung window frames and top light window frames. Metal roller doors in interior. Interior comprises main hall with ancillary storage rooms.</p> <p>Condition: Overall: very poor-poor (1-2).</p> <p>Exterior: heavily graffitied, windows smashed or boarded up, roof beams exposed/no longer waterproof.</p> <p>Interior: heavily graffitied, walls damaged, metal roller doors removed/destroyed. Doors removed and windows smashed, ceiling paint peeling in ancillary rooms.</p> <p>Significance: Moderate Significant Elements: Overall form (moderate), internal joinery (little)</p> <p>Tolerance for Change: Medium</p> <p>Maintenance:</p> <ul style="list-style-type: none"> – Ensure rainwater good are draining correctly and no water ingress into building – Ensure fence doors and windows are secure to prevent entry, vandalism and water ingress <p>Management Policy:</p> <ol style="list-style-type: none"> 1. Retain and conserve in accordance with this HMP. Undertake immediate conservation works outlined in Volume 1. 2. Item may be adaptively reused for an appropriate use. 3. Minor alterations including new windows openings, internal partitions and internal fitouts are appropriate subject to heritage consultant advice.

<p>Photos:</p> <p>Top: <i>Exterior, Gymnasium, showing damaged windows/doors and graffiti, Urbis, 2021.</i></p> <p>Bottom: <i>interior, Gymnasium, showing internal damage including to roof/ceiling, graffiti, removal of walls etc, Urbis 2021.</i></p>

No.	Information	Photo
	<p>4. Minor, single storey additions to the east or west may be appropriate to facilitate an appropriate new use.</p> <p>5. Proximate development should have sufficient setback and be of an appropriate scale such that it does not visually dominate the item.</p>	
	<p>Location:</p>

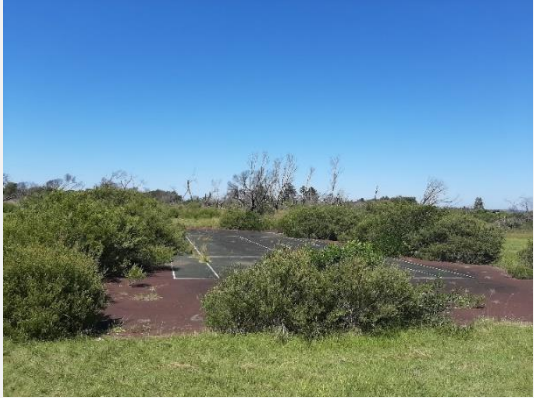
No.	Information		Photo
A0012	Name: Tennis Court Date of Construction: Unknown, visible in 1975 aerial.

Description: Tennis courts for recreation.		
	Condition: Overall: Fair (3). Overgrown but still visible.		
	Significance: Neutral	Significant Elements: N/A	
	Tolerance for Change: High		
	Maintenance: <ul style="list-style-type: none"> – Ensure item is kept clear of vegetation. Management Policy: <ol style="list-style-type: none"> Item may be retained or removed in conjunction with the adaptive reuse of the site overall. 		
	Location:

Photos: Top: view of tennis court, Urbis, 2021.

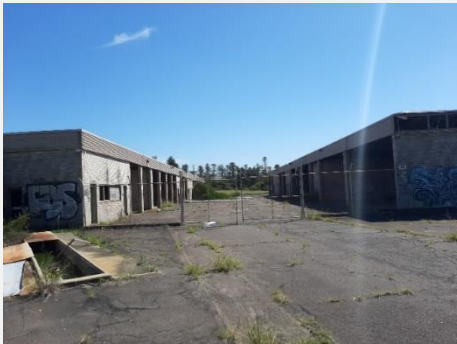
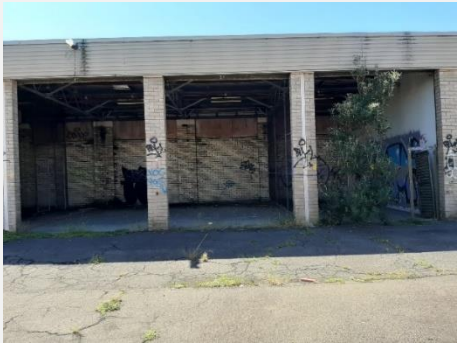
No.	Information		Photo
A0030	Name: Transport Naval Stores, Transport Compound

Date of Construction: unknown, visible in 1975 aerial.		
	Description: Twin storage facilities constructed of off-white painted brick with corrugated galvanised steel roof. Openings would once have been covered by roller doors, no longer present on site and/or no longer operable.		
	Condition: Overall: fair (3). Exterior: the exterior of the buildings is in fair condition with some graffiti and removal of doors. Interior: the interiors are largely open due to the removal of doors, and fixing and fittings have been vandalised. Graffiti is also present in the interiors.		
	Significance: Little	Significant Elements: N/A	
	Tolerance for Change: High		
	Maintenance: <ul style="list-style-type: none"> - Ensure rainwater good are draining correctly and no water ingress into building - Ensure fence doors and windows are secure to prevent entry, vandalism and water ingress Management Policy: <ol style="list-style-type: none"> 1. Item may be retained or removed in conjunction with the adaptive reuse of the site overall.

Location:	Photos: Top: <i>Exterior view, naval stores, Urbis 2021</i> Bottom: <i>Interior view, naval stores, Urbis 2021</i>

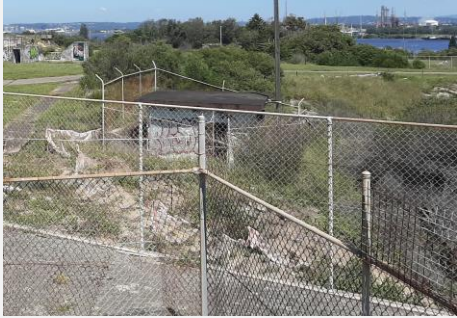
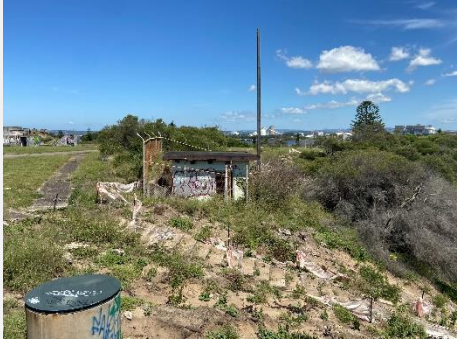
No.	Information	Photo	
A0035	Name: Radio Room, Wireless Room	Date of Construction: 1937

Description: Reinforced concrete building with flat slab roof. Originally two steel shuttered windows to each of the east and west elevations. Timber aerial mast attached to the western side of the separate footings. Intended for radio communication with RAAF spotting planes to relay target and shell fall information. Not known to have been used in 9.2" gun era. Used as a radio room by 130 Signal Squadron.		
	Condition: Overall: fair (3). Exterior in fair condition with graffiti, missing doors, and some damage to concrete. Interior was not inspected.

Significance: High	Significant Elements: Overall form (High)	
	Tolerance for Change: Medium		
	Maintenance: <ul style="list-style-type: none"> - Ensure rainwater good are draining correctly and no water ingress into building - Ensure fence doors and windows are secure to prevent entry, vandalism and water ingress Management Policy: <ol style="list-style-type: none"> 1. Retain and conserve in accordance with this HMP. Undertake immediate conservation works outlined in Volume 1. 2. Item has little adaptive reuse value and should be retained as a landscape element. 3. Proximate development should ensure some view lines are available to the element from the north/west.

</div> <div data-bbox="869 371 1518 687"> <p data-bbox="869 371 981 400">Photos:</p> <p data-bbox="869 432 1447 496">Top: external view, radio room, fenced off. Urbis 2021.</p> <p data-bbox="869 528 1487 592">Bottom: external view, radio room, fenced off. Urbis 2021.</p> </div>

No.	Information	Photo
	<p data-bbox="293 247 1518 336">4. Substantial development to the east of this item (i.e., within the Heritage Precinct) is not appropriate. Minor structures only within the Heritage Precinct, refer policies in Volume 1. All minor structures are to be designed to ensure no views to the item are significantly obstructed.</p> <div data-bbox="293 371 808 687"> <p data-bbox="293 371 421 400">Location:</p>

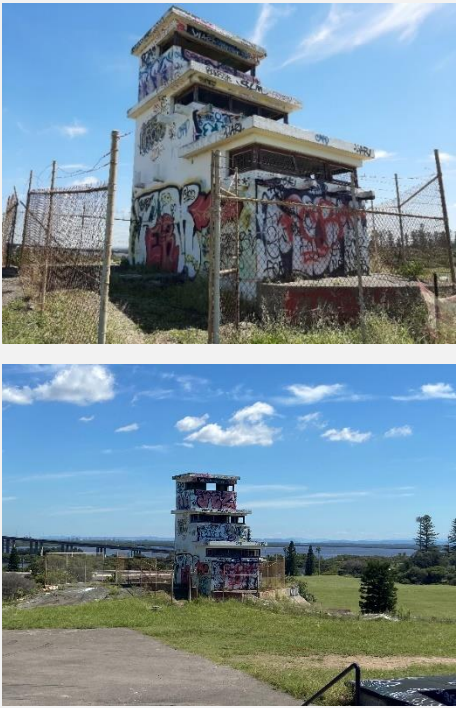
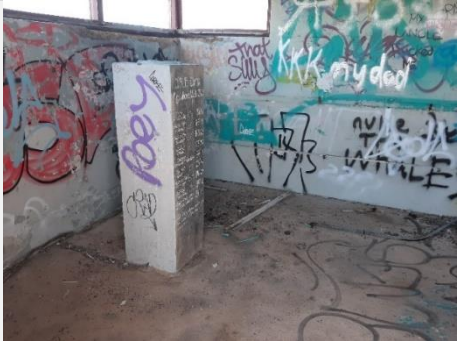
No.	Information		Photo
A0036	Name: Watch Tower, Observation Tower Date of Construction: C. 1939

Description: Three storey reinforced concrete construction containing three separate observation rooms, build directly on top of the concrete burster for the Powerhouse. Originally a two-storey building with third storey added later for use by 130 Squadron. Windows hinged down and were supported when open on concrete nibs protecting the walls, with an uninterrupted view seaward.		
	Condition: Poor (2) Exterior: heavily graffitied with some damage to concrete. Ladder to top level missing. Doors damaged. Interior: Windows damaged, some removed. Heavily graffitied, fixtures and fittings removed, although data block remains. Timber window frames damaged		
	Significance: Exceptional	Significant Elements: Overall form (exceptional), plinth to top floor (moderate).	
	Tolerance for Change: Low		
	Maintenance: <ul style="list-style-type: none"> – Ensure rainwater good are draining correctly and no water ingress into building – Ensure fence doors and windows are secure to prevent entry, vandalism and water ingress Management Policy: <ol style="list-style-type: none"> 1. Retain and conserve in accordance with this HMP. Undertake immediate conservation works outlined in Volume 1. 2. Item may be adaptively reused for an appropriate use. 3. Minor alterations including new internal fitouts are appropriate subject to heritage consultant advice.

<p>Photos:</p> <p>Top: exterior view, observation tower, heavily graffitied, Urbis, 2021</p> <p>Middle: exterior view, observation tower and seating, Urbis 2021.</p> <p>Bottom: Interior view, observation tower, heavily graffitied with data pole still in place, Urbis 2021.</p>

No.	Information	Photo
	<p>4. Substantial development to the east of this item (i.e., within the Heritage Precinct) is not appropriate. Minor structures only within the Heritage Precinct, refer policies in Volume 1. All minor structures are to be designed to ensure no views to the item are significantly obstructed.</p> <p>5. Proximate development should ensure the prominence of this elements from all internal viewpoints.</p>

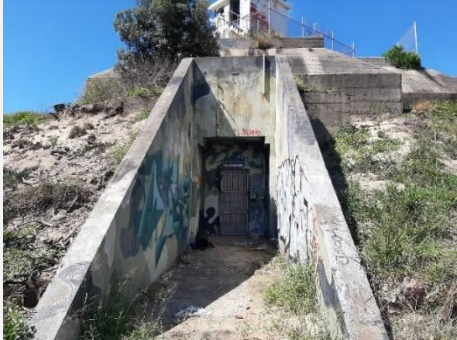
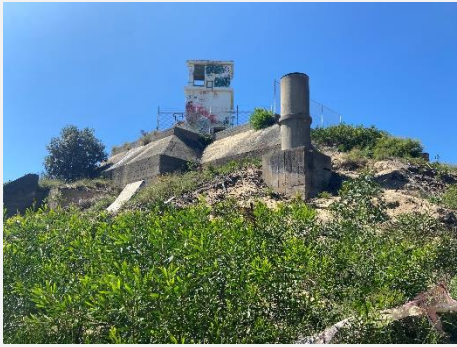
No.	Information		Photo
A0037	Name: Tunnels Date of Construction: 1939

Description: reinforced concrete tunnel carrying electrical conduits ad personnel between the Powerhouse and the magazines. Dimensions 3 feet x 7 feet high with barrel vaulted ceiling. 10-inch-thick concrete, increased to approximately 20 inches at end near gun emplacements, cast in 3m long sections. Drainage channel runs continually along the floor along the western side. Galvanised steel brackets are affixed to walls to carry electrical cables to the pump chambers.		
	Condition: Overall: fair (3). Exterior door (entranceway) intact, some graffiti. Interior: tunnels not inspected due to access.

Significance: Exceptional	Significant Elements: Internal layouts (exceptional)	
	Tolerance for Change: Low		
	Maintenance: <ul style="list-style-type: none"> – Ensure rainwater good are draining correctly and no water ingress into building – Ensure fence doors and windows are secure to prevent entry, vandalism and water ingress – Removal all vegetation to built structure and remove debris. – Include weed killing to interior of gun emplacement to concrete floor Management Policy: <ol style="list-style-type: none"> 1. Retain and conserve in accordance with this HMP. Undertake immediate conservation works outlined in Volume 1. 2. Item to be used for interpretation/education.

<p>Photos:</p> <p>Top: <i>Entrance to tunnels, Urbis 2021.</i></p> <p>Bottom: <i>Tunnel vents, Urbis, 2021.</i></p>

No.	Information	Photo
	<p>3. Minor alterations including new internal fitouts to some internal gathering spaces to facilitate an educational use are appropriate subject to heritage consultant advice.</p> <p>4. Installation of new services and minor additions to ensure safe and secure access are appropriate.</p> <p>5. No new development should occur in the immediate vicinity of the entrance.</p>	
	<p>Location: <i>*entrance only*</i></p>
