MOULD ANALYTICAL REPORT

Report Number: 1999

Purpose of Report: To assess the levels and genera of mould present pre-remediation.

Inspection Report & Findings

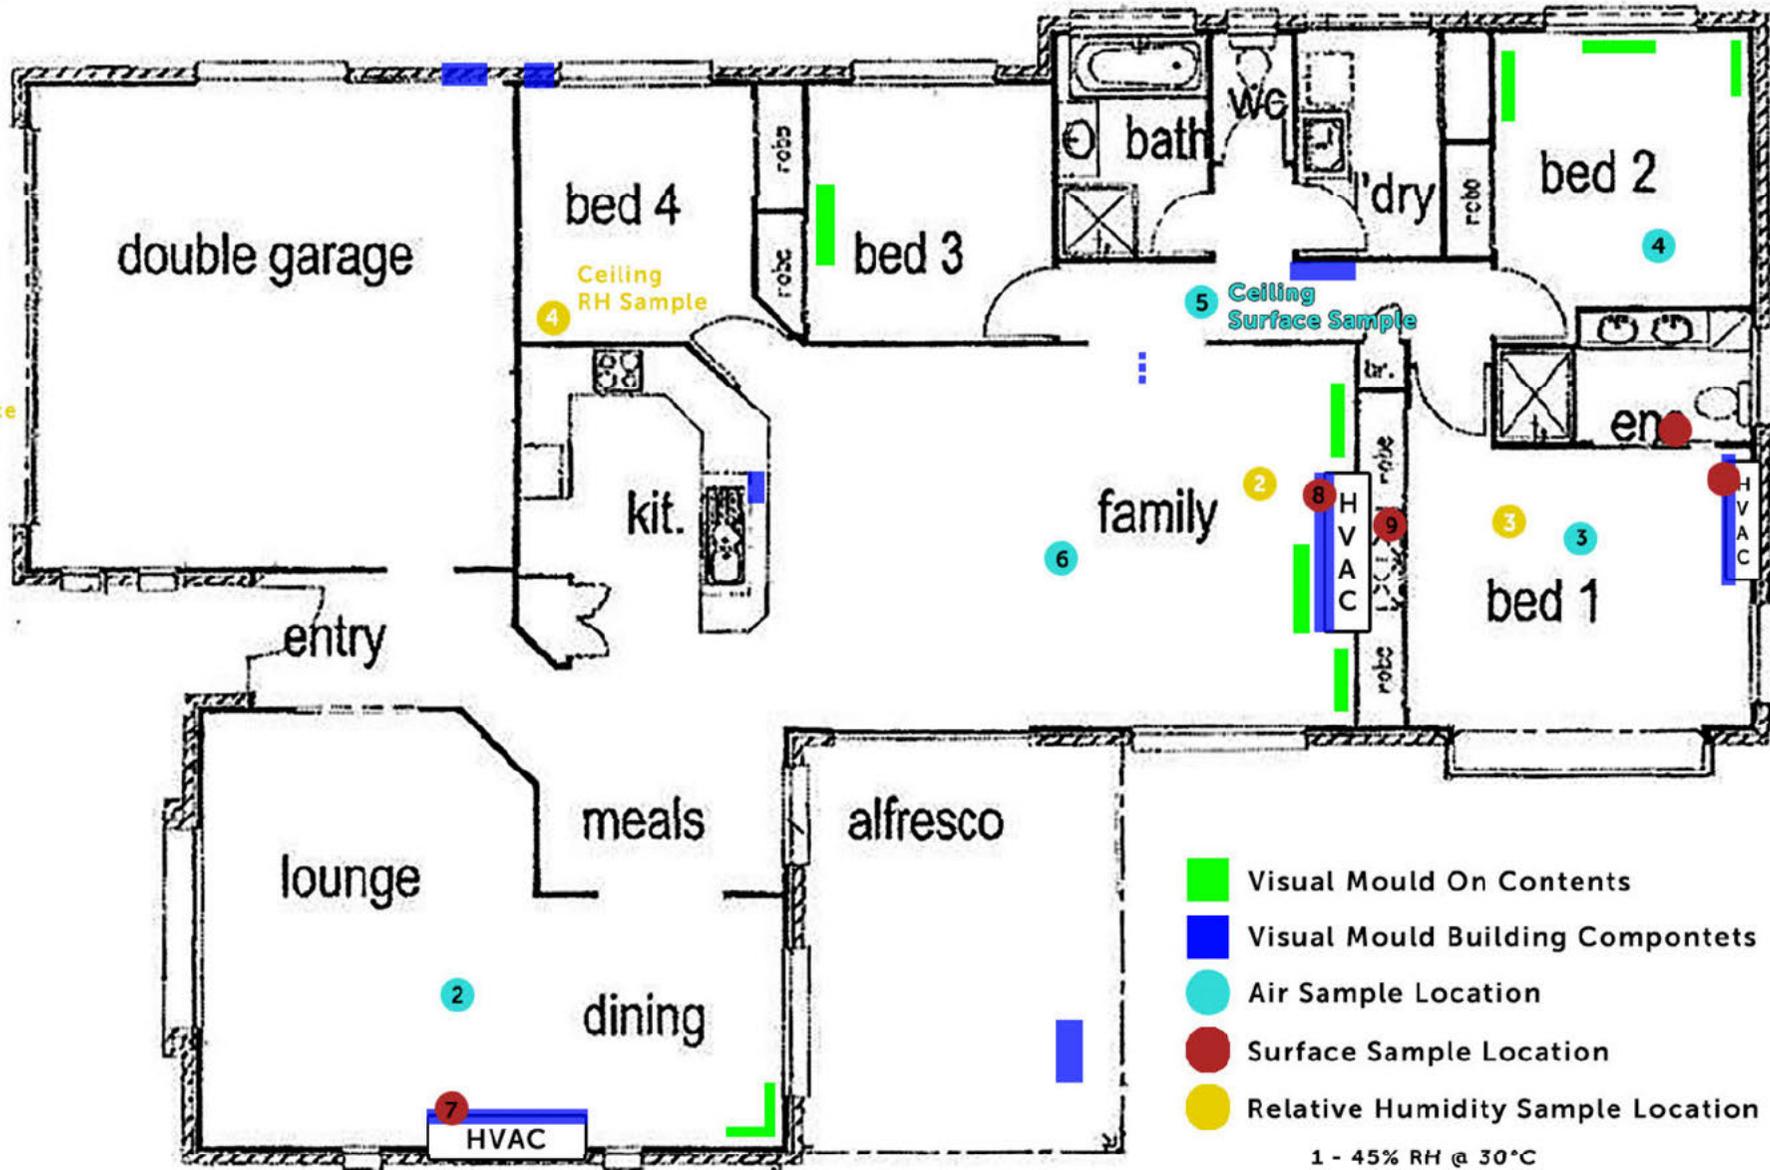
- Visual Mould On Contents
- Visual Mould Building Components
- Air Sample Location
- Surface Sample Location
- Relative Humidity Sample Location

1 - 45% RH @ 30°C
2 - 63% RH @ 26°C
3 - 65% RH @ 26°C
4 - 35% RH @ 40°C
