**Re: Termite activity found at [REDACTED]  
2155**

RE: [REDACTED]

Further to your request and meeting with Joe at the property on Monday May 7, 2012, please find here our professional opinion regarding the termite damage sustained at this property between December 2010 to January 2012.

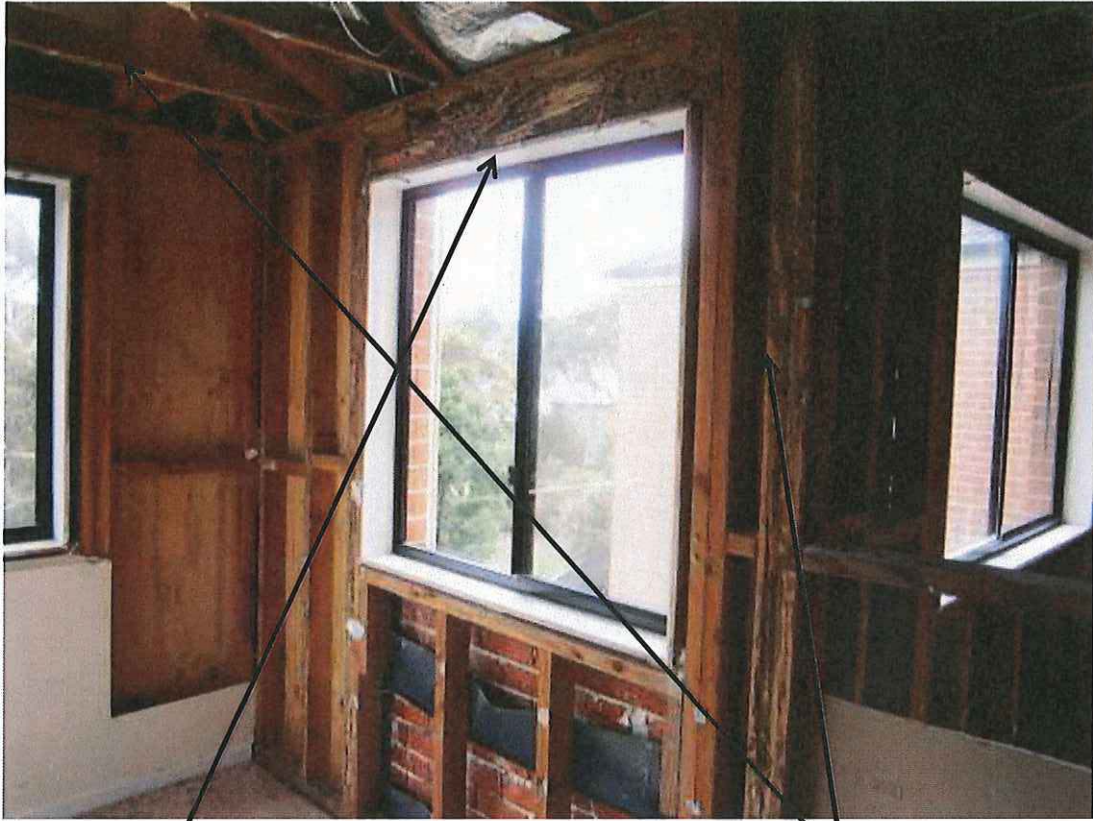
Damage to lintel above upstairs bedroom window, as originally located in December 2010

Damage located in studs and joists adjacent to areas where termites were originally located.

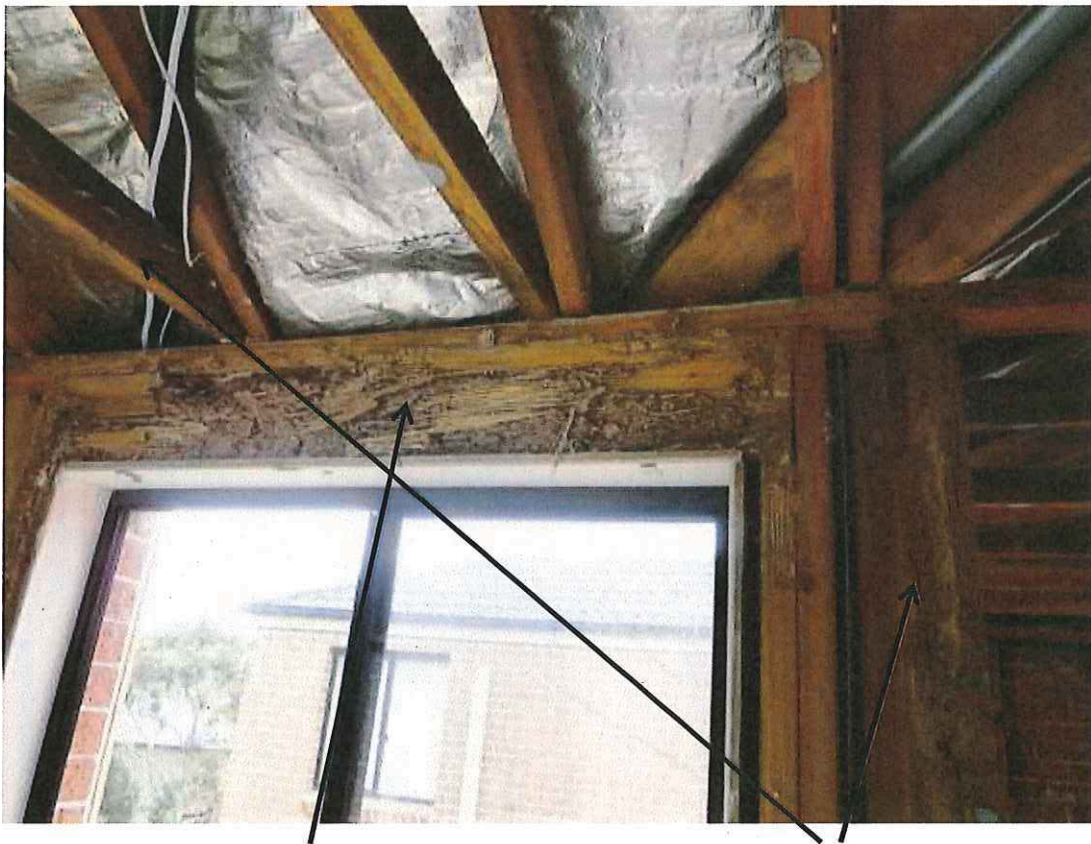
Damage to lintel above upstairs bedroom window, as originally located in December 2010

Damage located in studs and joists adjacent to areas where termites were originally located

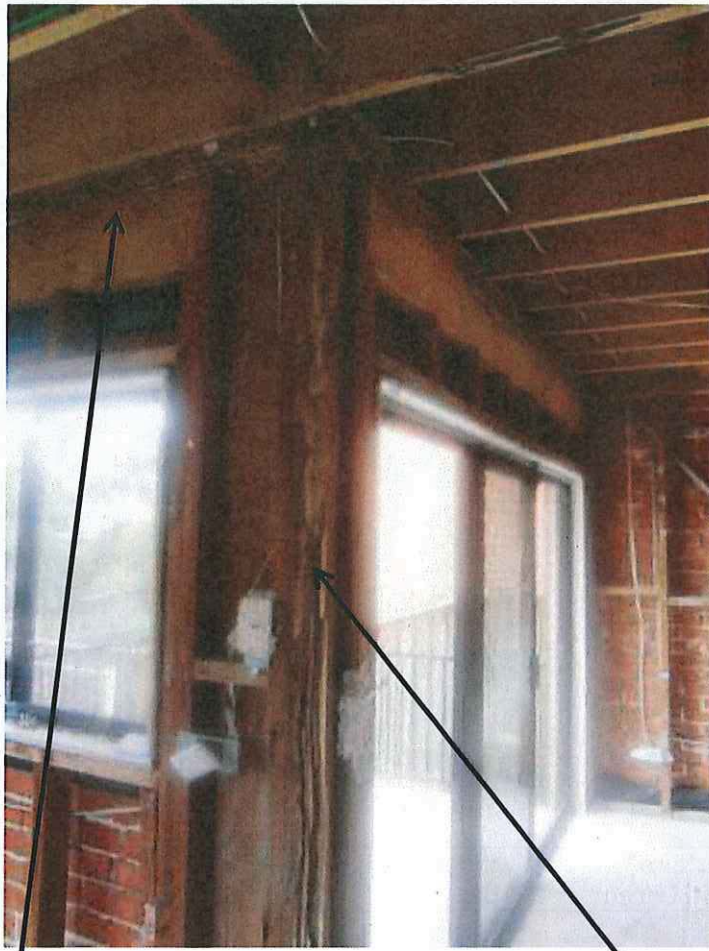
Damage to top plate and beams below upstairs bedroom

Damage to studs below upstairs bedroom

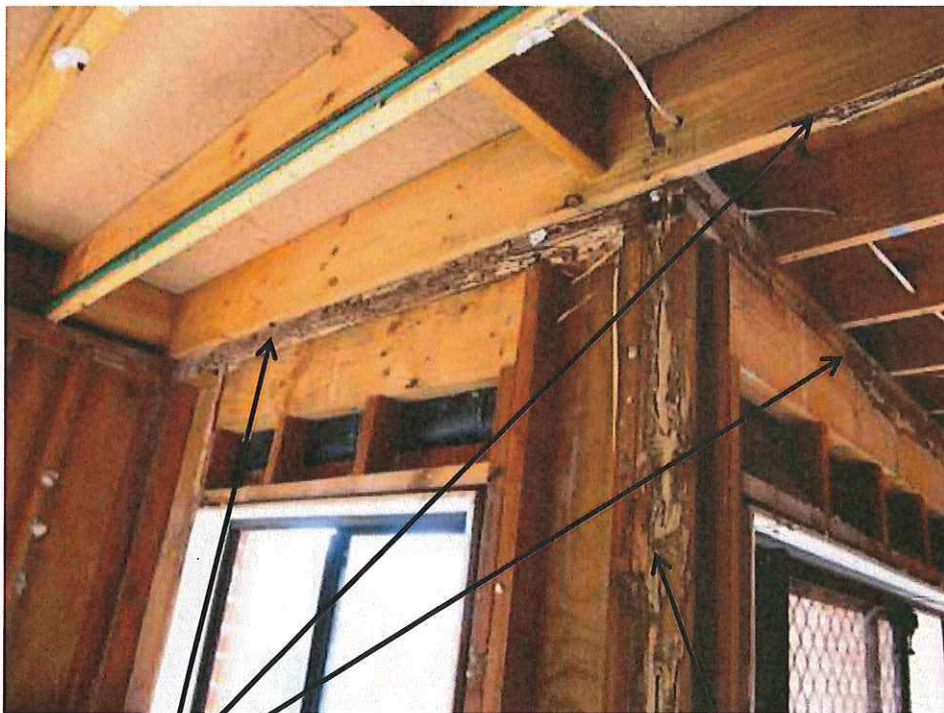
Damage to top plate and beams below upstairs bedroom

Damage to studs below upstairs bedroom

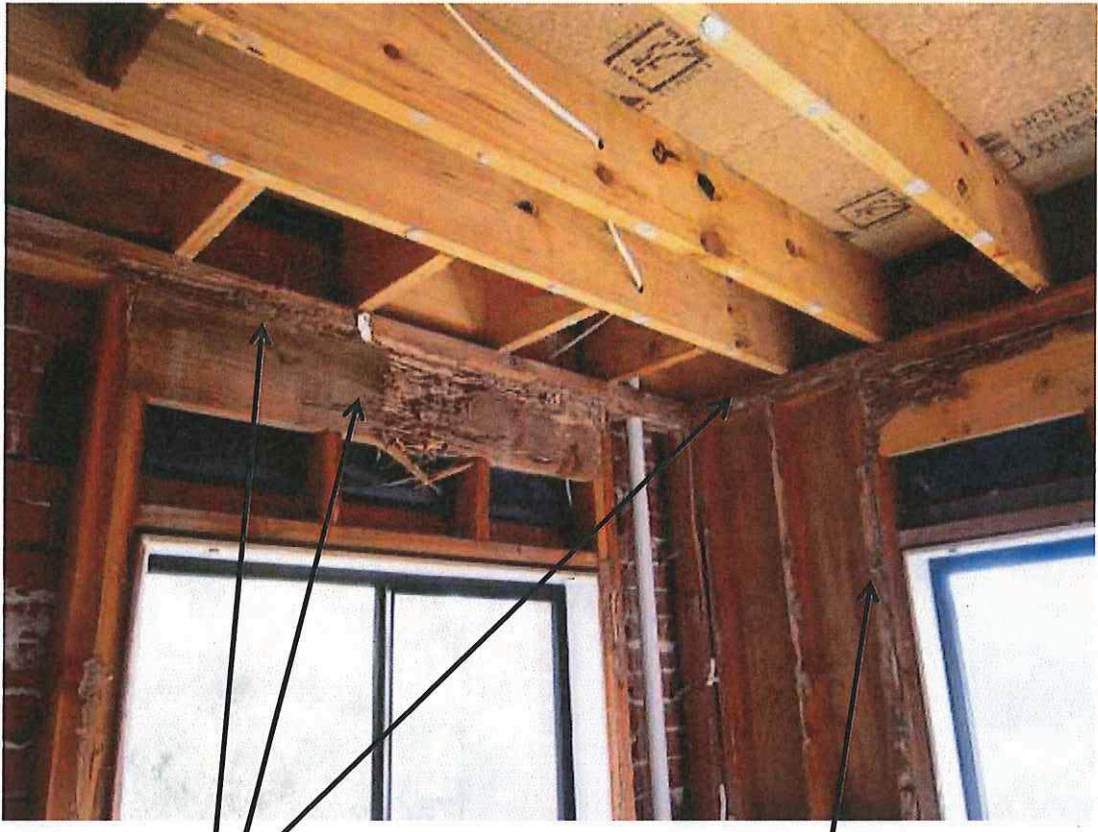
Damage to beam/window lintel on ground floor level      Damage to studs on ground floor level

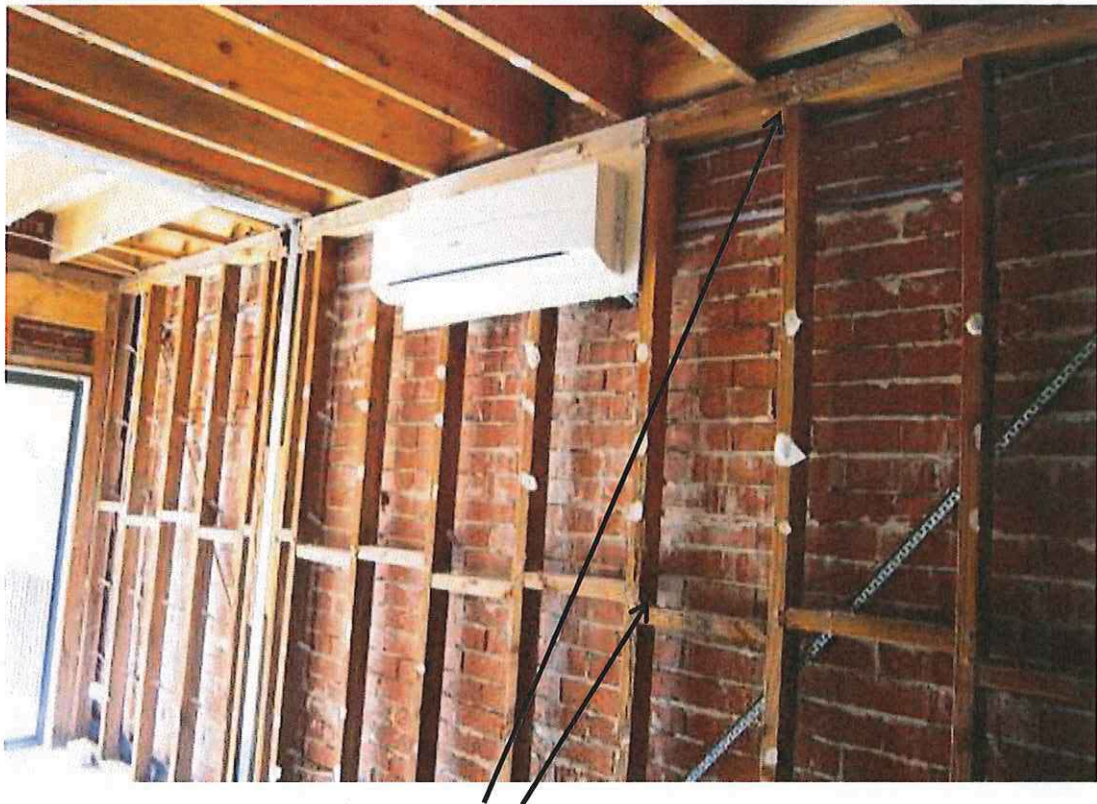
Damage to studs and top plate in ground floor lounge room

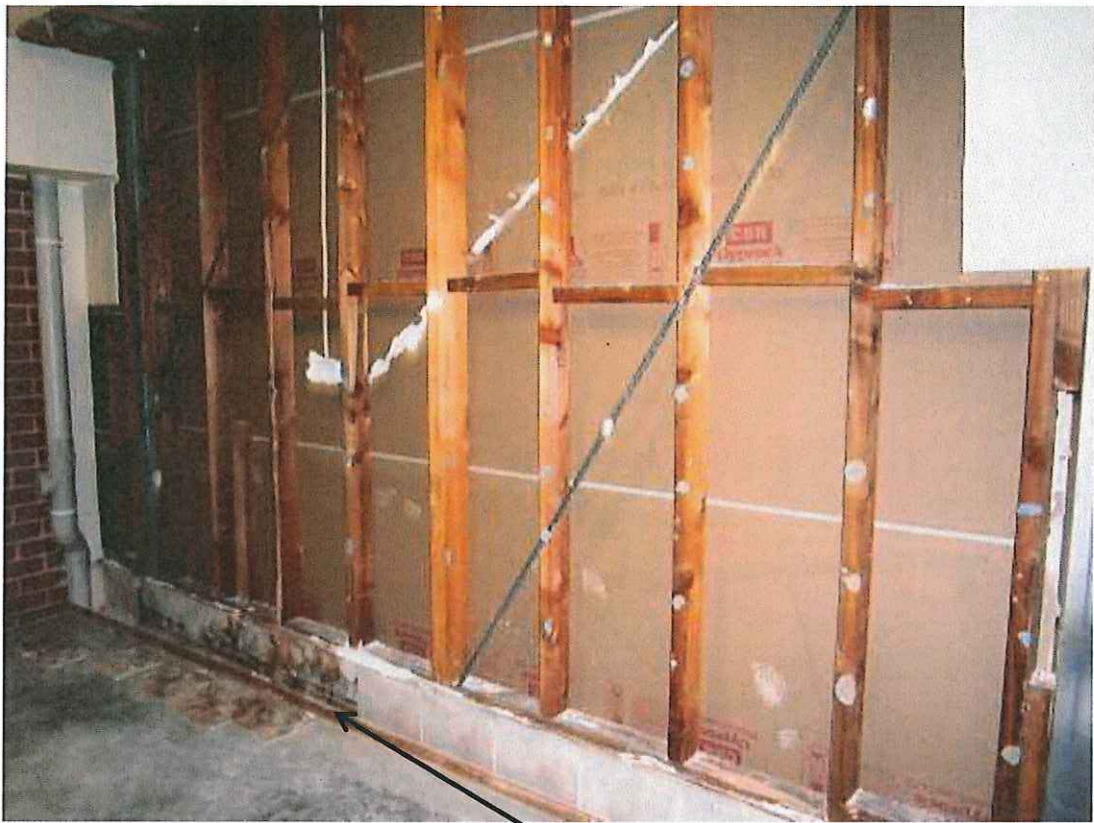
The entry point was finally located at the garage slab junction. As stated previously the location of the termites upstairs indicated they had to be elsewhere in the property as shown when the investigative works commenced. The correct use and placement of a moisture meter along this wall would have indicated a problem in this area and other areas downstairs such as the kitchen and lounge room. The extensive amount of workings in the walls, especially of the garage, and other areas in the property should have been picked up with a moisture meter and thorough inspection.

Location of entry point at slab joint in garage

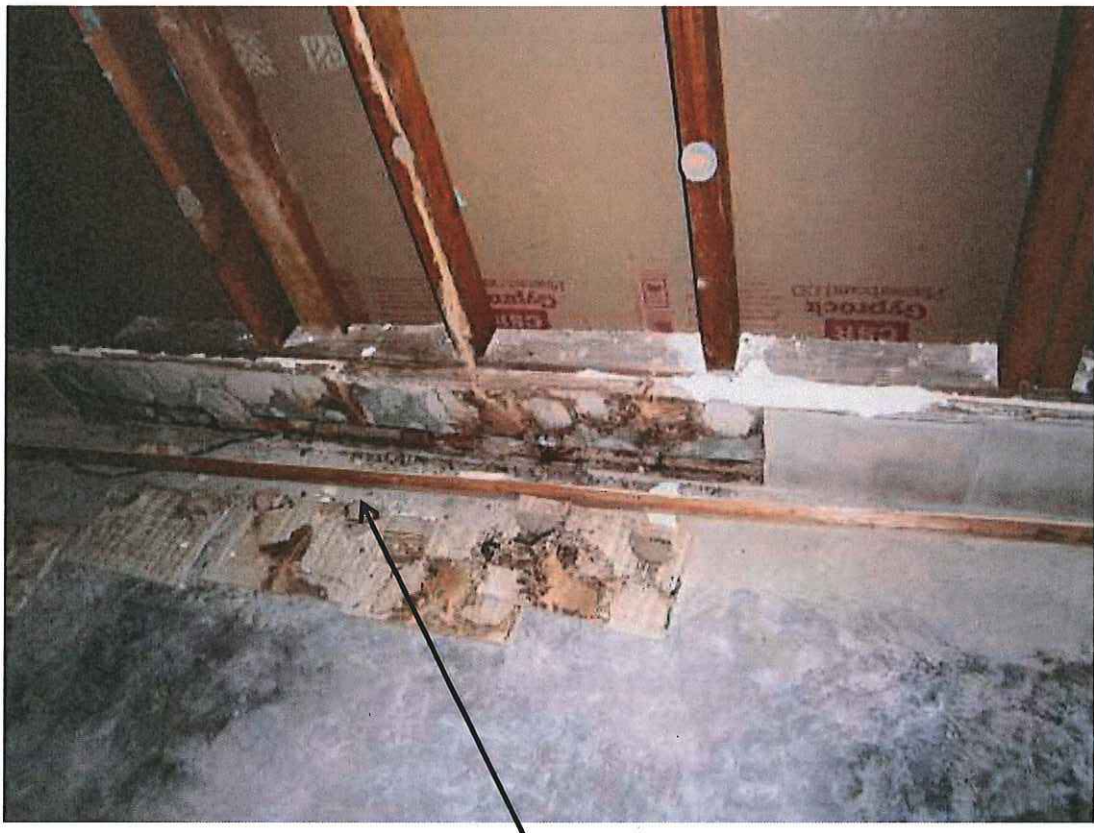
Closer view of location of entry point at slab joint in garage

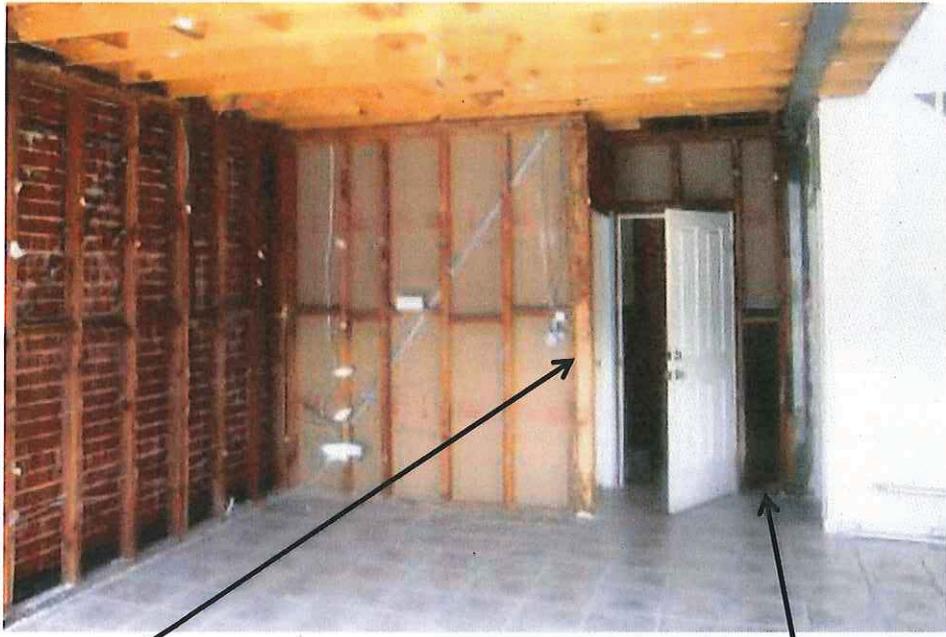
Damage to studs close to entry/sub nest location point on ground floor

Location of sub nest showing easy access for inspection with moisture meter

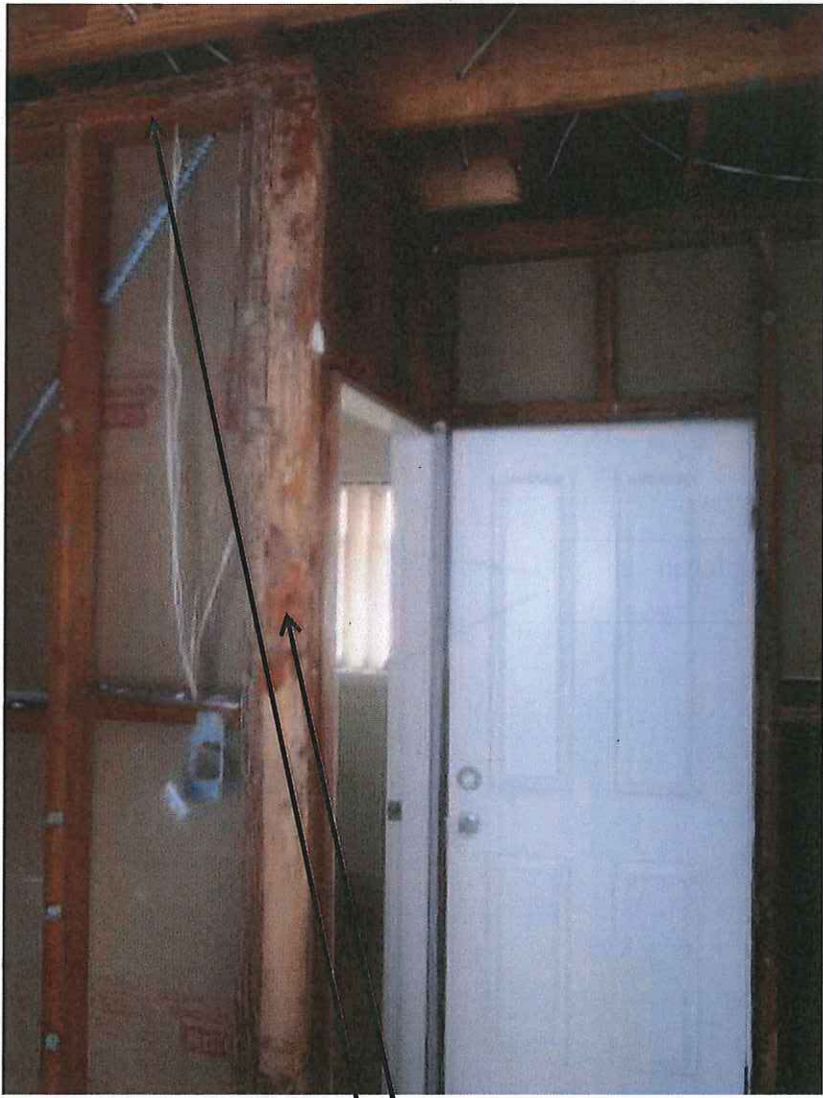
Closer view of damage to studs close to entry/sub nest location point on ground floor. Shows travel up the stud and along the top beam.

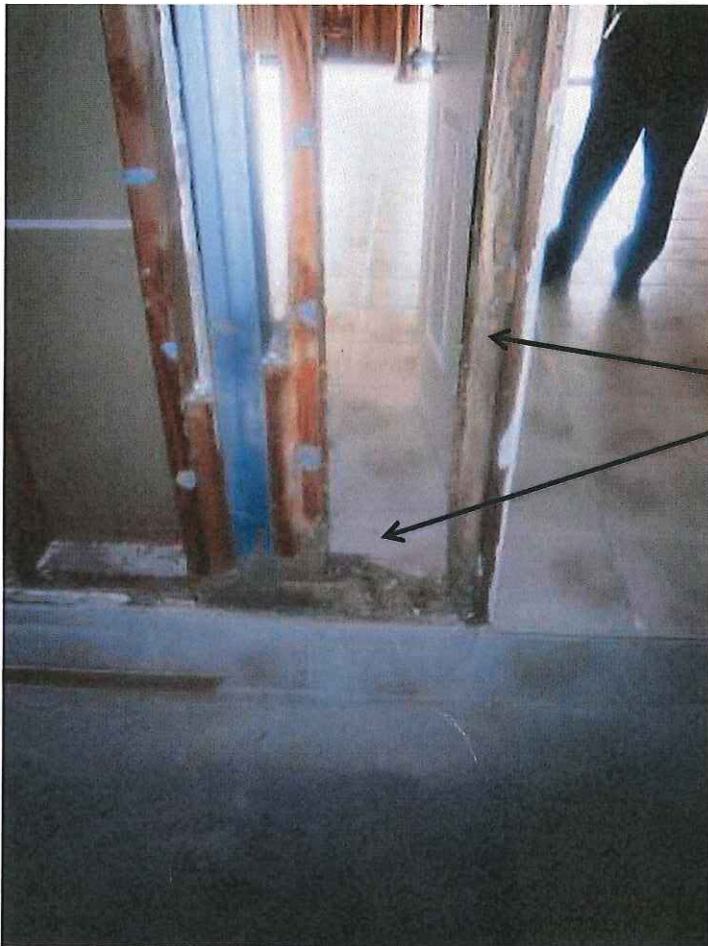
Closer view of location of sub next adjacent to entry point in garage with evidence of damage in adjoining stud.

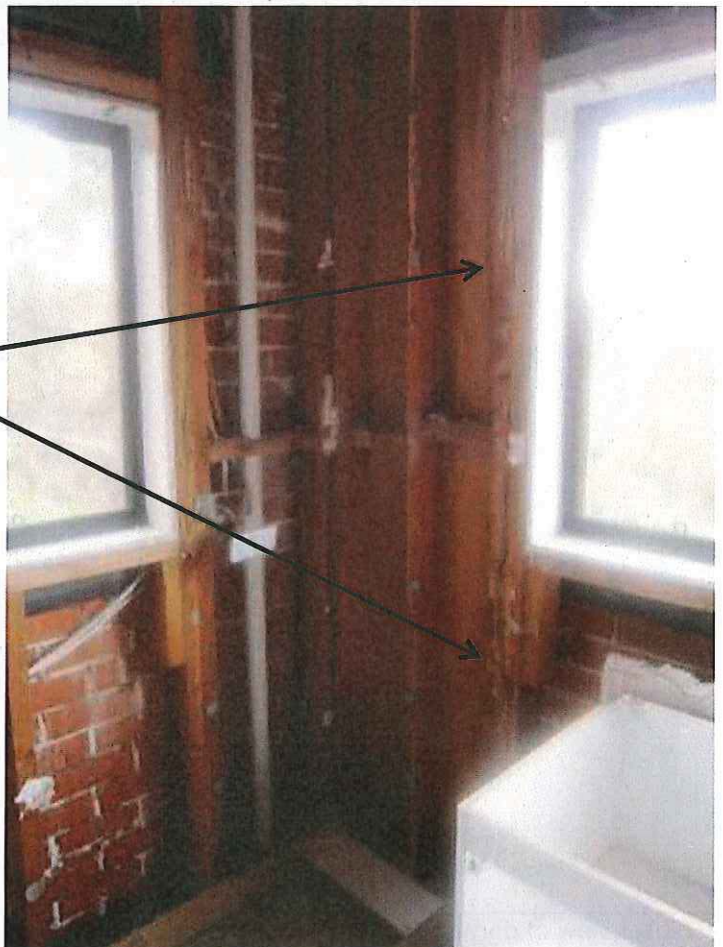
Damage to studs in kitchen on ground floor.

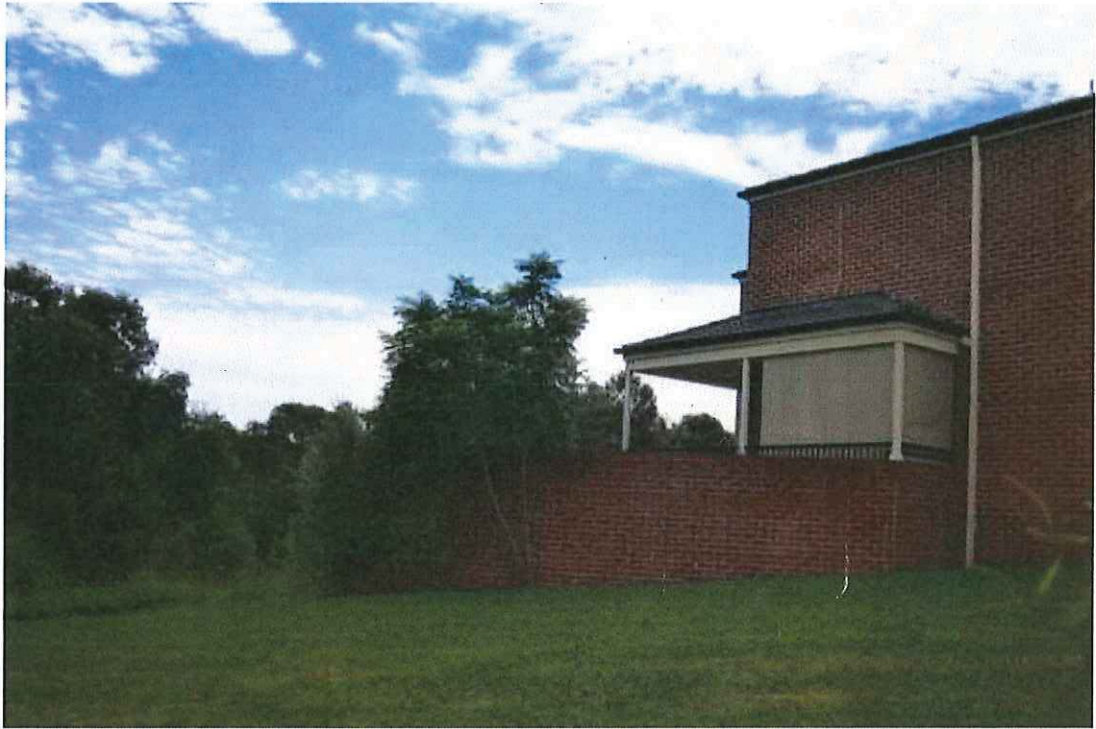
View of bushlands surrounding property, showing the close proximity of large trees to the property, making it high risk for termite infestation.
