Belconnen Naval Transmitting Station

Heritage Management Plan

Report prepared for Defence Housing Australia

September 2020

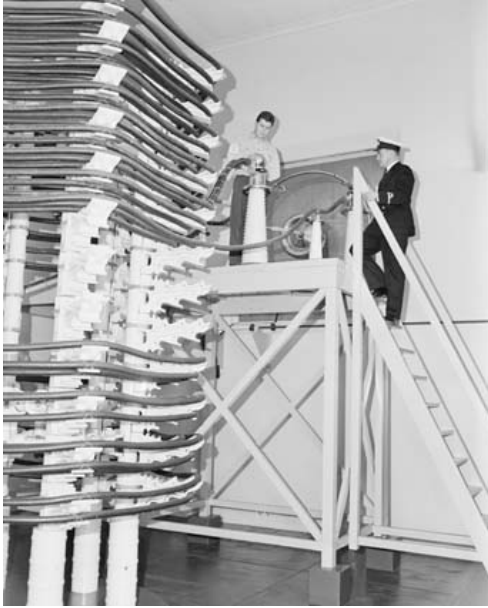
Figure 3.21 Aerial loading coil located in the helix room at the transmitting station, 1961. (Source: National Archives of Australia, A1200, 11139796)

John and Waygood in 1941. For its operation, an addition known as the helix room was built onto the transmission hall in 1940 and 1941 as a purpose-built room housing for the aerial loading coil and aerial tuning variometer (Figure 3.21 and Figure 3.22).⁴⁷ Particular adaptations were used for this specialist communications equipment building. Metal nails were replaced with timber dowels to fix the timber ceiling panels after the metal fittings conducted the high electrical current of the facility and burned the ceiling panels. The building foundations also attracted special treatment with alternating layers of concrete and cork to achieve stability and cushioning for the transmitting equipment.⁴⁸ Other technologically significant construction details to the helix room included embedded copper wires in the walls and ceiling to act as a protective Faraday cage and a fibreglass laminate window with corona rings at the point where the cable exited.⁴⁹

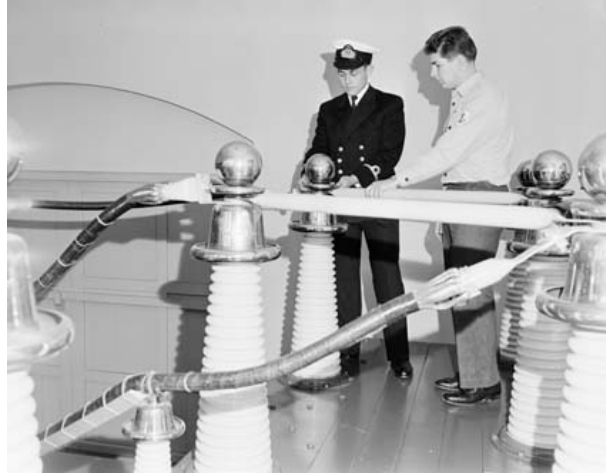
Figure 3.22 Connecting links of the loading coil between a transmitter and its aerial. The stainless-steel globes prevent corona discharge. (Source: National Archives of Australia, A1200, 11139799)

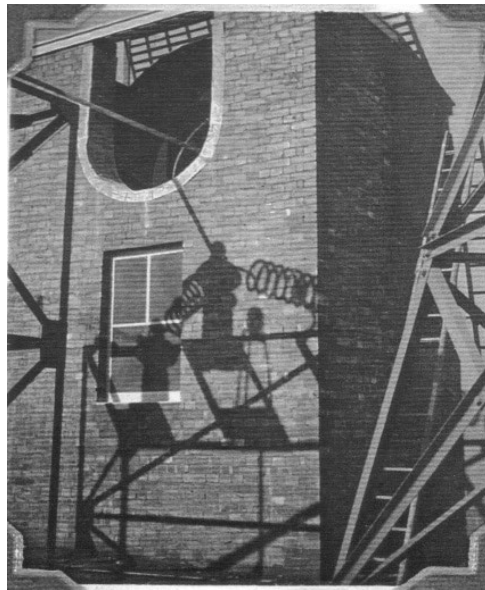
Figure 3.24 Bomb-blast proofing situated around the aerial feeder, at the northern wall of the Helix Room, before render 1942. (Source: Tremlett Collection from 2001 HA)

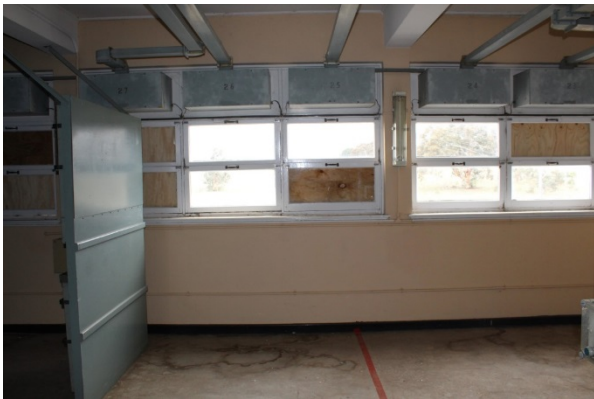
Figure 4.27 First floor Aerial Switching Room with water damage to the floor (2018).

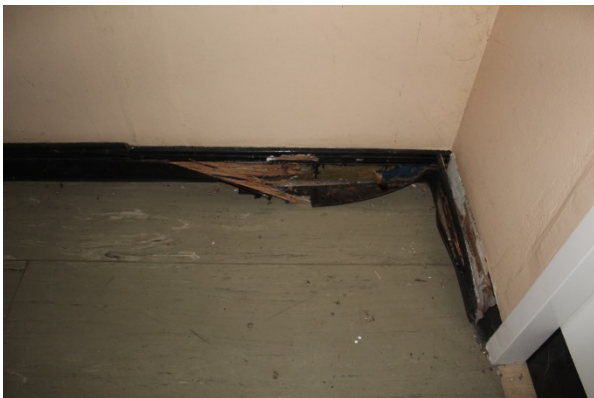
Figure 4.29 Water damaged skirting in room 13 (2018).

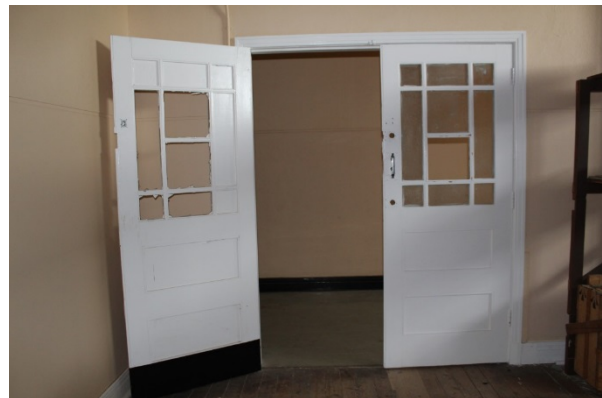
Figure 4.30 Smashed glazed panels in doors to room 32 (2018).

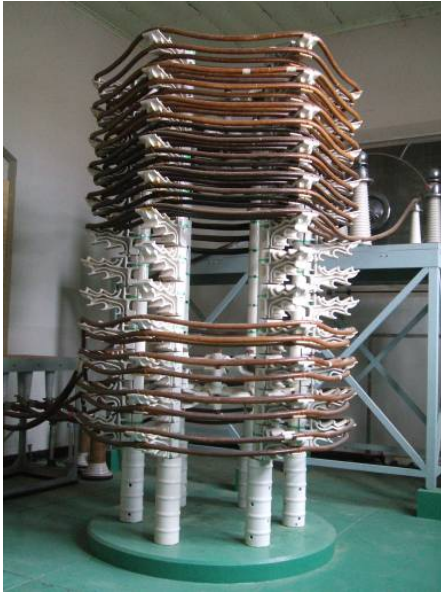
Figure 4.39 The aerial loading coil in the helix room, 2018.

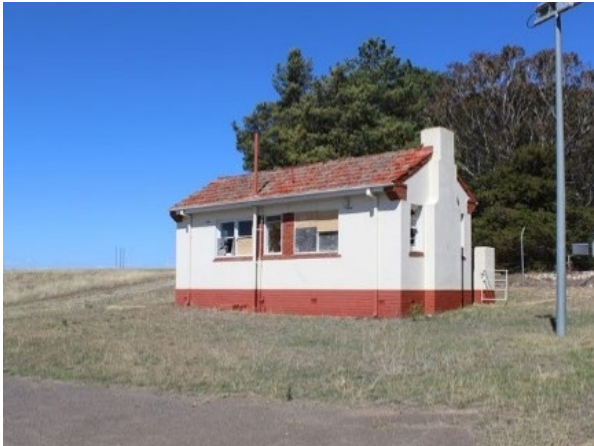
Figure 4.43 The guardhouse looking east. Note the partially ply infill windows, 2018.

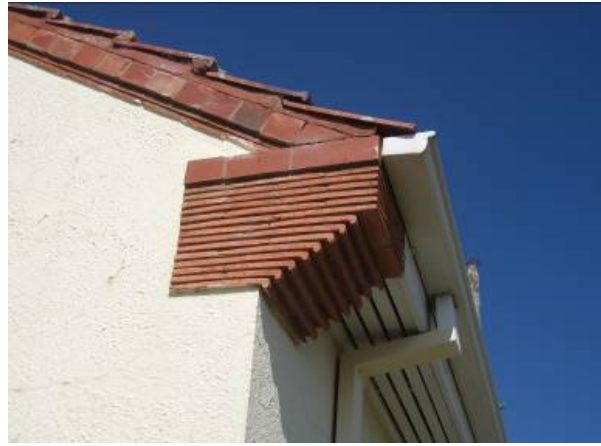
Figure 4.44 Decorative terracotta corbels on the guardhouse which are also featured on the earliest section of the transmitting building, 2018.

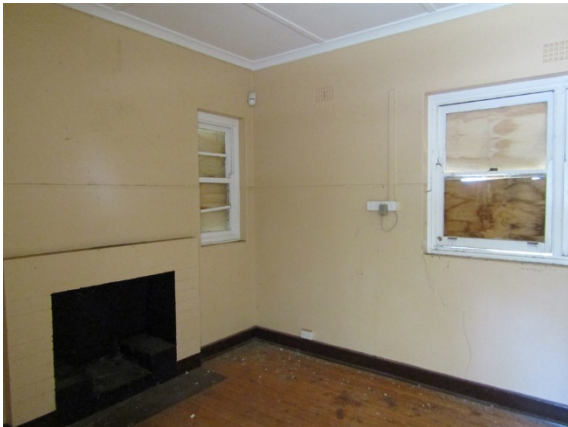
Figure 4.45 Main room within the Guardhouse. Note the boarded windows and broken glass, 2019.
