s47F

North Nowra, NSW

## Report Information

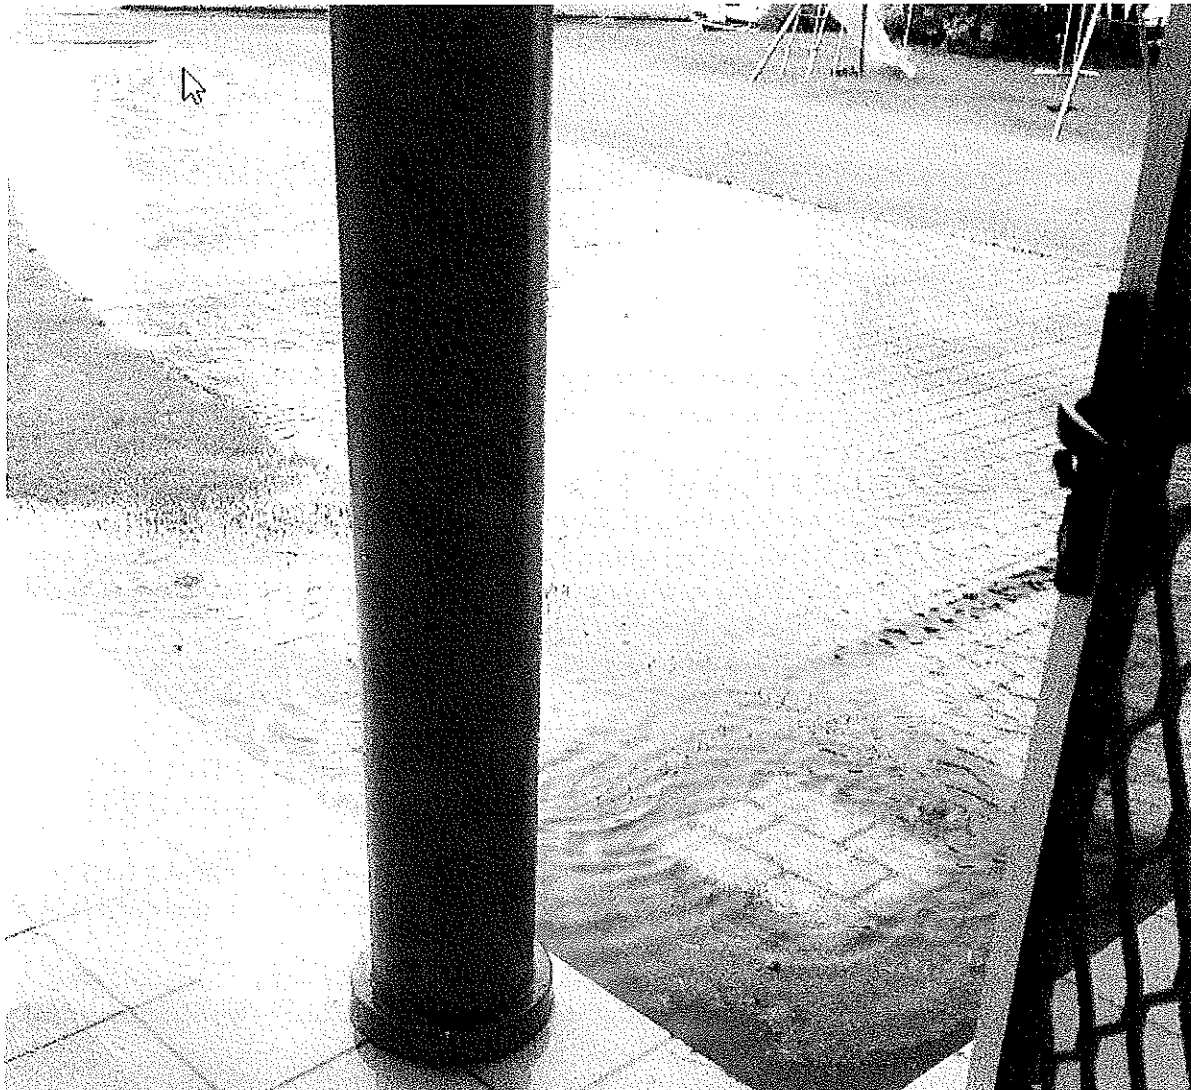
Appendix A – Flooding 18<sup>th</sup> Dec 2015 s47F

- 18<sup>th</sup> Dec 2014 - Large local flash flooding inundates the front driveway/porch/shed at s47F and the pool in s47F leading to further deterioration of the boundary fence between the properties (Appendix A)

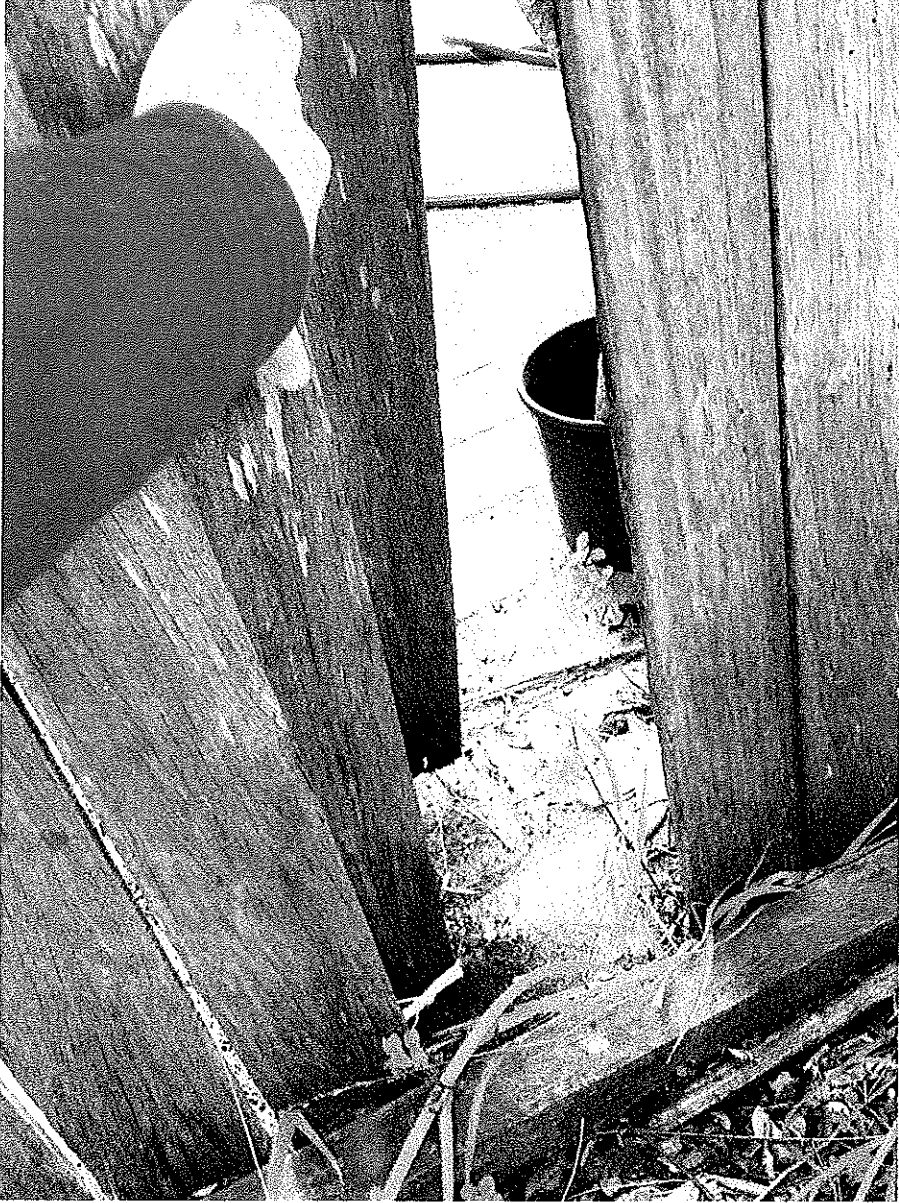
Appendix C

Please also find attached a recent photos (May 21<sup>st</sup>) we took a few days after a storm showing how the slats and railing are in poor condition and easily moved (appendix C).

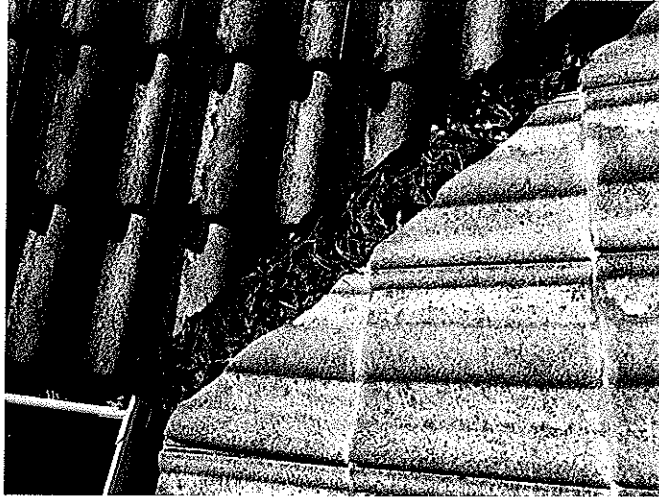
Debris in guttering areas- this requires cleaning out to prevent blocking of down pipes and leaking into eaves and fascia

Gutter ponding - This can relate to poor fall, inadequate down pipes, gutter or debris build up. If debris presence has been noted above clean same out and re-assess for any ponding. If clean guttering is ponding it can be a blocked down pipe or the guttering fall is inadequate. Recommendations: A qualified plumber should be engaged for advice and recommendations.

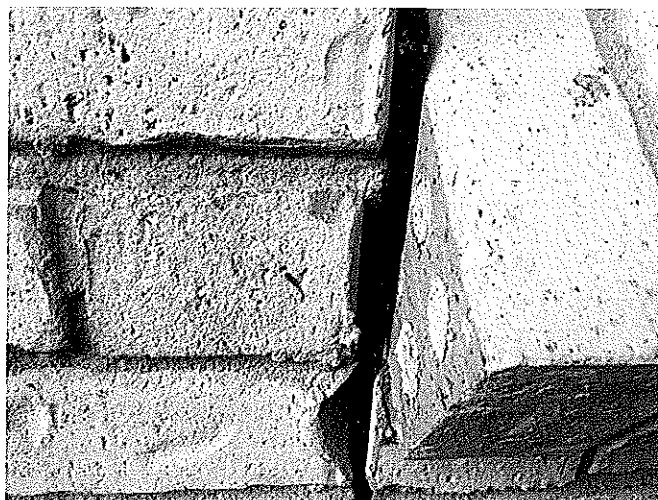
The control joints have not been sealed completely. Recommendations: Engage carpenter to carry out same - Minor and easily rectified. Where any water penetration could occur, i.E. No eave coverage, they should be sealed.
