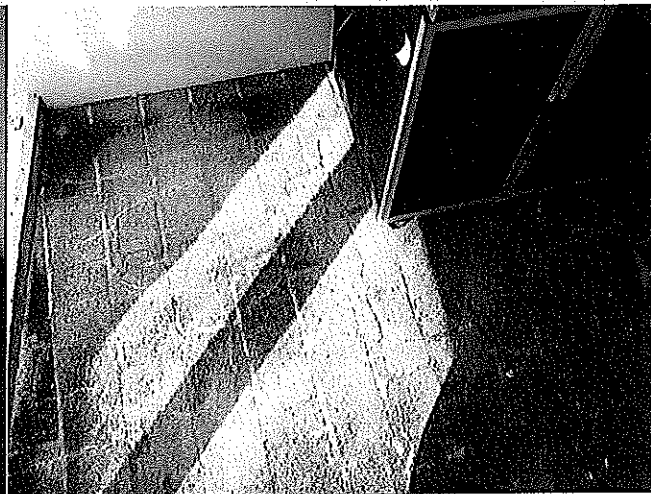
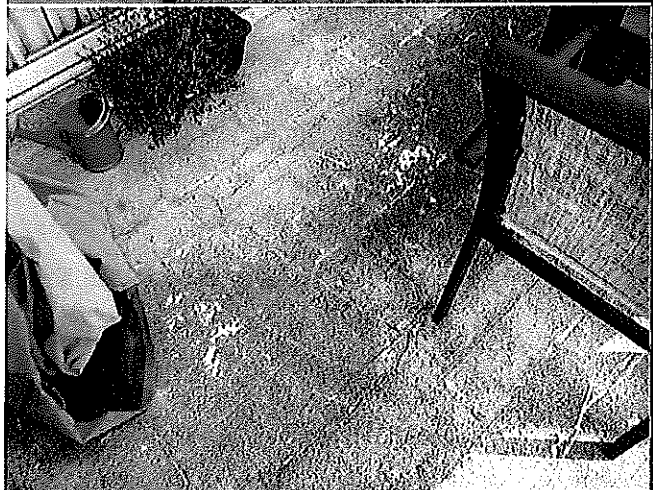
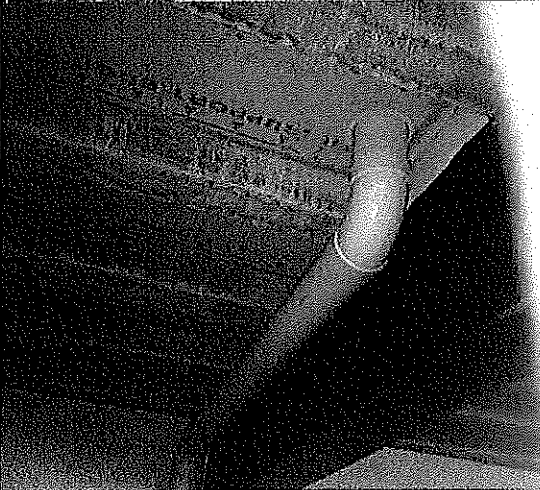
### PHOTOS

The 1<sup>st</sup> floor balcony and 2<sup>nd</sup> floor balcony have experienced major water damage over a long period of time. The 2<sup>nd</sup> Floor Balcony has no overhead covering exposing it to all elements of rain hail frost etc. The stencil crete has lifted and there are cracks forming in the slab. There is a drainage point that at the time of inspection was clear of obstructions. Although this size drain complies with the BCA in my professional opinion it is too small to cope with down falls of rain without overhead covering.

The first floor balcony has suffered extensive stencil crete damage as the drainage point has not been able to cope with the amount of water from the above balcony and has flooded this balcony many times. The ceiling of this balcony has also experienced damage from water leaking from the above surface. This indicates to me that the waterproof membrane has failed from the 2<sup>nd</sup> floor balcony.

Structural engineer to inspect the 2<sup>nd</sup> floor slab for safety as it has extensive "spider web" cracks throughout. If still safe then a builder and plumber be engaged to install larger drainage to the 1<sup>st</sup> and 2<sup>nd</sup> floor balconies and reconfigured into the ground floor car park. 2<sup>nd</sup> Floor balcony to have an overhead covering built with the water being diverted into a separate drainage location. Both balconies require re sealing and re stenciling. The 1<sup>st</sup> floor balcony ceiling requires complete strip and rebuild as it has dropped 50mm either side

**IMPLICATIONS FOR TENANCY OCCUPATION:** Tenant will need to be in temporary accommodation and all relevant agency will need to be notified and be granted approval of works.
