## Site Audit Report

Former Sewage Treatment Plant and Landfill 2, Former Schofields  
Aerodrome, Triton Parade, Nirimba Fields, NSW 2763

Audit Number: MP169\_04

6 March 2023

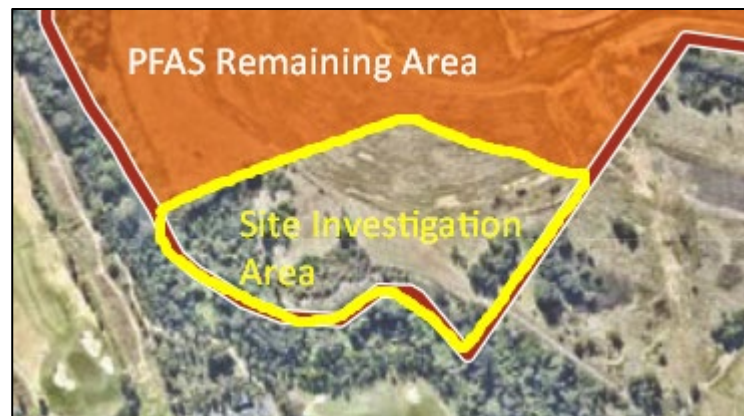
1. **Section 1:** The 'Site Investigation Area' adopted in this report is shown in Figure 1 to be a rectangular-shaped area of approximately 26 ha. As the ultimate objective is to achieve a Section B SAS/SAR for STP and Landfill 2, which were excluded from 'the audit site' as shown in Figure 1a of Ramboll's PFAS Remaining Site Area Validation Report dated 21 October 2021, it is recommended that the 'Site Investigation Area' (i.e. STP and Landfill 2) is the same area which was previously excluded (refer to marked up screen shot of Figure 1a of Ramboll's PFAS Remaining Site Area Validation Report below):

This way the entire former Schofields Aerodrome will be eventually audited.
