## Site Audit Report

No Scrape Area South, Former Schofields Aerodrome, Triton Parade,  
Nirimba Fields NSW 2763

Audit Number: MP169\_05\_R1

5 September 2023

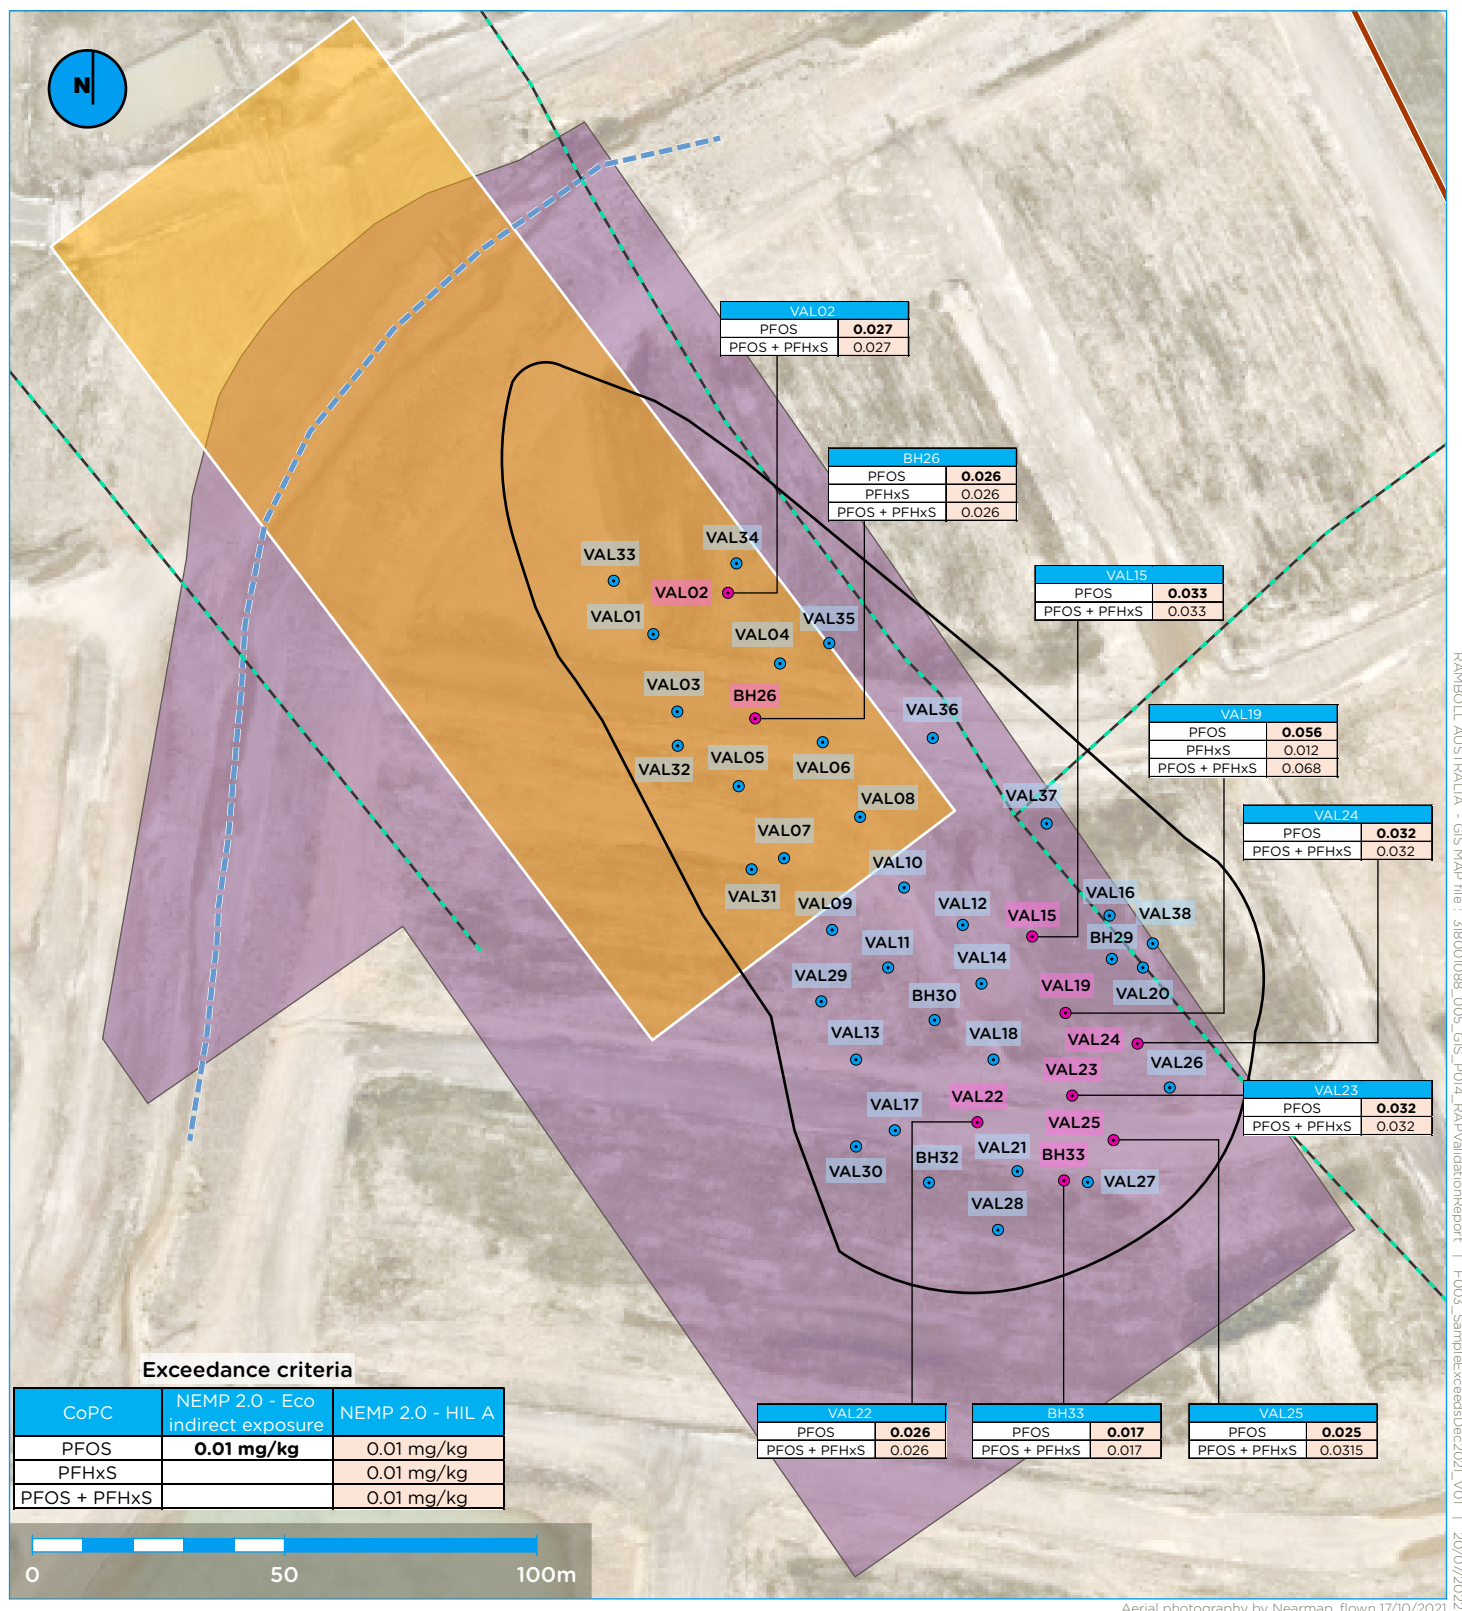
**Figure 3: Post Round 1 Excavation Validation Sampling Locations and Exceedances**

- Approximate Former Schofields Aerodrome site boundary
- No scrape area south
- Approximate location of remediation former Fire Fighting Training Area (FFTA)
- Remediation extent 3.2m to 3.7m - November to December 2021
- Swale
- Former drainage channel

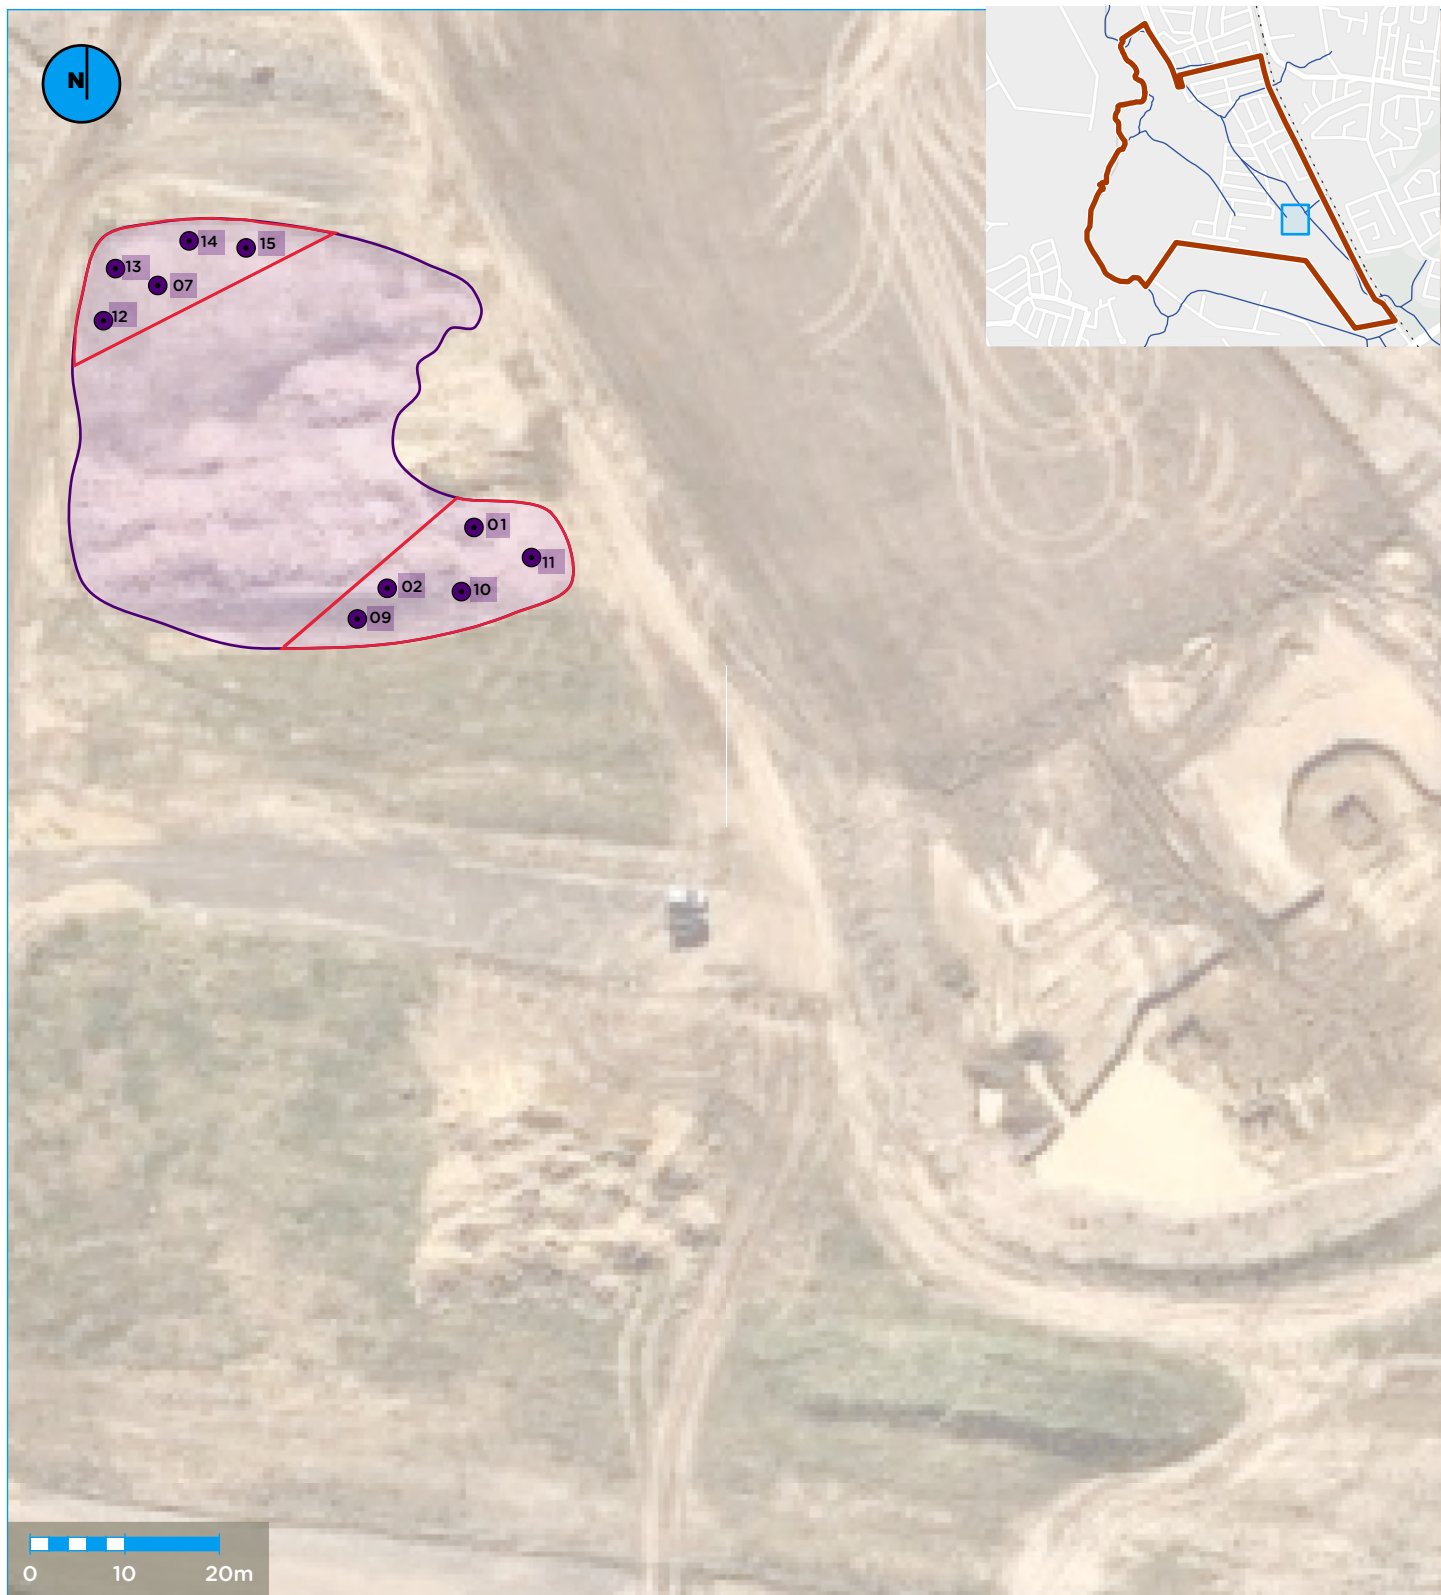
**Figure 10: Further Excavation of SP03 and Validation Sampling**  
 No Scrape Area South PFAS Remedial Action Plan - Former Schofields Aerodrome

- SP03
- SP03 Further Excavation

- Stockpile 3 (prefix "SP03\_VAL\_")

**8. Section 6.1.2, Stockpile Removal Footprint Validation:** Further excavation of the footprint of stockpile SP03 conducted on 16 and 17 February 2023 was to what depth?
