Reserve 980, Former Schofields Aerodrome, Access off Aerodrome Drive, Nirimba Fields NSW 2763

Audit Number: MP169\_07

# Site Audit Report

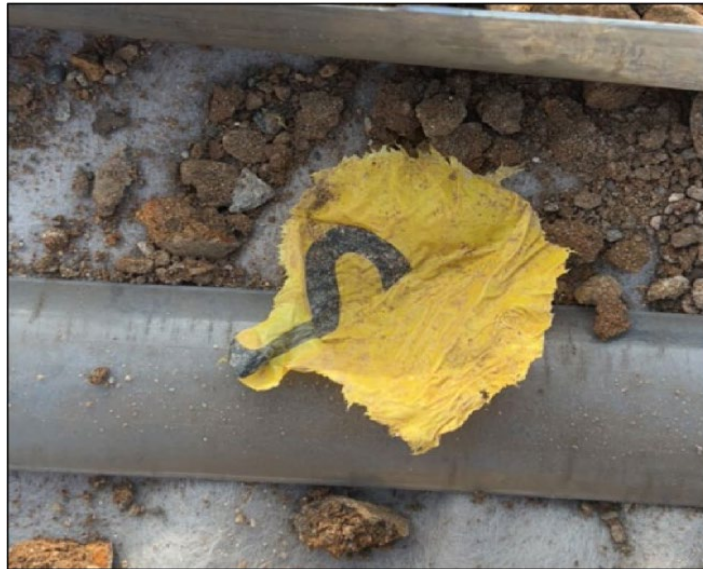
**Plate 1: Fragment of yellow plastic observed at R980\_MW01at 0.9 mbgl (Source: Photograph 2, Appendix 7 of Ramboll 2025b)**

Soil logs are provided within Appendix 5 of the DSI, indicating sample depth, PID readings and lithology. The logs report no indications of contamination (staining, odour) were found. A piece of yellow plastic tape was observed at R980\_MW01 and this material was considered to be associated with loading or transport of the VENM material (i.e. not gross inclusion of anthropogenic waste).

One piece of yellow-coloured plastic (refer to **Plate 1**) was identified at 0.9 mbgl in the imported fill soil at R980\_MW01 during the DSI. This material was interpreted to be associated with the loading or transport of the imported material and waste inclusion in the imported VENM. No other anthropogenic material was observed. The auditor concurs with the DSI that the yellow plastic observed at R980\_MW01 is likely to be material used during the transportation and somehow one isolated fragment was buried. This was an isolated case as all other previous soil investigation conducted in as part of the PFAS MEA and Remaining Site Area (as well as other areas external to Reserve 980 within the former aerodrome) had not identified any inclusion of anthropogenic waste.

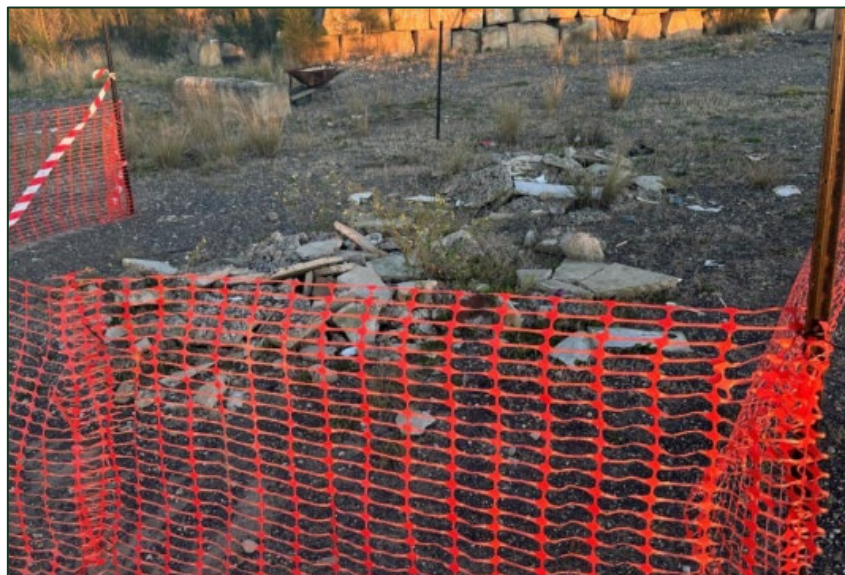
**Plate 2: Off-white coloured illegally dumped fibre cement sheets, 28 July 2025 (Source: Photograph 11, Appendix 7 of Ramboll 2025b)**

Illegally dumped compressed fibre-cement sheets as shown in **Plate 2** were observed by Ramboll on ground surface in an isolated area marked with 'FRAG1' on Attachment 2 (**Appendix A**). Ramboll collected a fragment of fibre-cement (Sample R980\_FRAG1) on 11 April 2024 and submitted this for asbestos identification. Chrysotile and crocidolite bonded asbestos were identified (refer to Table 1b of the DSI).

The cement sheets were removed by Undercover Landscapes Pty Ltd (The Undercover Group) on 28 July 2025 with environmental consulting provided by Ramboll. The surface soil down to 0.2 mbgl was also scraped and removed. The waste, pre-classified as 'Special Waste (Asbestos Waste)', was placed directly into five asbestos-labelled bulk bags (approximately 1 tonnes) and taken to Bingo Recycling at Eastern Creek (Environment Protection Licence 13426) for disposal. The landfill dockets are provided in Appendix 8 of the DSI.

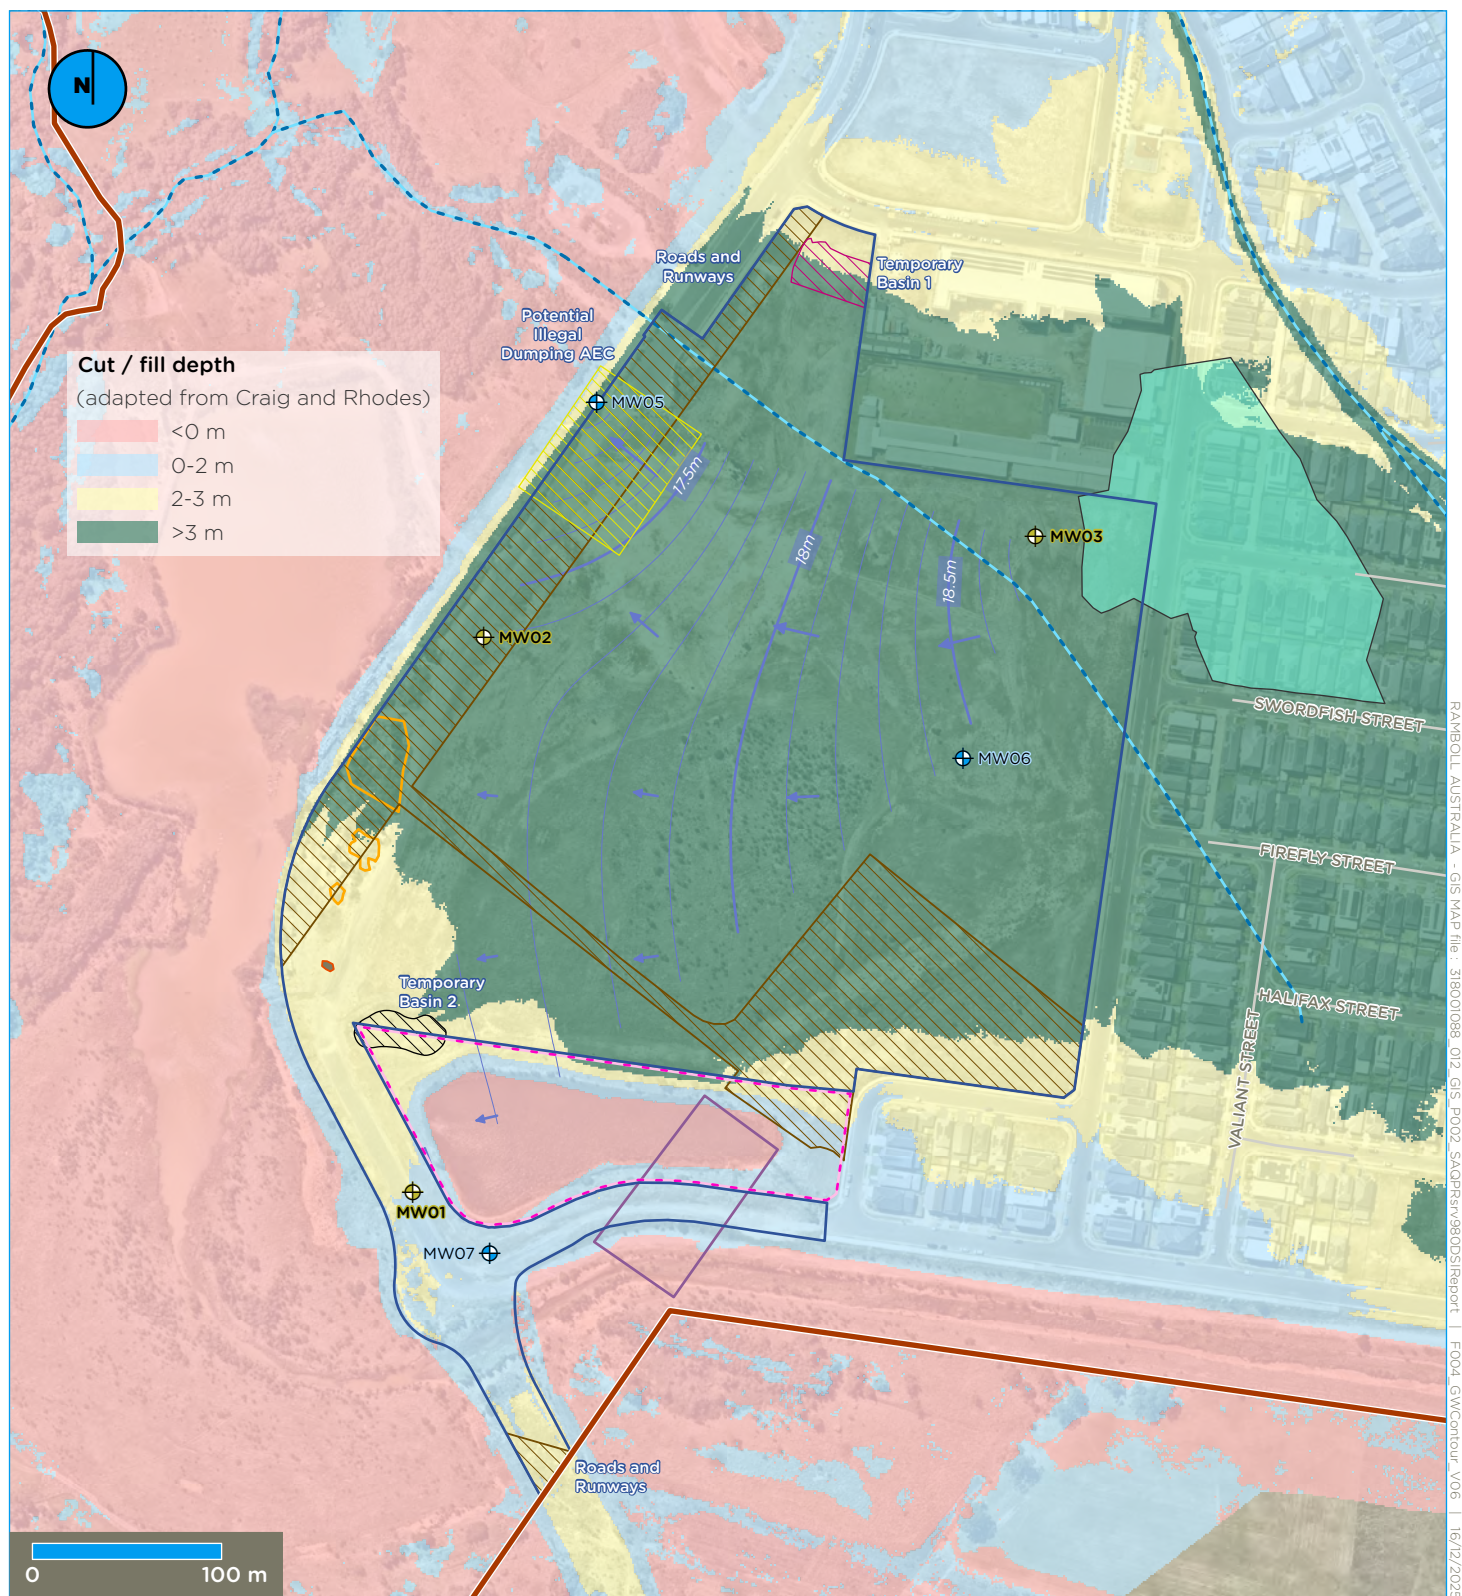
**Figure 4: Contoured Groundwater Elevations**  
Sampling and Analysis Quality Plan, Reserve 980 PFAS DSI

Note: MW07 has been destroyed.

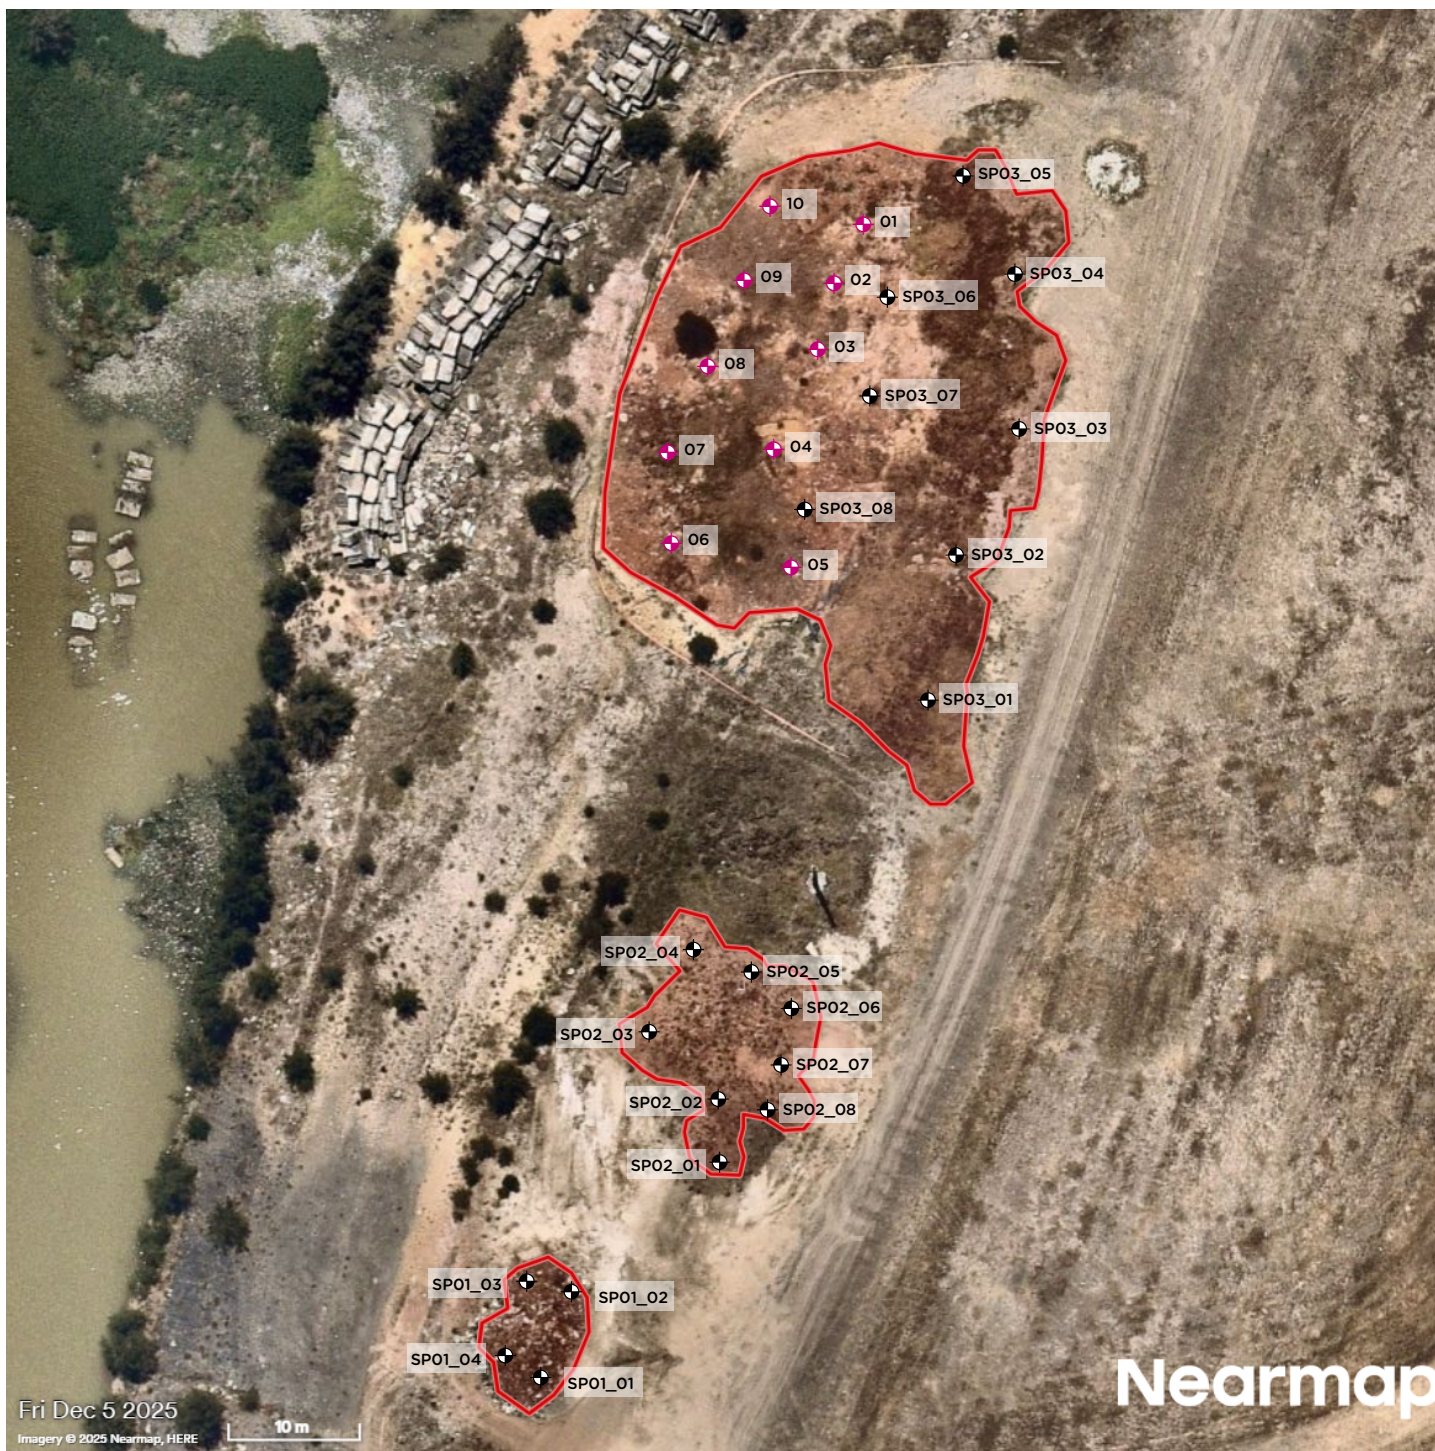
**Figure 1: Stockpile Locations and Layout and Sampling Locations**  
 Defence Housing Australia - Former Schofields Aerodrome

- ◆ Stockpile Sampling Locations
- ◆ April 2023 Stockpile Sampling Locations with Pre-fix "WC\_SP06\_"
