MOULD ANALYTICAL REPORT

Report Number: 1999

Purpose of Report: To assess the levels and genera of mould present pre-remediation.

Inspection Report & Findings

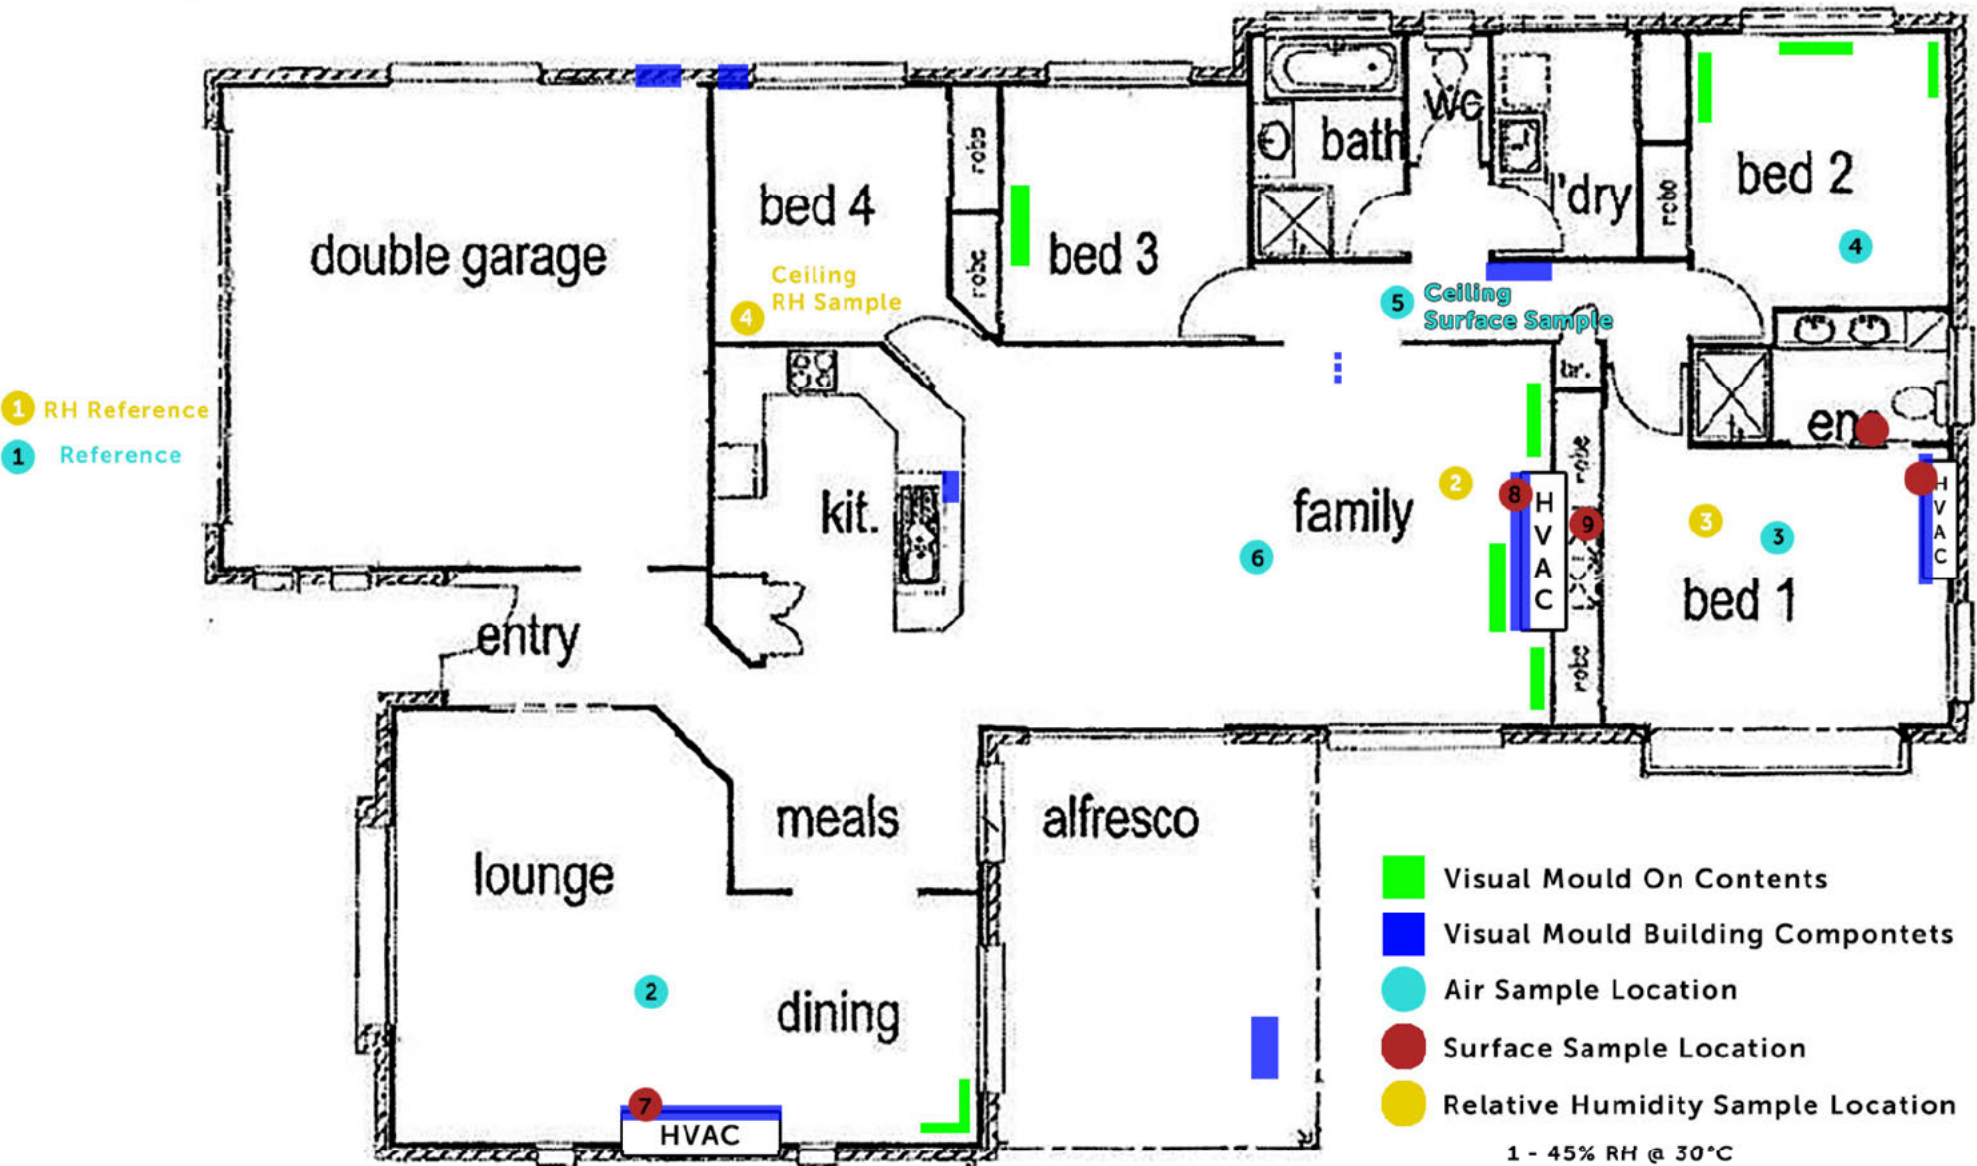
- Visual Mould On Contents
- Visual Mould Building Components
- Air Sample Location
- Surface Sample Location
- Relative Humidity Sample Location

1 - 45% RH @ 30°C
2 - 63% RH @ 26°C
3 - 65% RH @ 26°C
4 - 35% RH @ 40°C

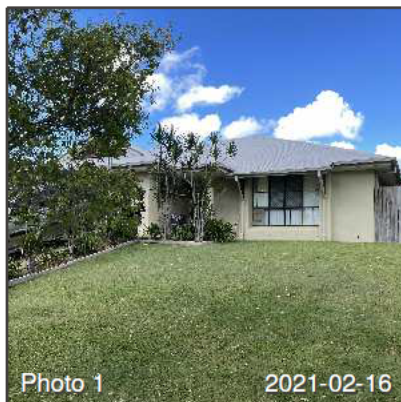
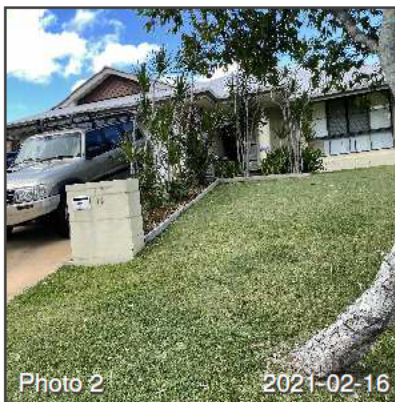
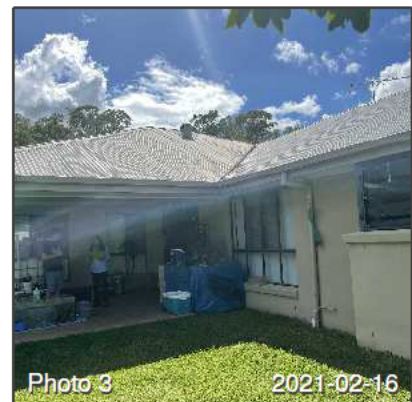
OVERVIEW PHOTOS: Exterior, Outside Mould Locations

- Condition 3 heavy visual mould to picture frame and backing hanging near fish tank
- Condition 3 visual mould growth to alfresco ceiling believed to be from water ingress into ceiling cavity (leak requires repair)
- Condition 3 visual mould growth to external eaves back of garage near bedroom 4, believed to be from gutter overflow issue

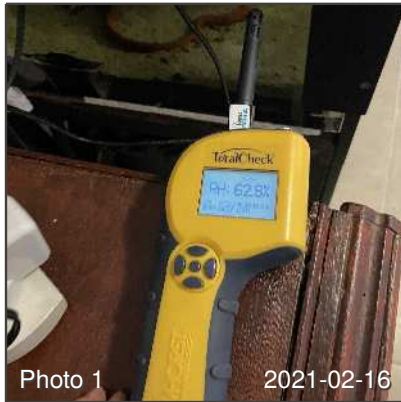
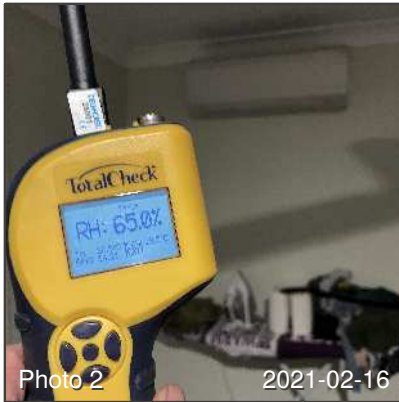
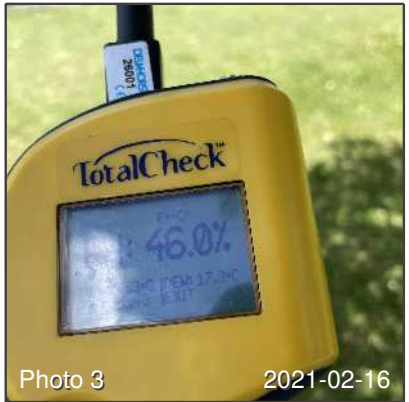
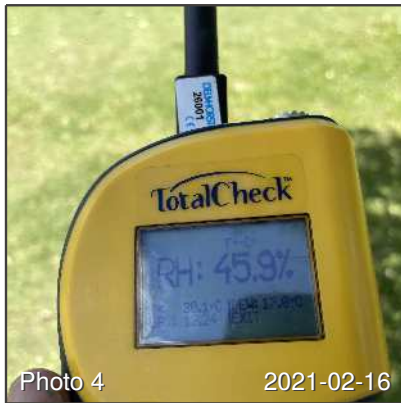
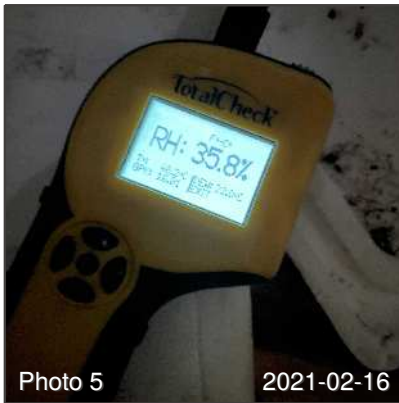
OVERVIEW PHOTOS: Inside 62 and 65%, Outside 45%, Ceiling 45%

Inside 62 and 65%, Outside 45%, Ceiling 45%
