MOULD ANALYTICAL REPORT

Report Number: 1999

Purpose of Report: To assess the levels and genera of mould present pre-remediation.

Inspection Report & Findings

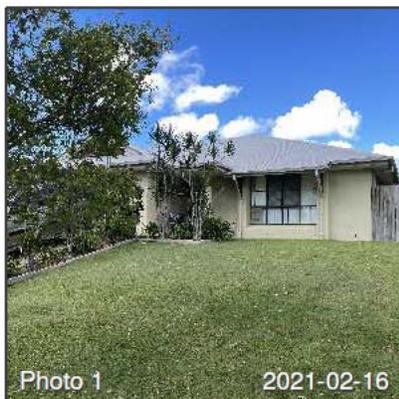
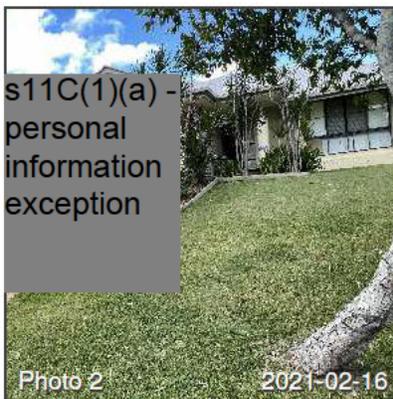
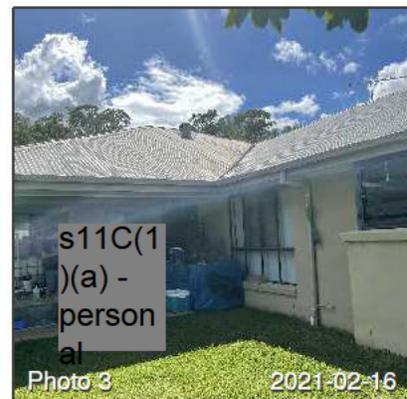
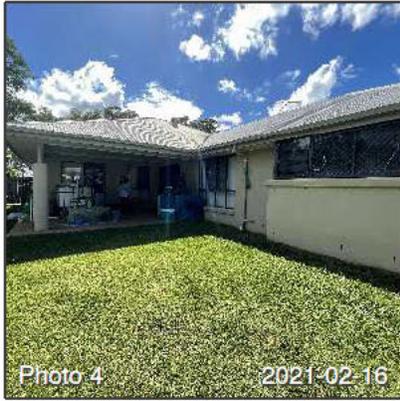
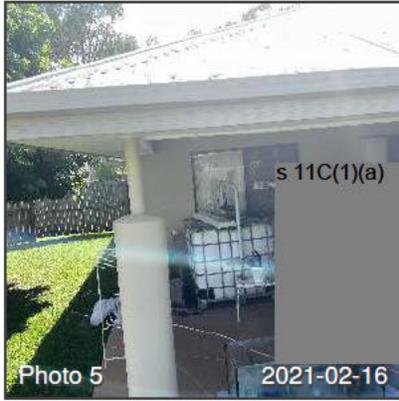
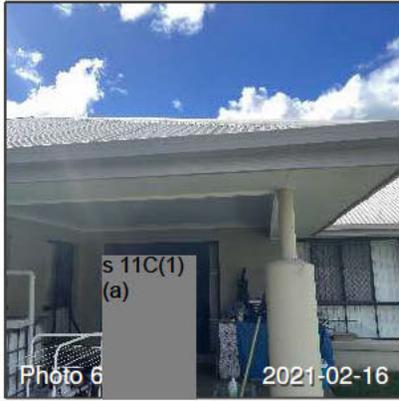
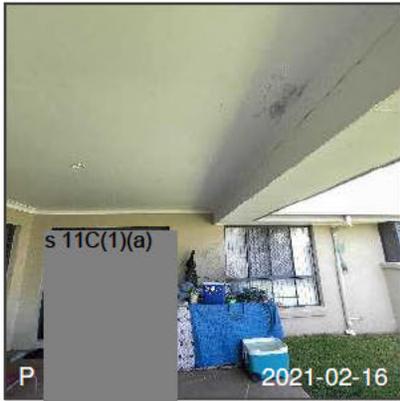
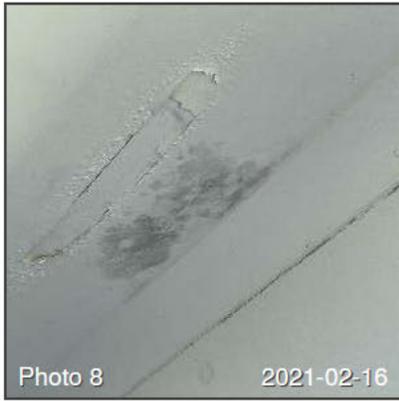
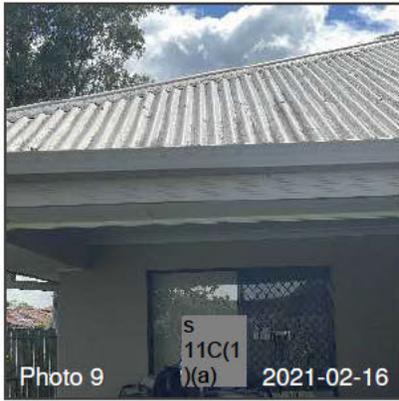
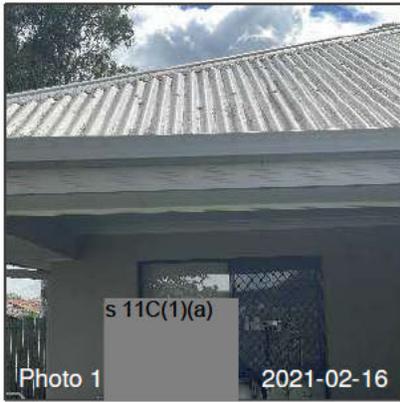
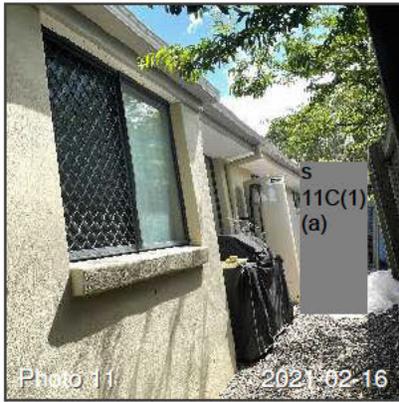
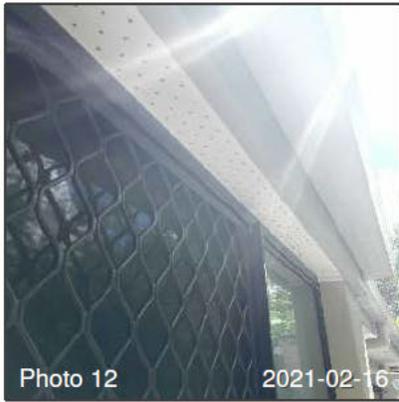
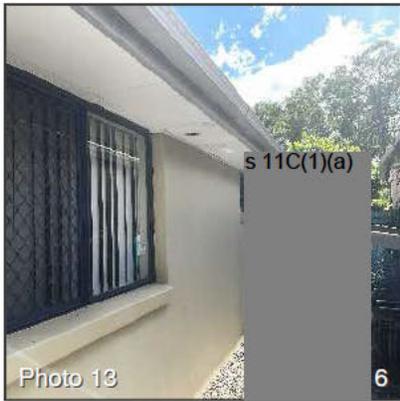
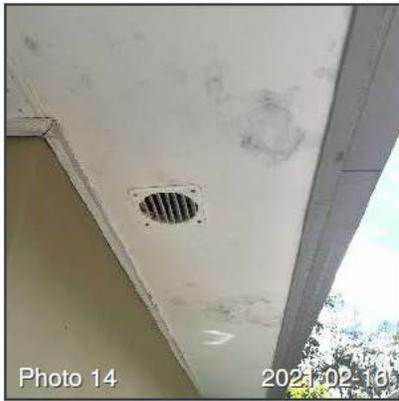
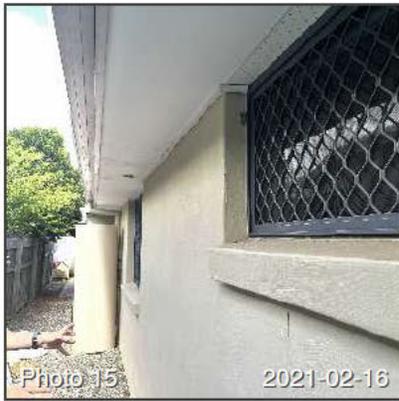
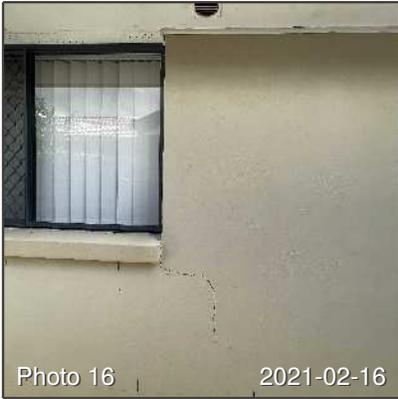
OVERVIEW PHOTOS: Exterior, Outside Mould Locations

- Condition 3 heavy visual mould to picture frame and backing hanging near fish tank
- Condition 3 visual mould growth to alfresco ceiling believed to be from water ingress into ceiling cavity (leak requires repair)
- Condition 3 visual mould growth to external eaves back of garage near bedroom 4, believed to be from gutter overflow issue

Note: mould affected from gutter leak

8) Replace mould affected eave panels down L/H side of house

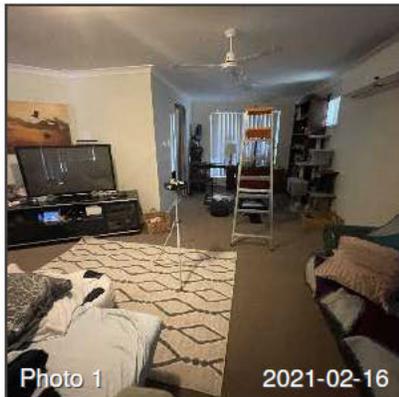
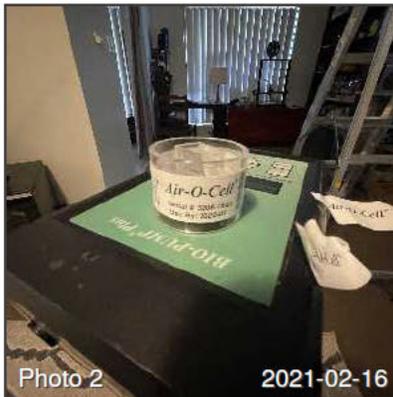
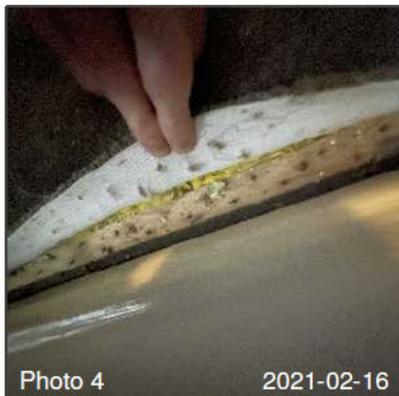
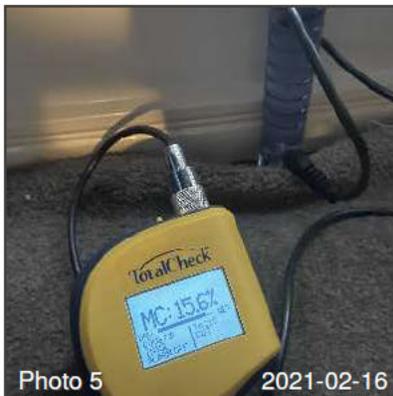
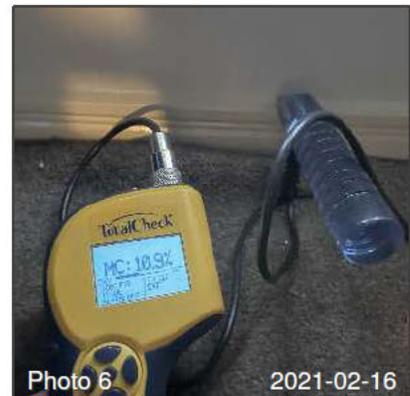
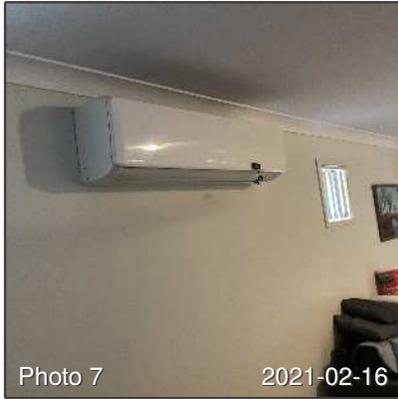
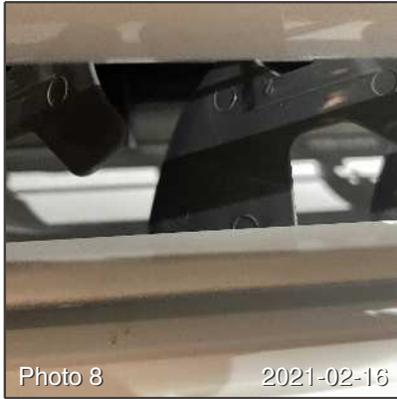
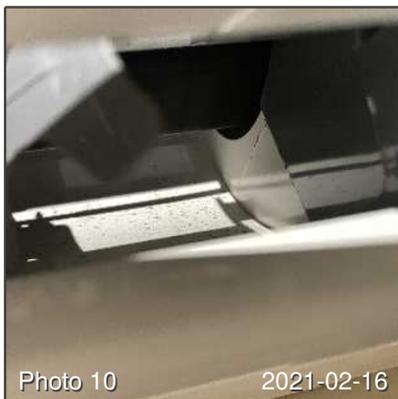
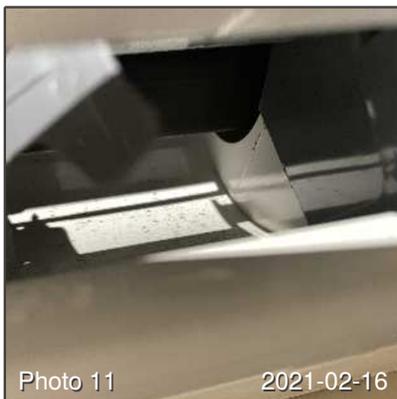
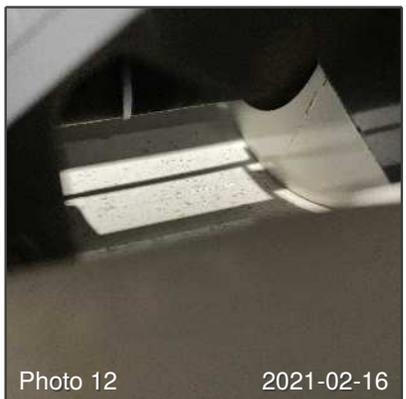
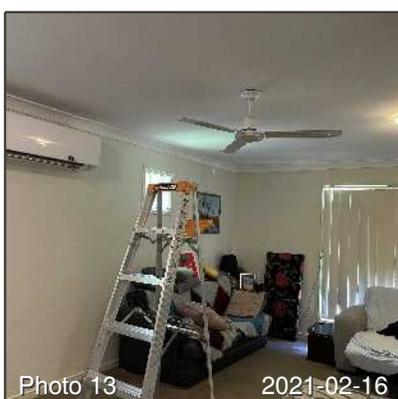
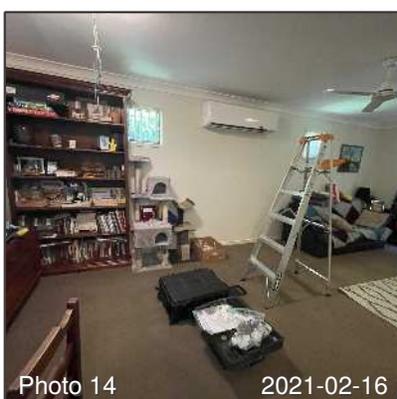
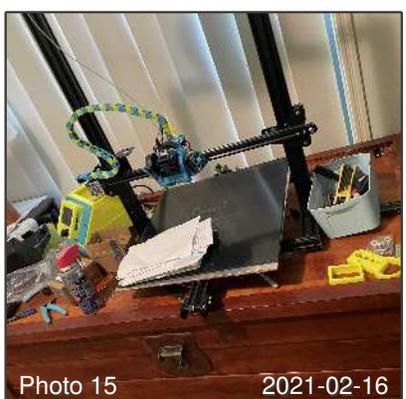
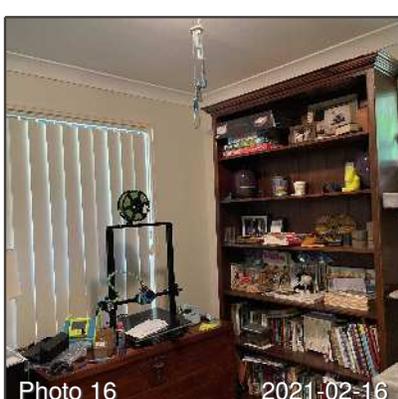
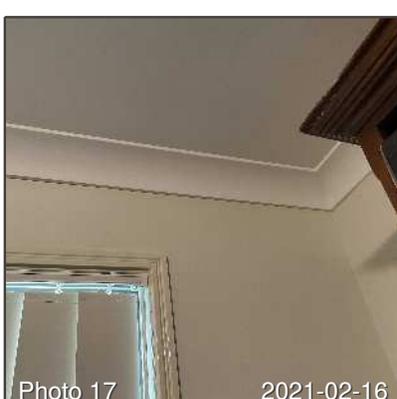
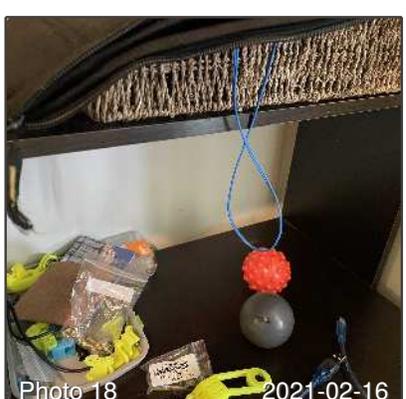
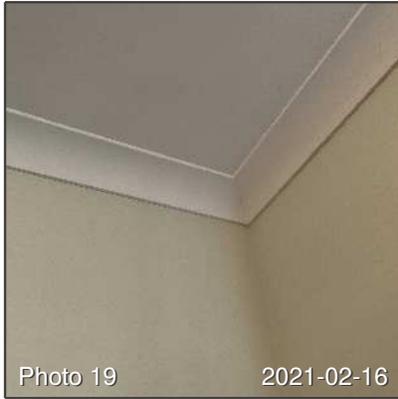
OVERVIEW PHOTOS: Lounge/Dining Room

- Premises condition - Property displays a good level of cleanliness. Presence of pets in the property (dogs, cat, fish tank)
- Visual mould in ceiling observed, previously cleaned by occupant, in family room/entrance to hallway
- Condition 2 mould settled spores and airborne mould found throughout property and content surfaces (refer to IECL Analytical Report NM1999)
- Condition 3 visual mould found on occupants contents to varying levels in dining, family, bedroom 1, bedroom 2 and bedroom 3
- Condition 3 visual mould growth found within 3 x HVAC split system air conditioning units
- Condition 3 visual mould growth found on glass pane cover on fish tank. A temporary fan in use on top of the fish tank also with heavy visual mould growth.
