**Re: Termite activity found at [REDACTED]  
2155**

RE: [REDACTED]

Further to your request and meeting with Joe at the property on Monday May 7, 2012, please find here our professional opinion regarding the termite damage sustained at this property between December 2010 to January 2012.

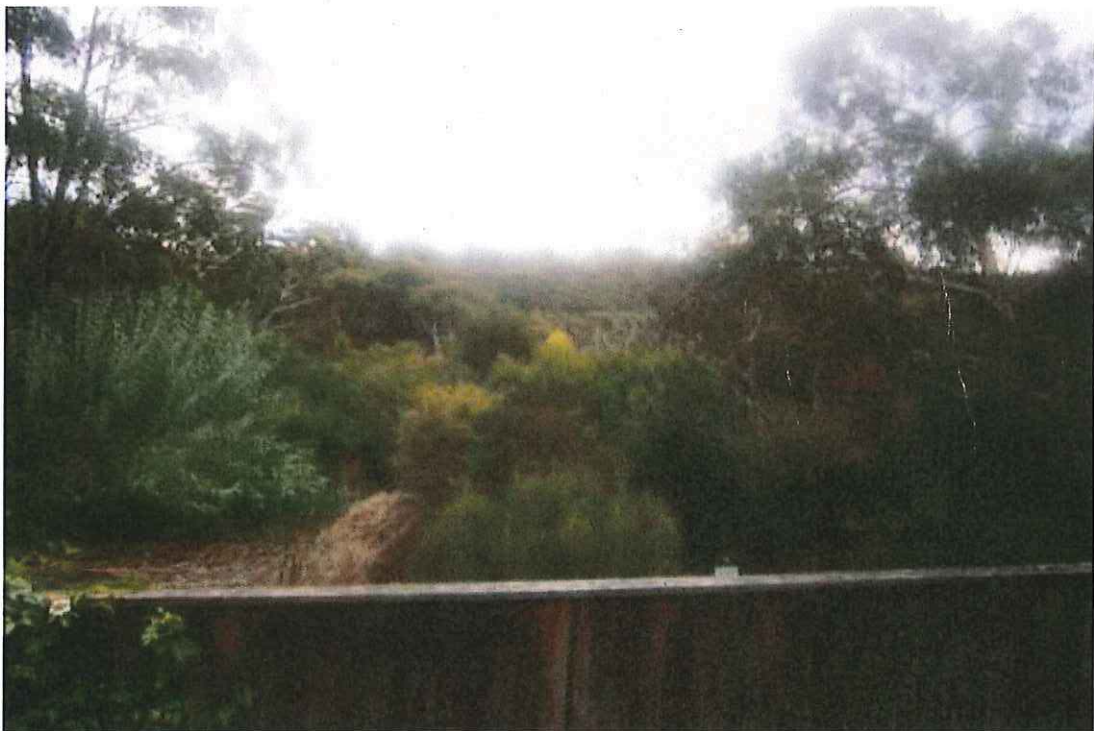
View of bushlands surrounding property, showing the close proximity of large trees to the property, making it high risk for termite infestation.
