Property Status	Ownership H / Ast. Status HB / Rep. Status	
Key	<input checked="" type="checkbox"/> MITM-2615525 WF	s11C(1) 15/01/2018 10:14
Raised From	<input type="checkbox"/> INSP-533205 WF PT Product Team 25/10/2017 09:00	
Invoice	<input type="checkbox"/> MINV-1574966 WF	Maintenance Use... 21/01/2018 08:53
Tax Invoice	<input type="checkbox"/> View Tax Invoice	
Status	<input checked="" type="checkbox"/> Maintenance Done	
Summary	s11C(1)(b) - business : GMATM : Ease and adjust gate Repair broken fence pailings appro...	
Location	Rear Yard	
Fixture Maint. Type		
Charge Type	P (Ready House)	
Maintenance Code	GMATM: Grounds maintenance T&M	View Spec.
Estimated Price	\$250.00	
Contractor Instructions	Ease and adjust gate Repair broken fence pailings approximately 4. Install sleeper along rear RHS fence.	
Access Details

Visual Termite Inspection Report in accord with AS 3660.2-2000

Account To:	DEFENCE HOUSING AUSTRALIA	Phone:	
	SUITE 3-6, 240 WATERWORKS RD	Fax:	07 3294 2660
	ASHGROVE QLD 4060	Invoice No:	0000
Re: Structure at:	[REDACTED]		
Date Inspection:	08 May 2018	Report No:	s11C(1)(b) - business [REDACTED]

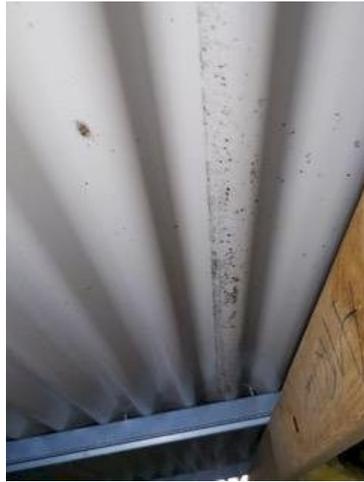
Mould evident on the underside of the sheets

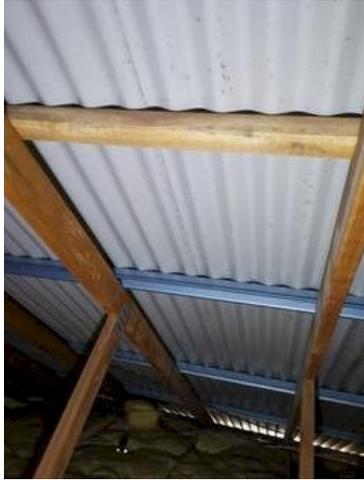
Sheet 1m from gutter has evidence of mould

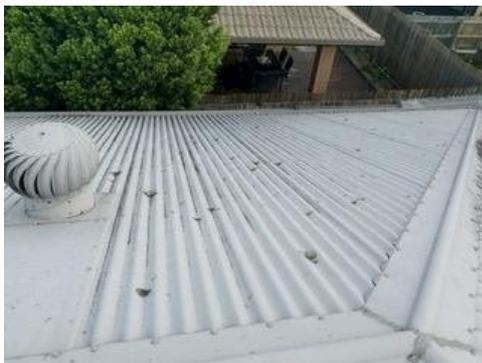
Evidence of mould on roof sheeting

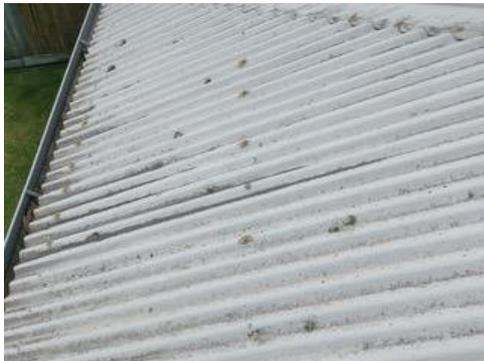
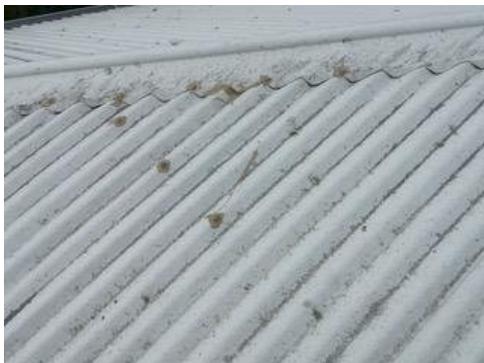
Scribed ridge capping on rear elevation
Leaf debris underneath

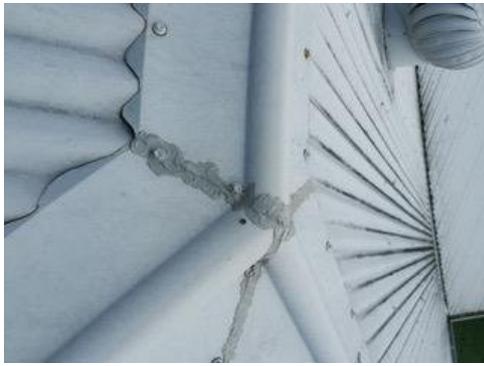
Gap evident on scribed ridge capping

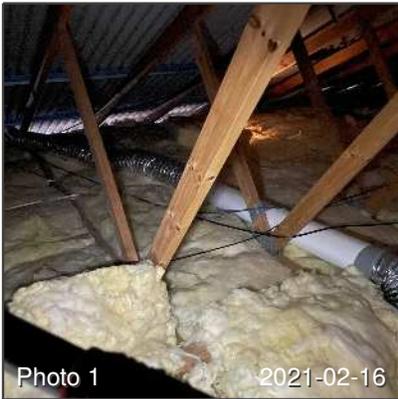
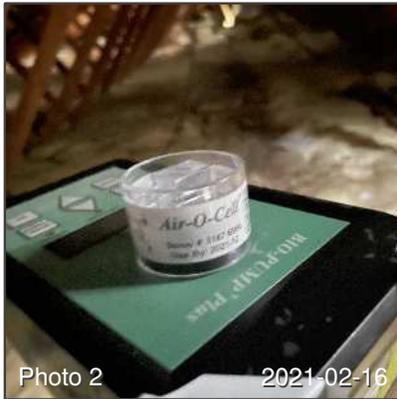
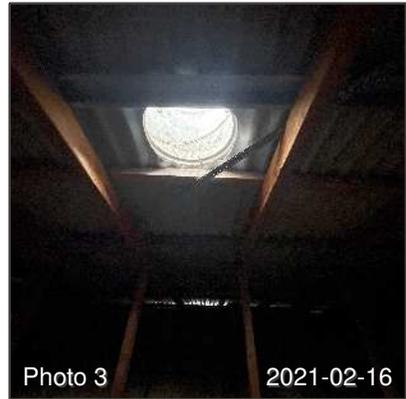
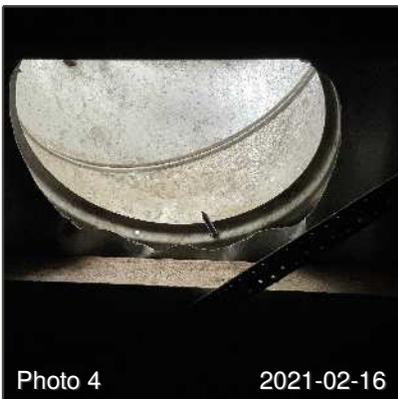
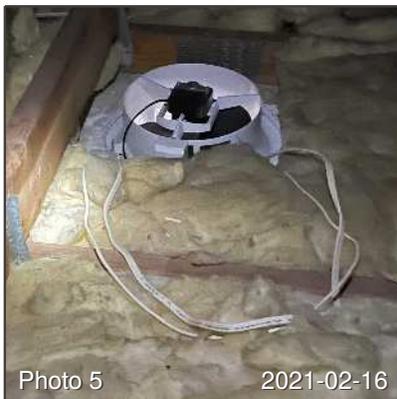
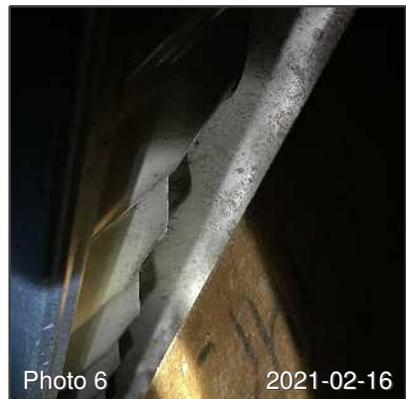
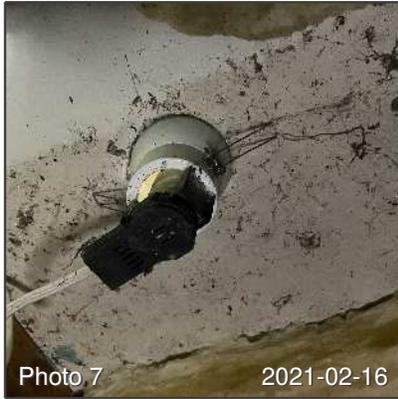
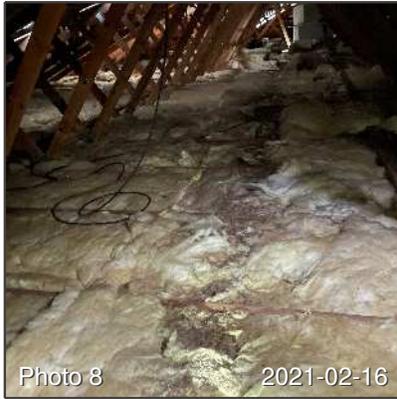
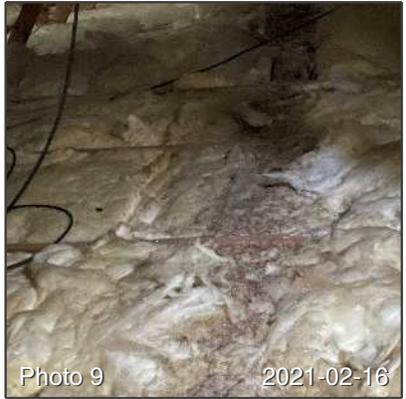
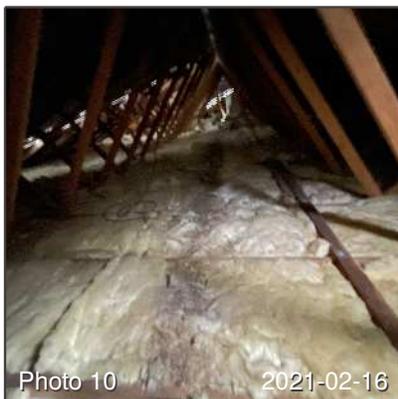
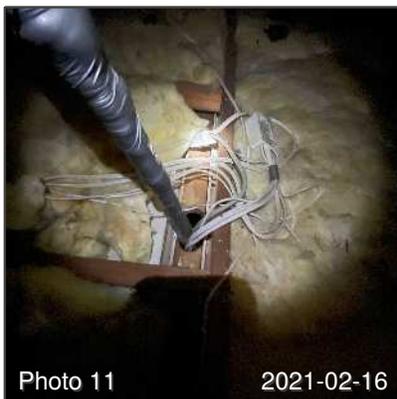
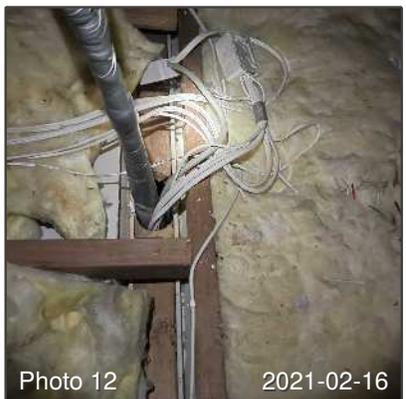
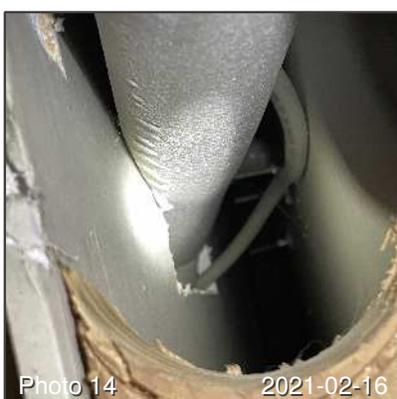
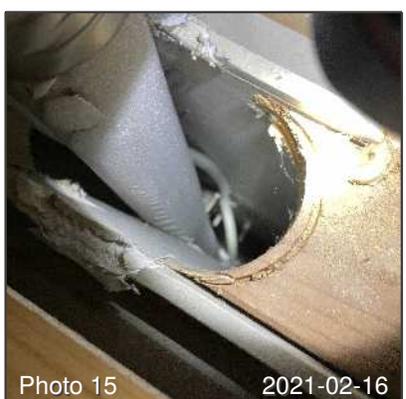
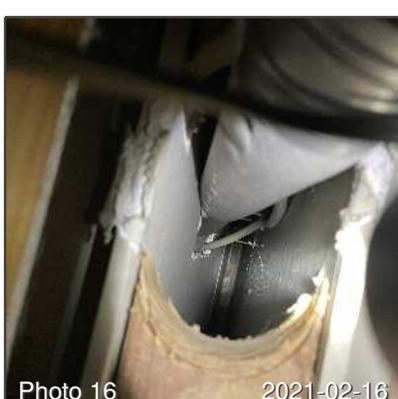
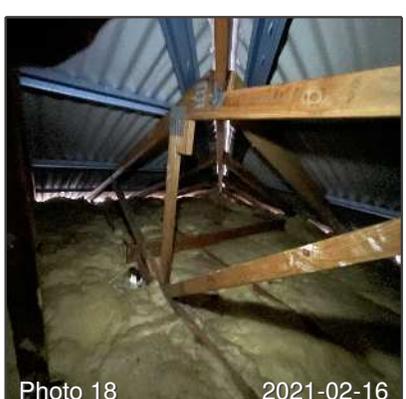
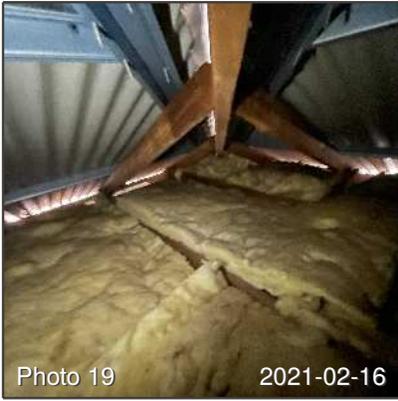
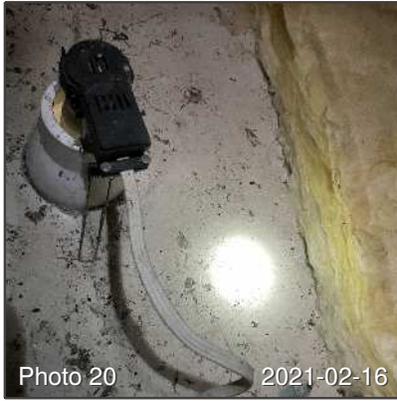
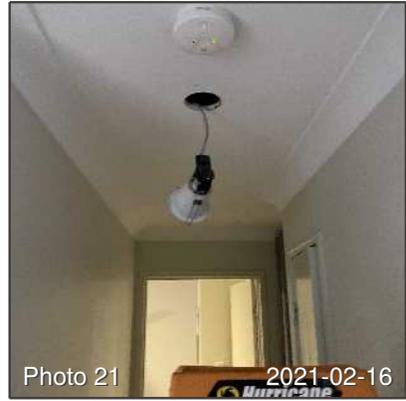
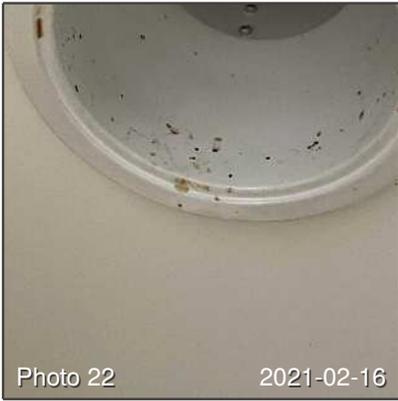
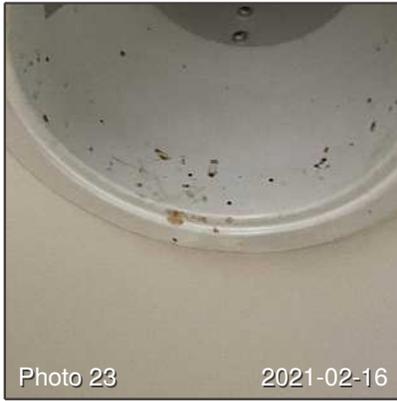
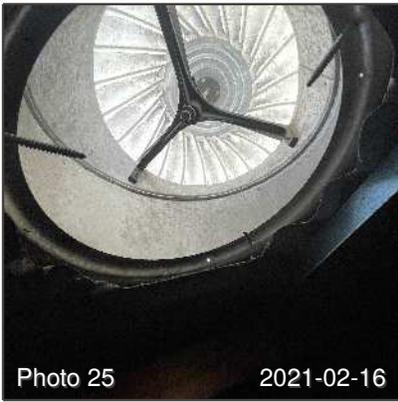
OVERVIEW PHOTOS: Ceiling Space

Note: All sections under ridge capping and valley gutter directly affected with visual damage, dirt, water depressions and contamination beneath ridge capping and valley gutters. (see results test sample #5)

7) Remove/replace ceiling insulation batts

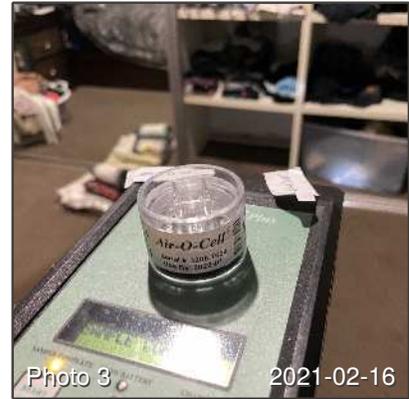
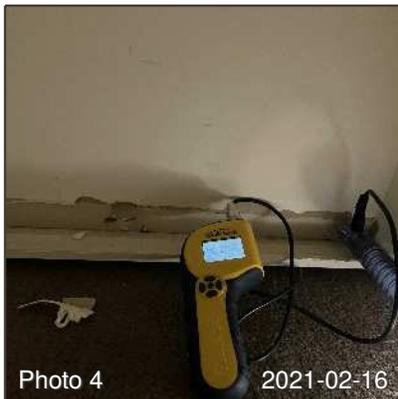
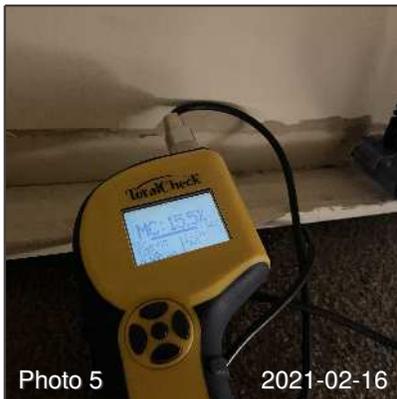
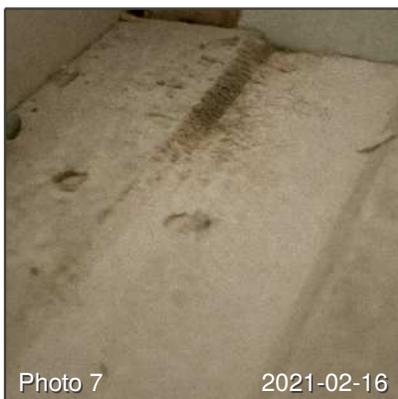
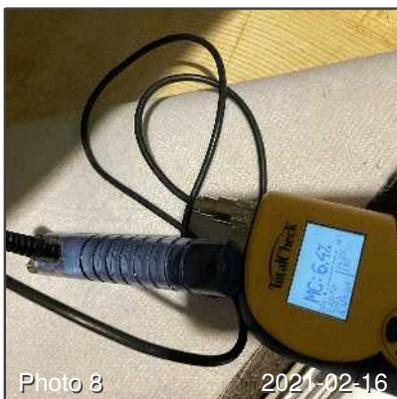
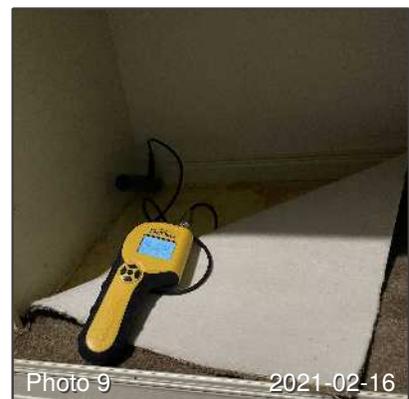
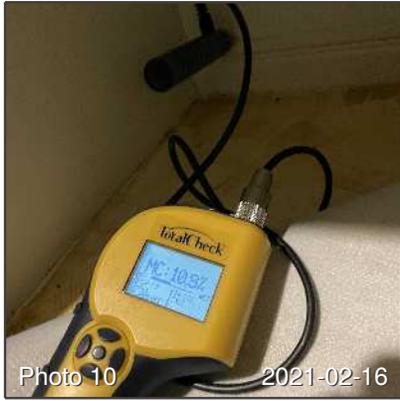
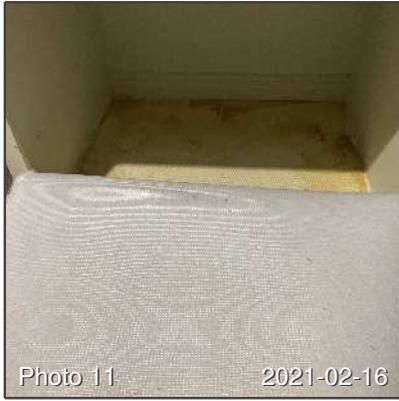
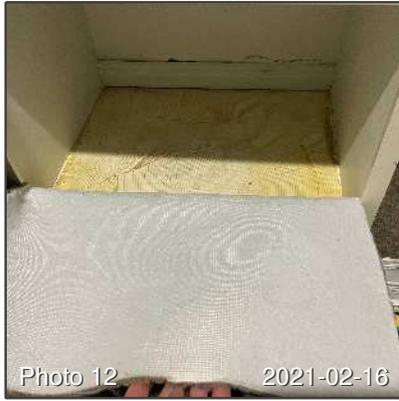
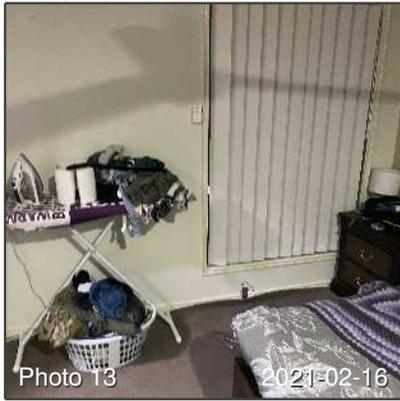
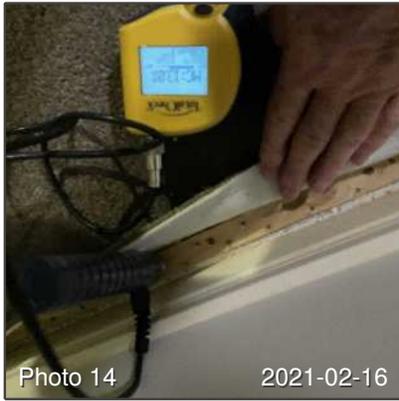
OVERVIEW PHOTOS: Bedroom 1& Ensuite

Note: Visual mould growth on back side of skirting board found (see results test sample #9)

Note: Minor visual damage/separation from wall in this area

2) Replace 2 skirting sections in bedroom 1 robe. Mould remediation required to property before reinstatement.

4) Remove skirting 3 sides of walls backing onto ensuite shower, if mould found then wall sections for removal/remediation and subsequent replacement
